Report from HERA

58th Physics Research Committee Meeting at DESY

October 28, 2004

F. Willeke, DESY

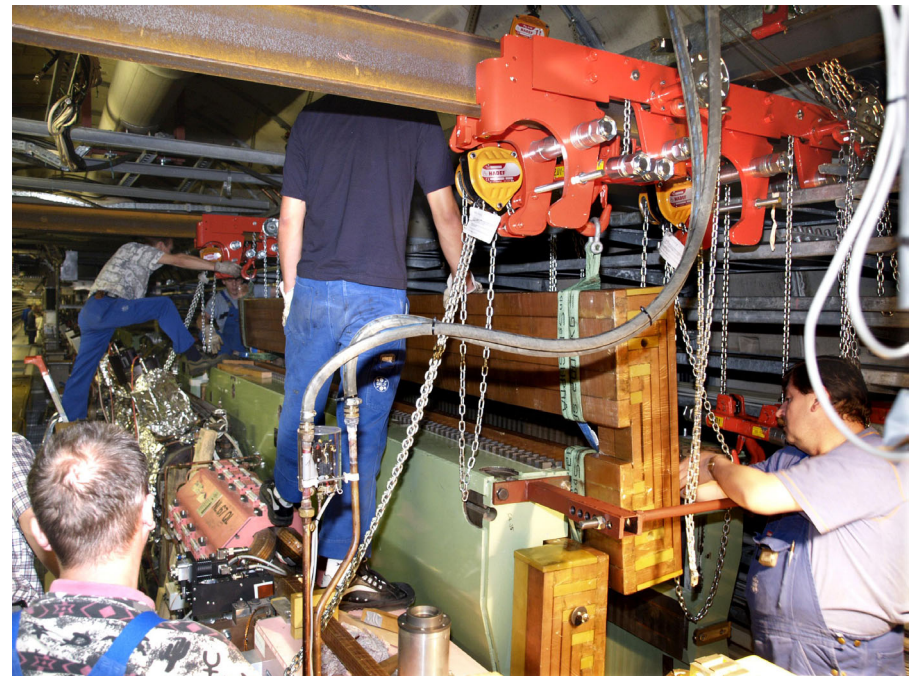
Coil Refurbishing Vertical n.c. BU Dipole Magnet in HERA p

- Needed to bend proton beam upwards at both ends of the IR
 - There are 3 Magnets on both sides of the IP in the three IR-s
 - = 18Magnets
 - Magnets develop ground faults because of water leaks of the brazed Cu conductor
 - All coils tested so far ~8 have leaks
- ➔
- Refurbishing program
 - This shutdown: 6 Half coils NL replaced
 - 8 more coils ordered for later replacements

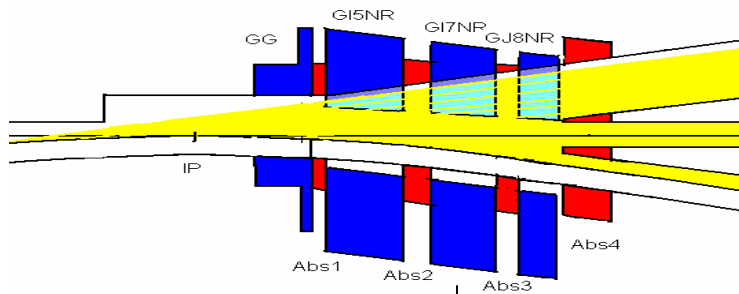
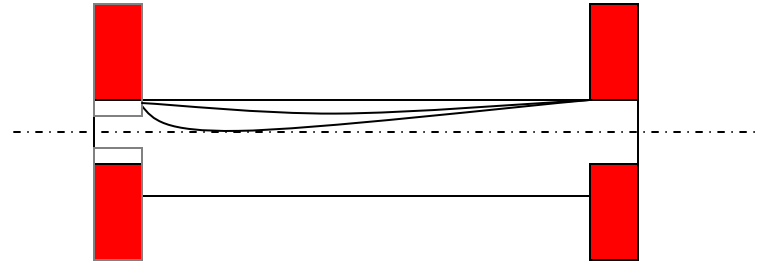
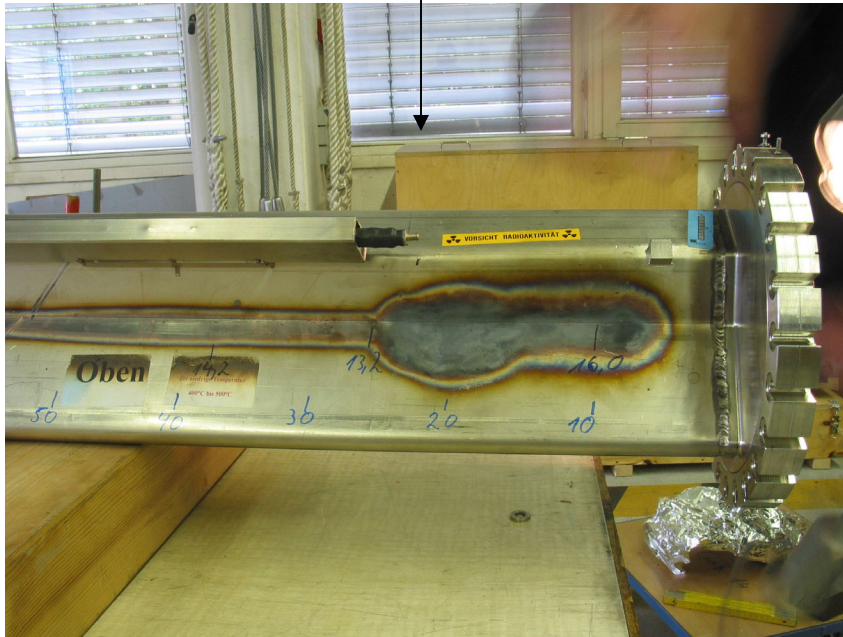
Pipe of GI NR7m hit by direct Synchrotron Radiation

Measures:

Restauration of absorbers 2
→ planned to be installed 2005

Improved Temperature survey
→ implemented

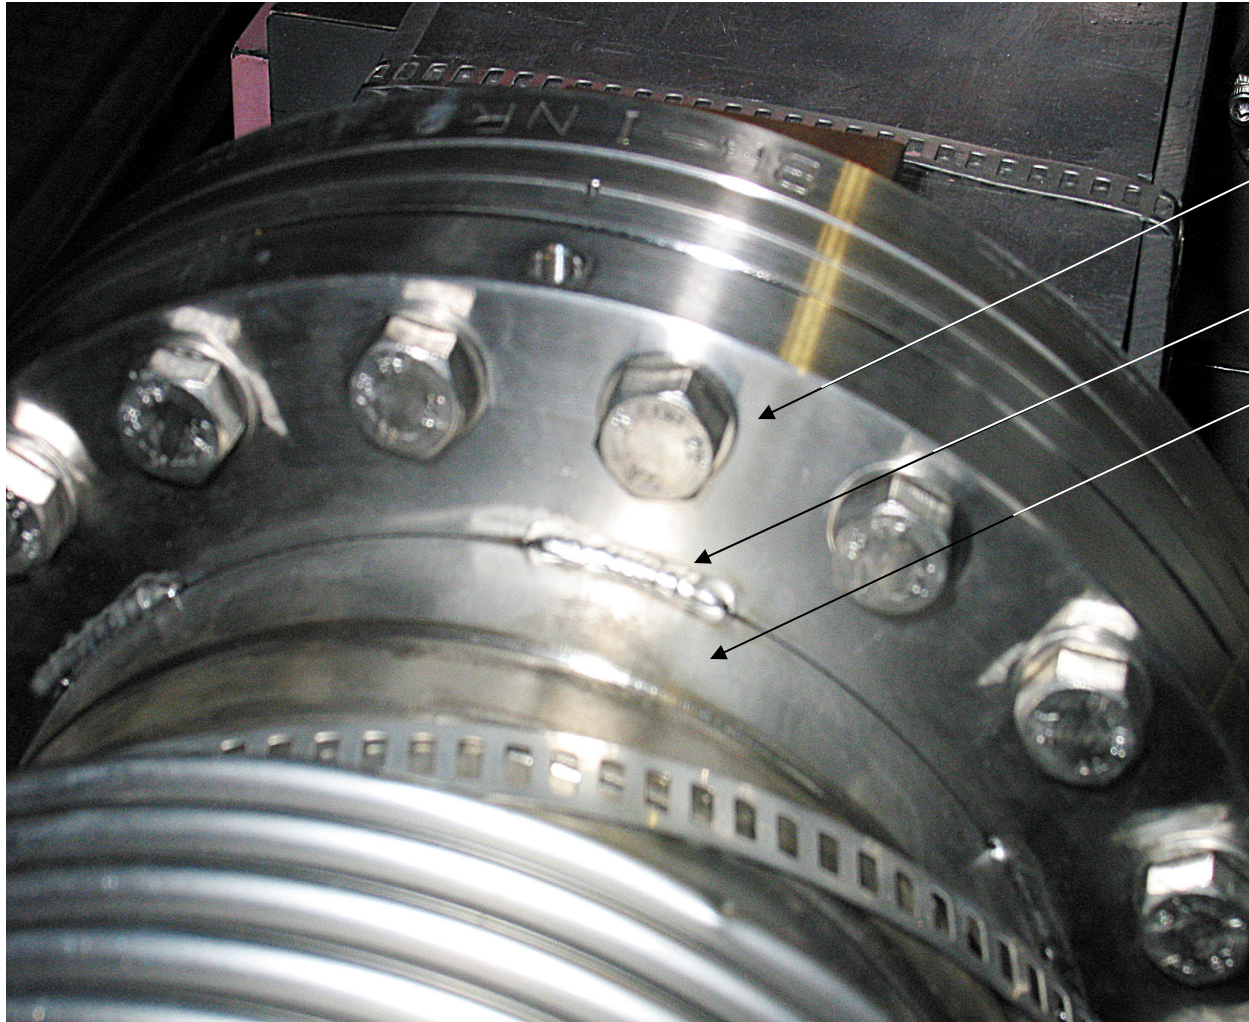
Shielded Bellow Rotator NR/SR- Support Welds

Bordscheibe
Conflat Flansch

Neue Stütznahte

Wassergekühlter
Edelstahlabsorber
