H1 Forward Silicon Tracker: water damage

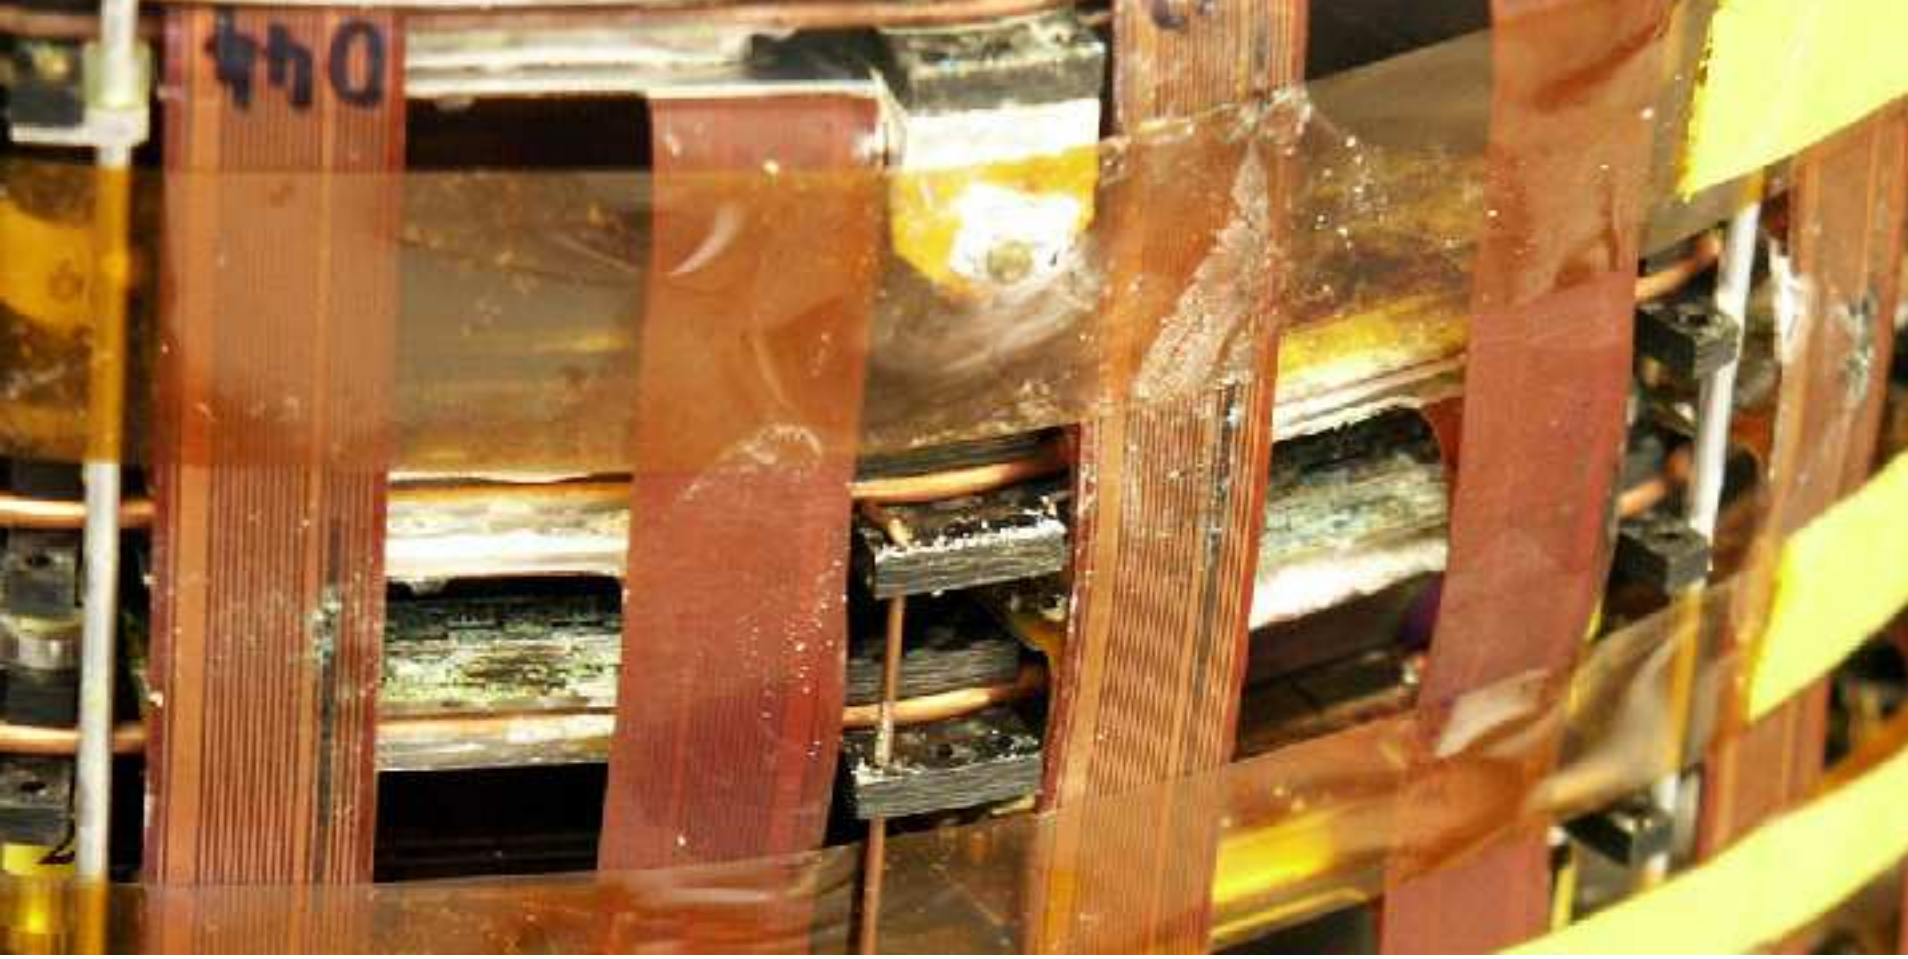
- Corrosion of Cu traces on PCBs.
- Most likely caused by small water leak. Chemistry not understood.
- H1 check lists indicate possible loss of 0.4–0.8 l of cooling water in April–May 2004.
- Investigations are ongoing in Zeuthen.
- BST is fine. Installation decision on Monday.

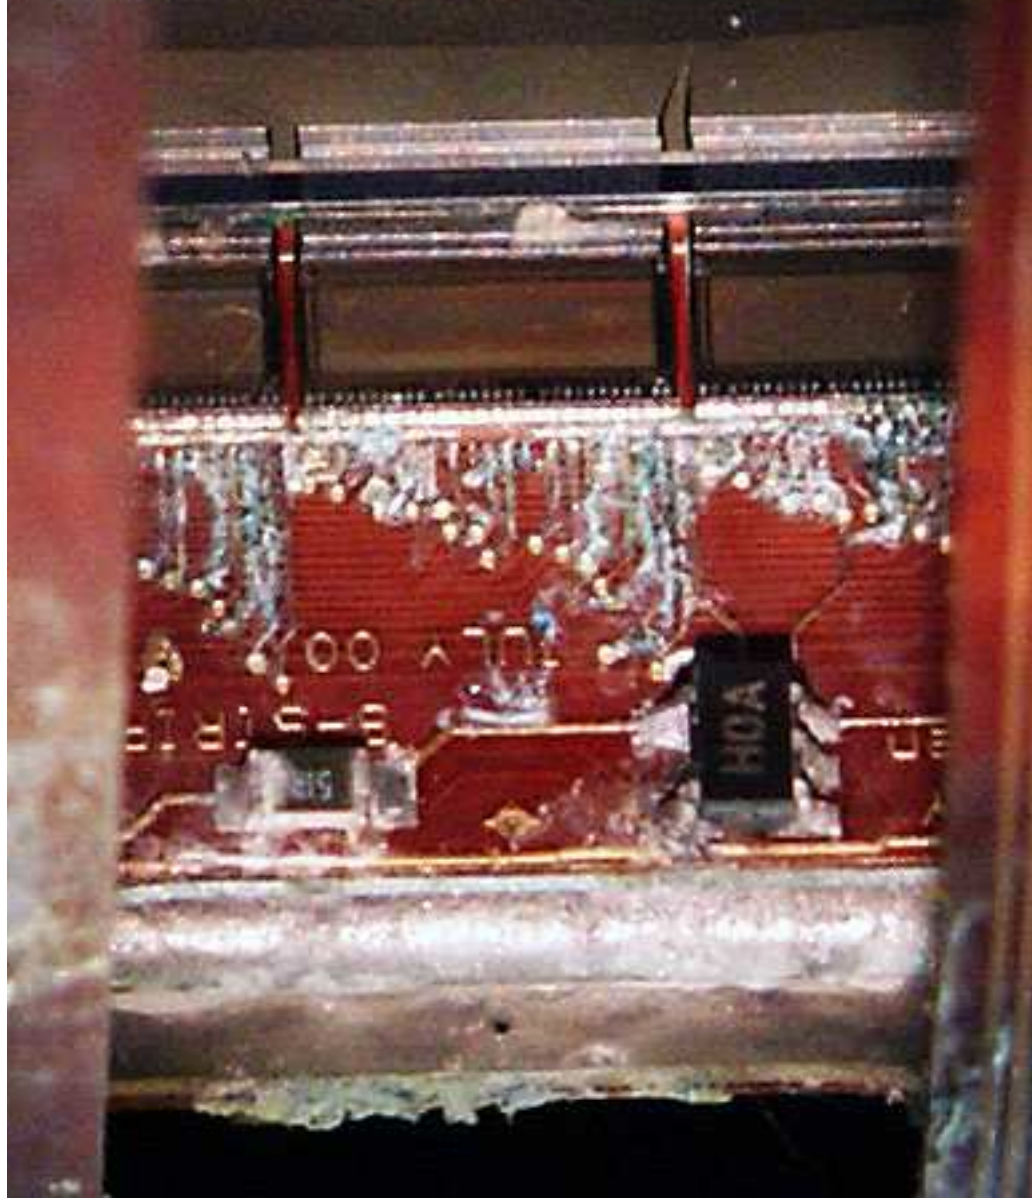
FST: water damage

- 4 of 7 wheels have corroded hybrids.
- Consistent with the damage pattern observed in May 2004.
- Corroded wheels have good water flow: condensation.
- Clean wheels have blocked cooling pipes.

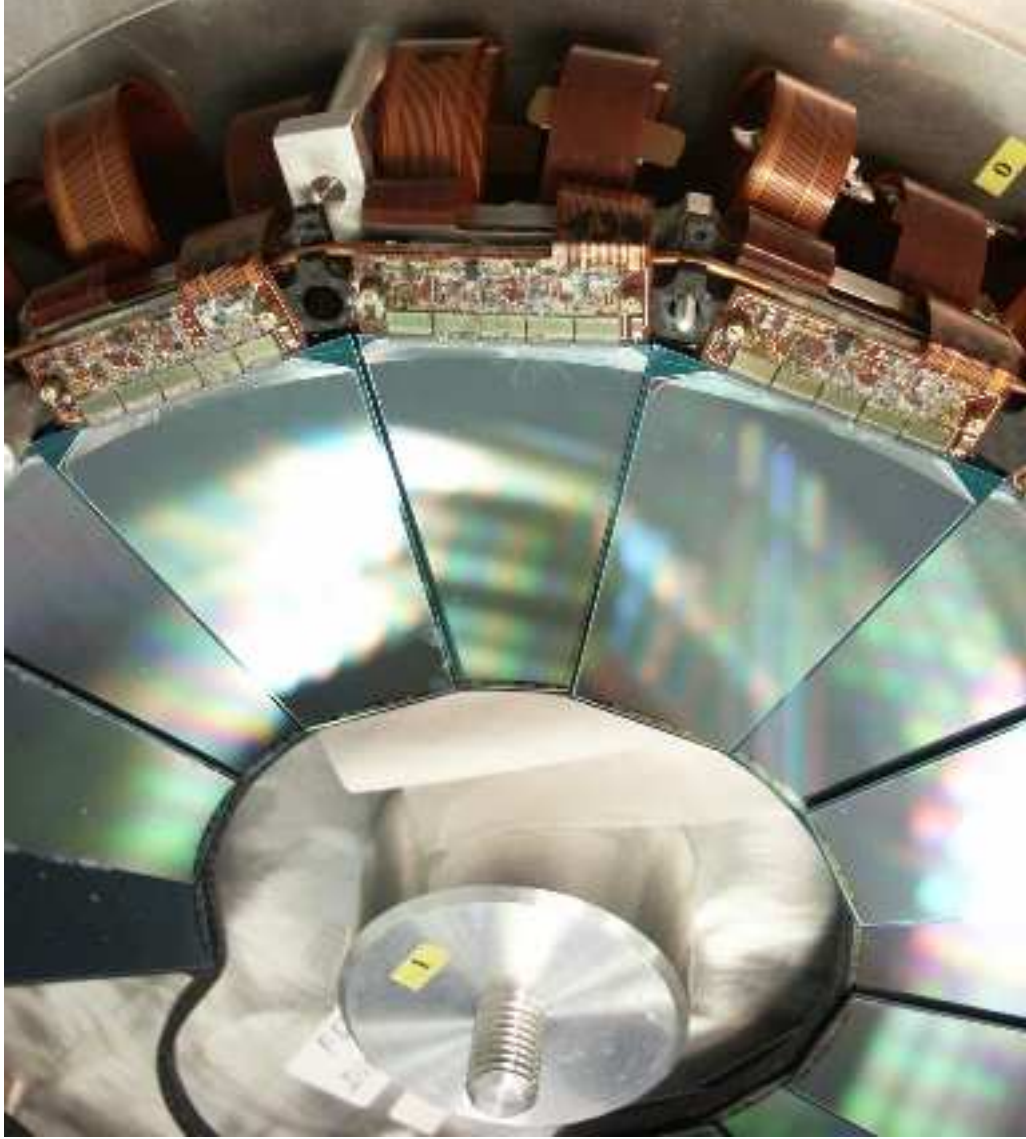
Damaged FST under the microscope

- Corrosion on hybrid traces.
- Deposits on APC readout chip.
- Damage to Si sensor bond pads likely.

- Order new Si sensors for FST (need 120) at CIS Erfurt. Production capacity available.
- Order new hybrids. Prepare bonding.
- Tests on possible radiation damage underway in Zeuthen.
- Design of radiation hard readout chip continues.
- Rebuild cooling manifolds.
- Consider different cooling medium.
- Install repaired FST and BST next summer shutdown.

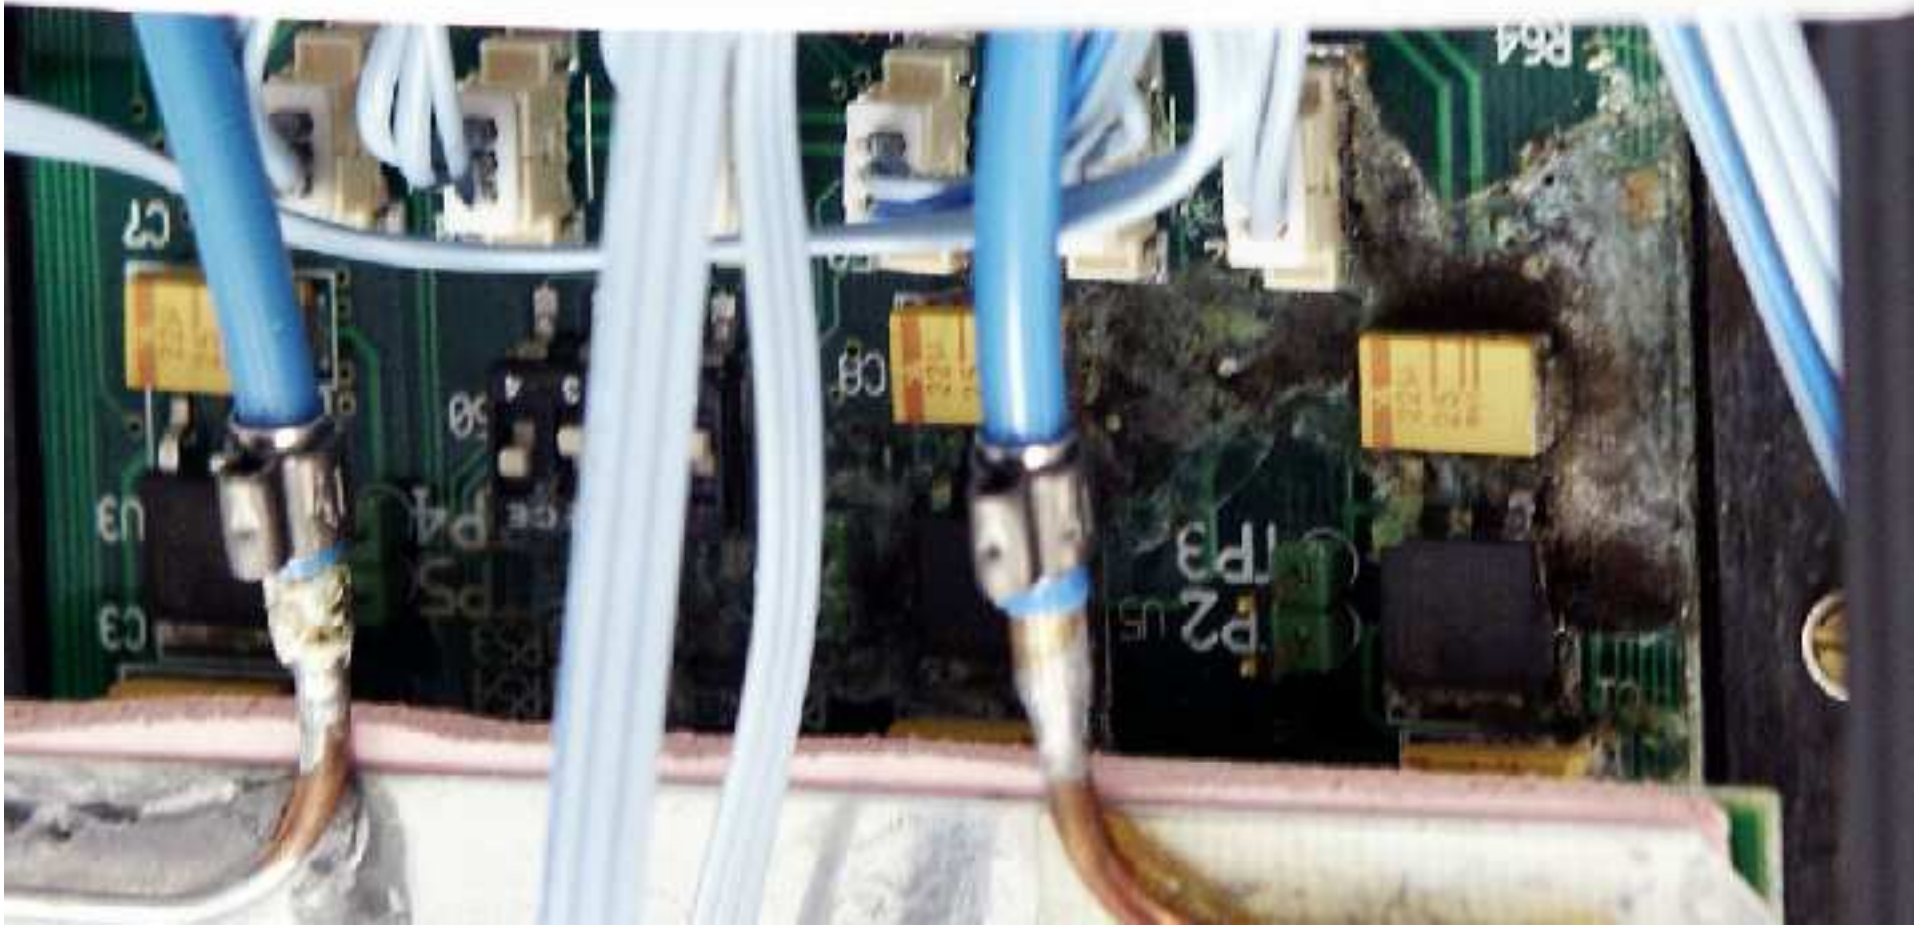
FST leak was here

- Bad crimp connection.
- Developed leak after aging of plastic tube.

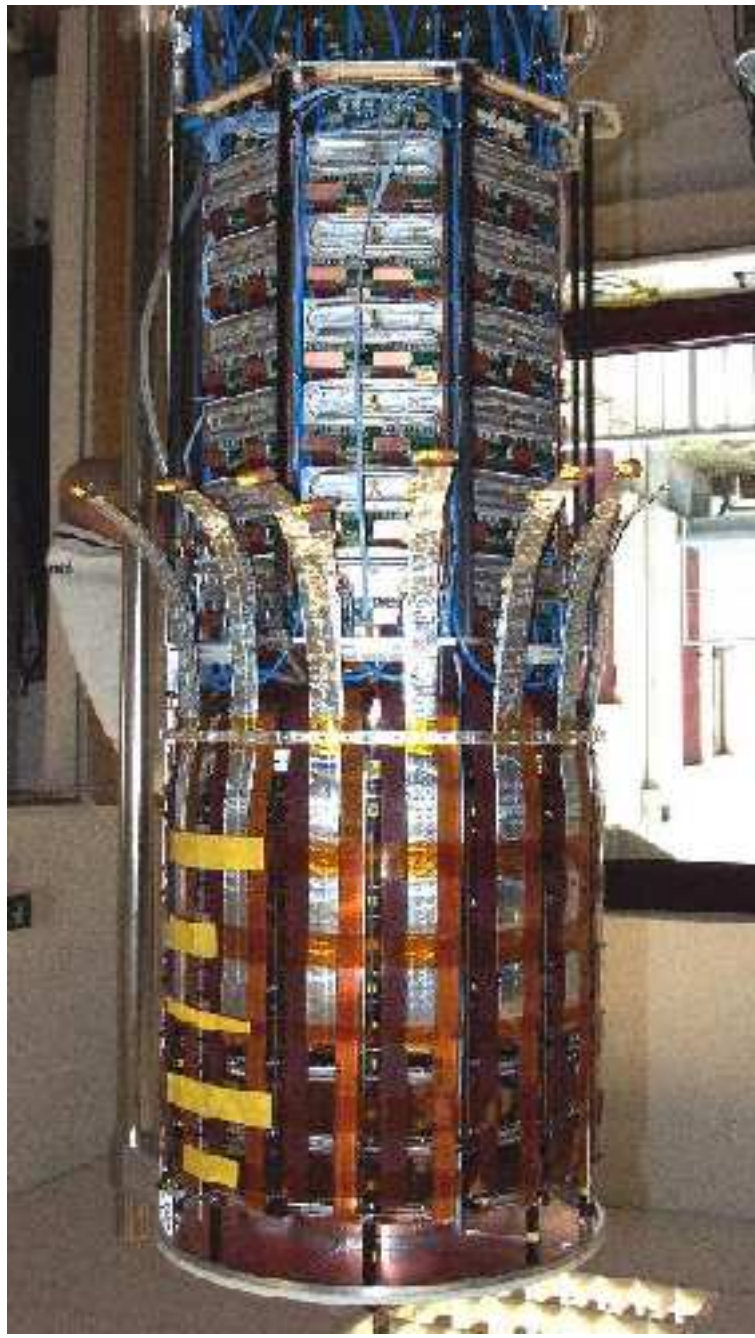
H1 Backward Silicon Tracker: blocked cooling pipes

- 3 of 6 BST Pad repeater boards have blocked cooling pipes: noisy pad trigger regions.
 - One strip repeater was not cooled: inefficient tracking.
 - 6 of 10 Si wheels are badly cooled. Dosimeters: 25–58 Gy. SacMOS readout chips degrade after 100–150 Gy, dead after 300 Gy.
- ⇒ BST stays for repair in Zeuthen.

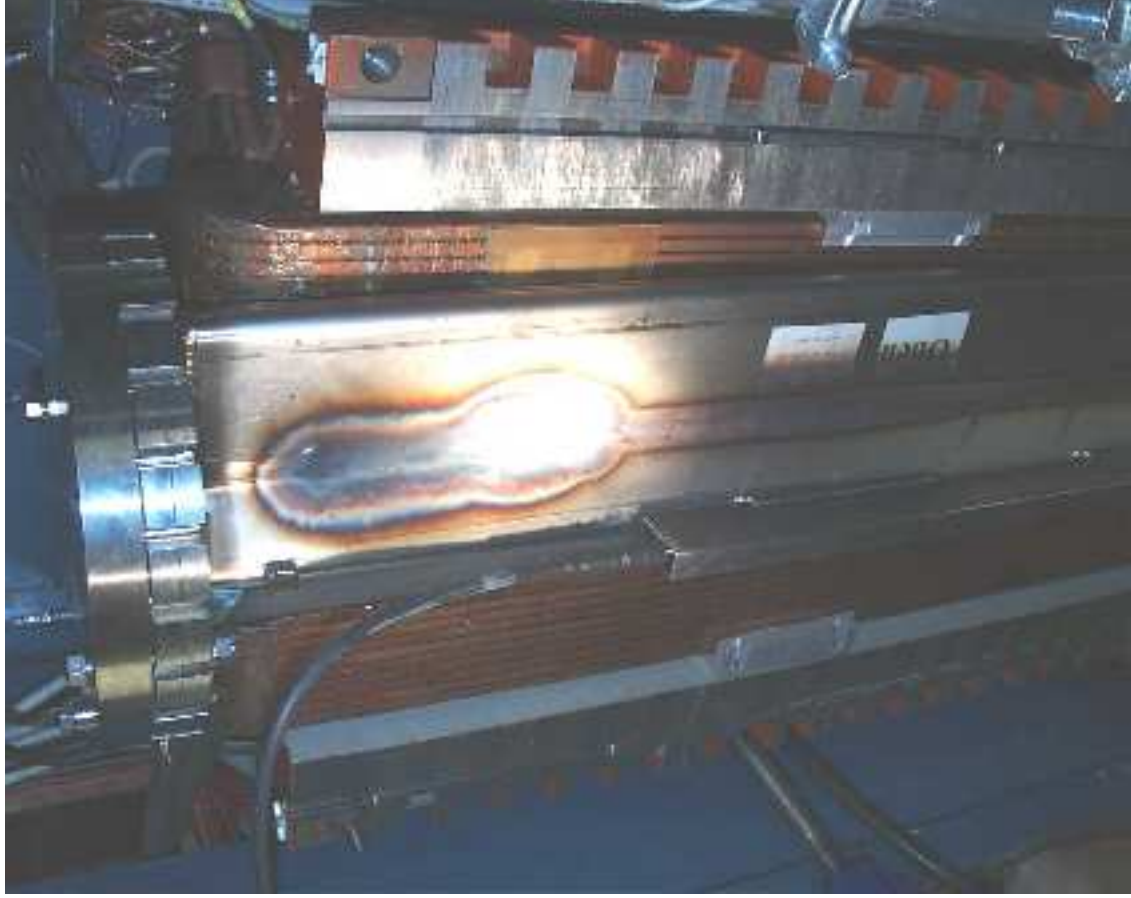
NR6 G12 beam pipe burned and deformed

- Install temperature sensors.
- Monitor vacuum pressure.
- Connect BTS counters to e beam dump.

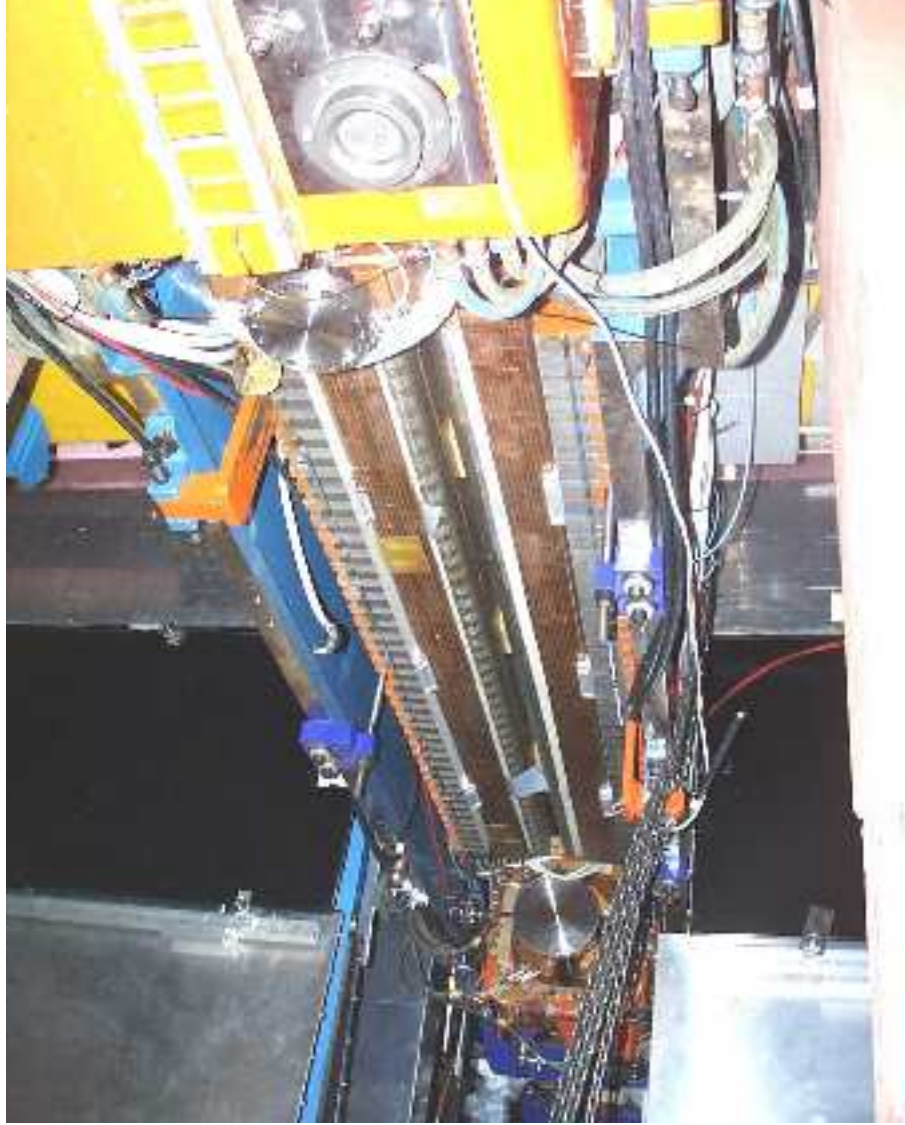
GI2 magnet opened

- Burned coil exchanged.

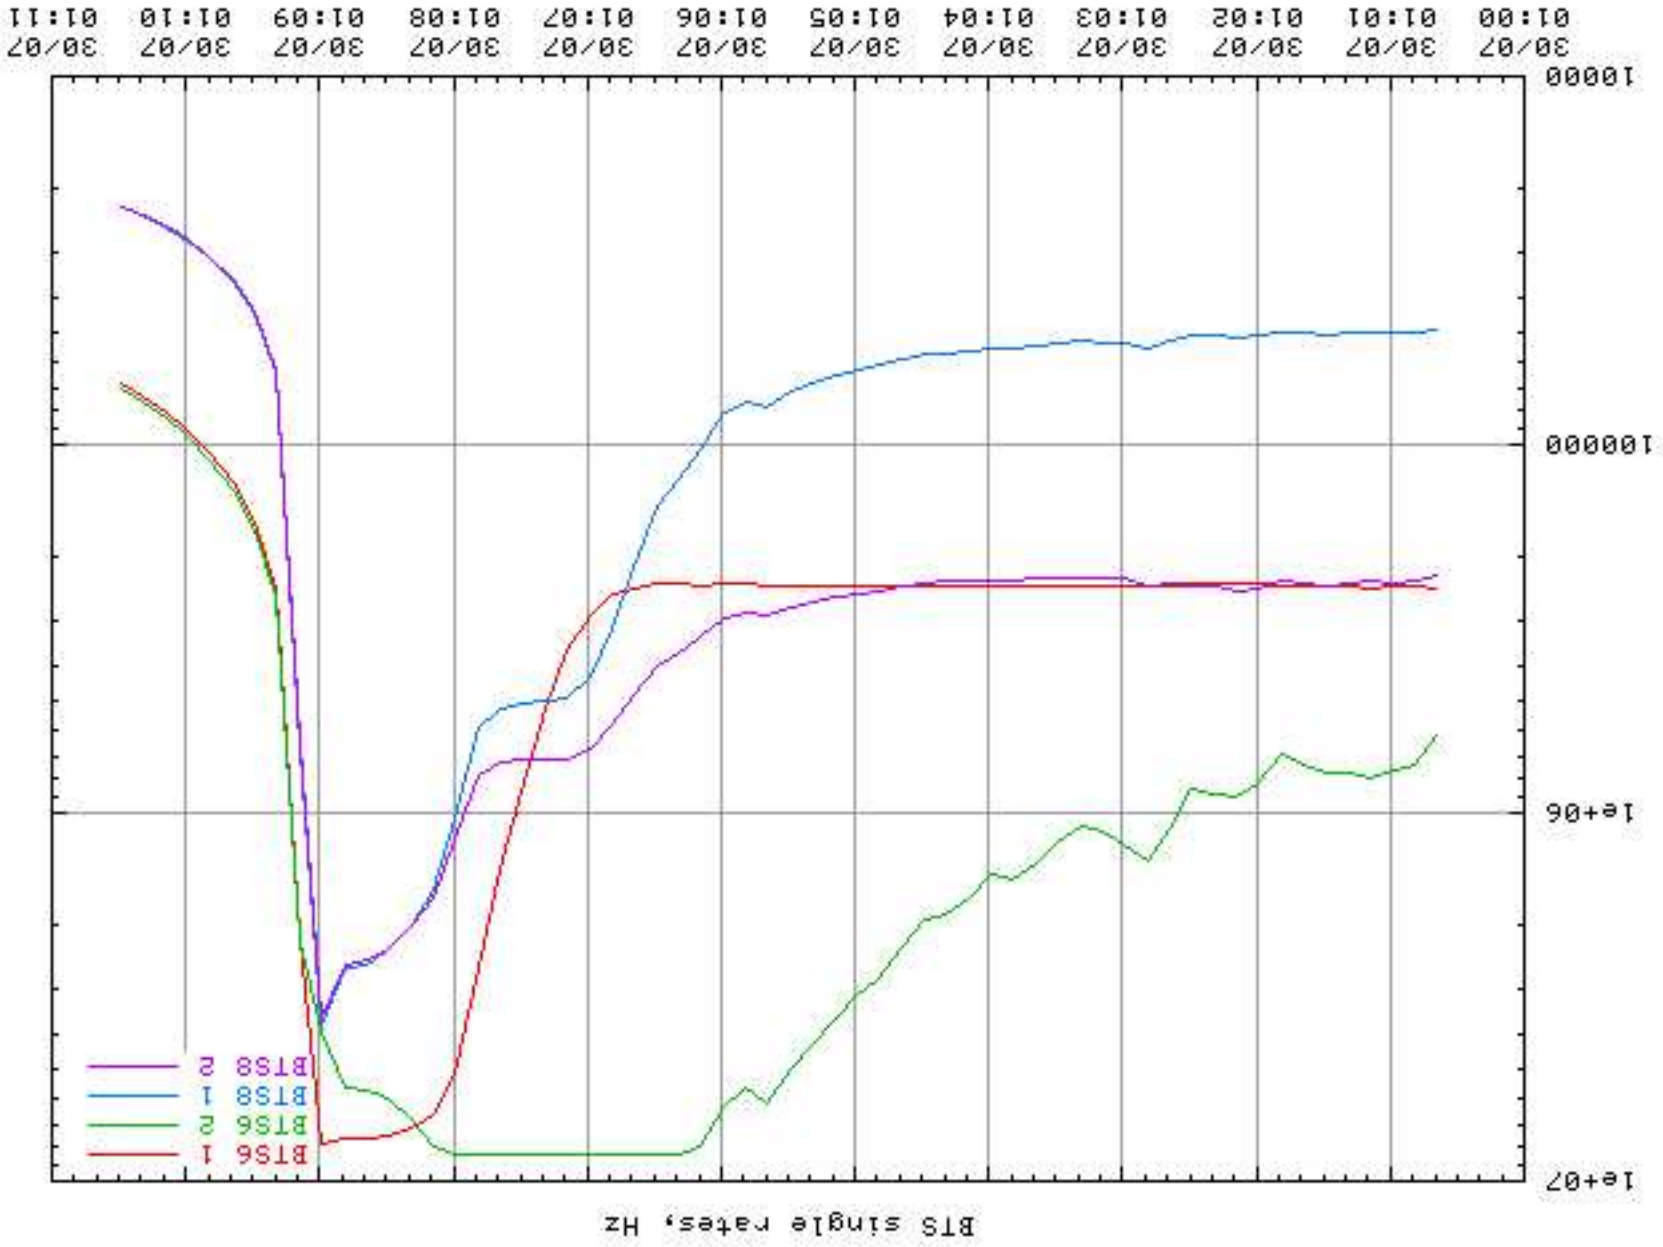
BTS counter during gas burst on 30.7.2004

- BTS6.2 reacts 2 min before chamber trip.
 - Chamber trips at onset of gas burst.
 - Beam loss is another 1.5 min later.
- ⇒ Plenty of time for a BTS beam dump signal.
