PETRA-III 500 MHz Cavity

Status Report

Michael Ebert
DESY-TEMF-Meeting
Hamburg, 23.01.2017

Unsolved Reflected Power Trips „r events“

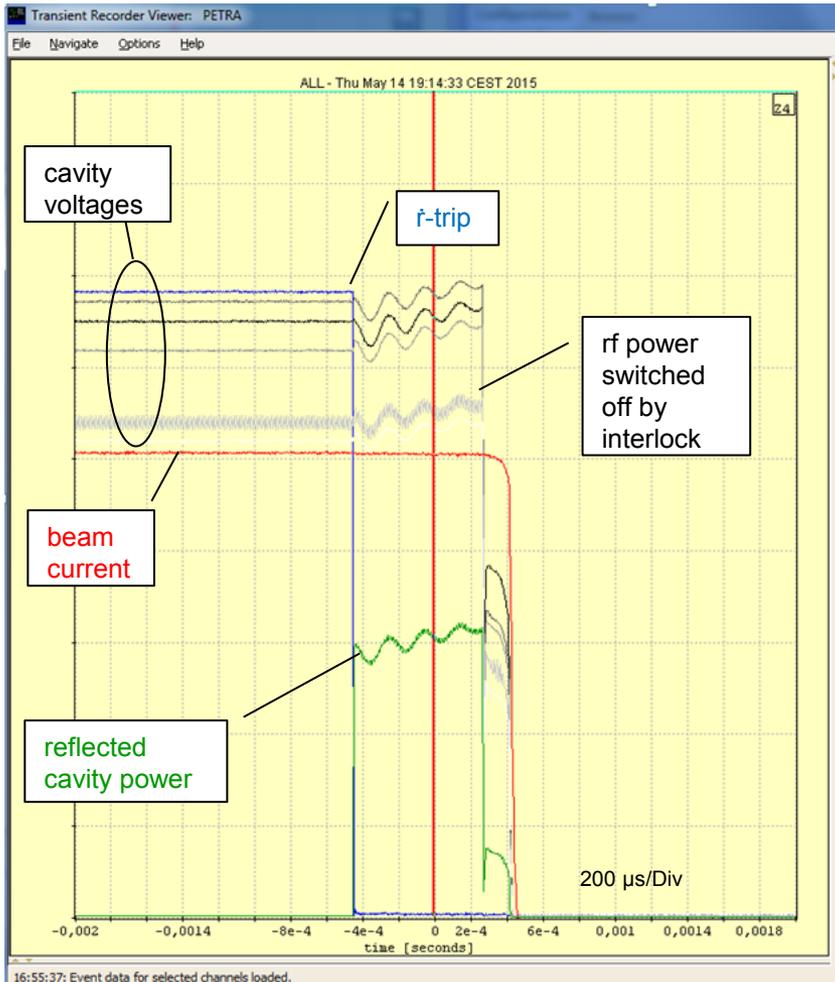
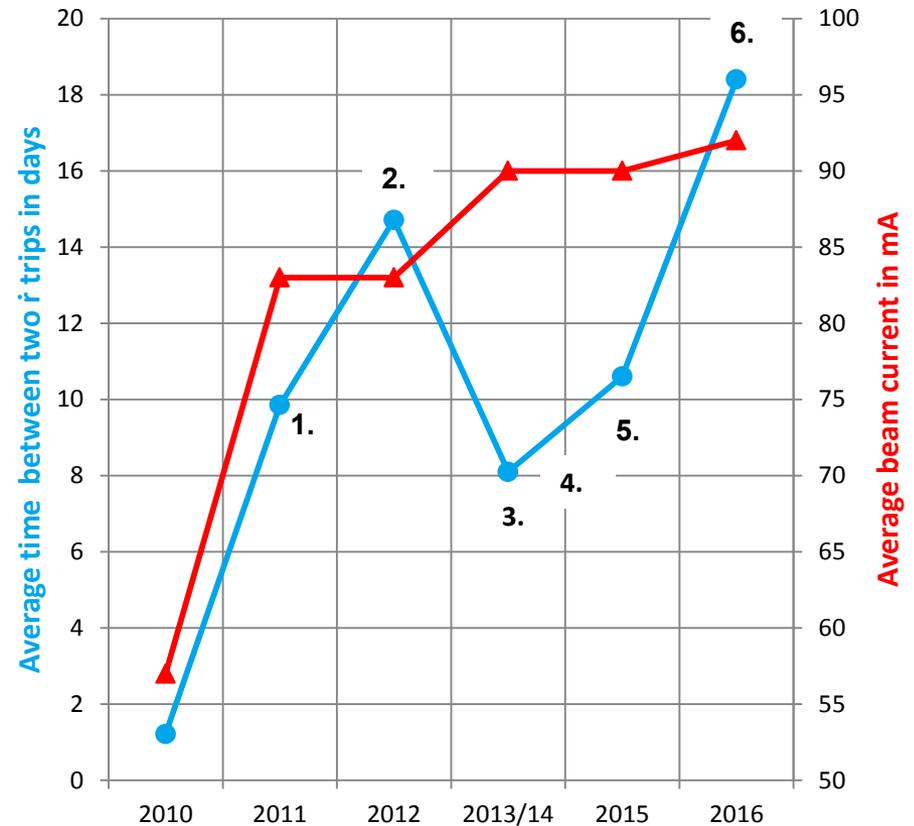
Development of the r event rate over the last years

1. Cavity temperature controller installed to detune harmful HOMs
2. Temperature tuning seemed to be successful
3. Increased beam current destroyed our confidence
4. A new finding led to new hope
5. Measures taken seemed to help, but a different problem occurred
6. Measures have finally been successful

We now have a medicine, but we still do not know the cause of the problem

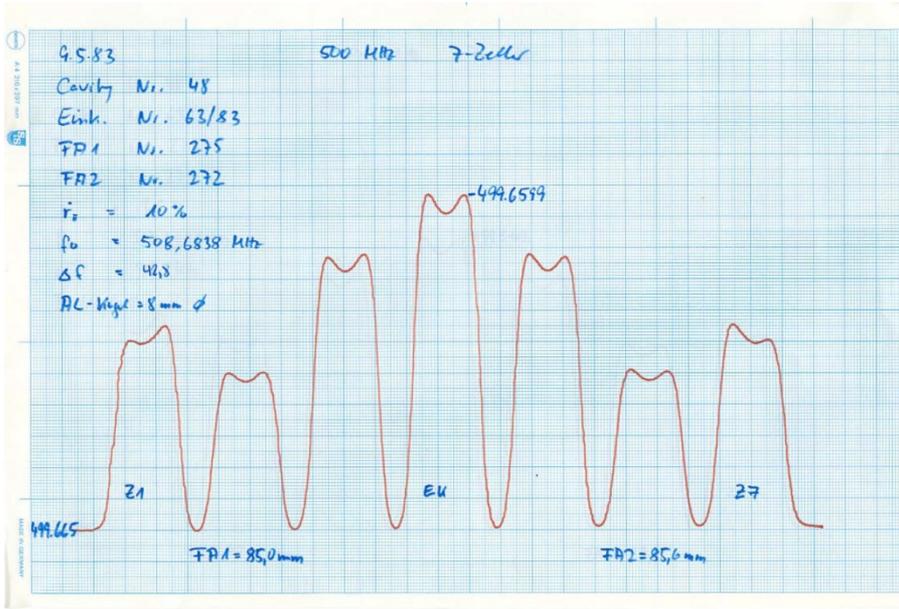
Field pattern of reliable cavities

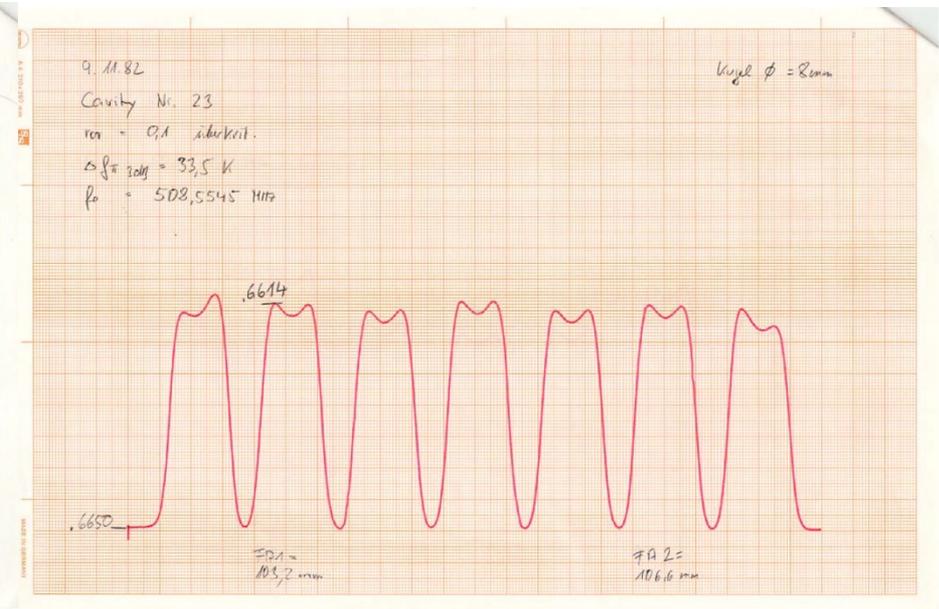
Field pattern of unreliable cavities

By heating the unreliable cavities up to 70 °C we could change the field pattern and turned **unreliable** into **reliable**

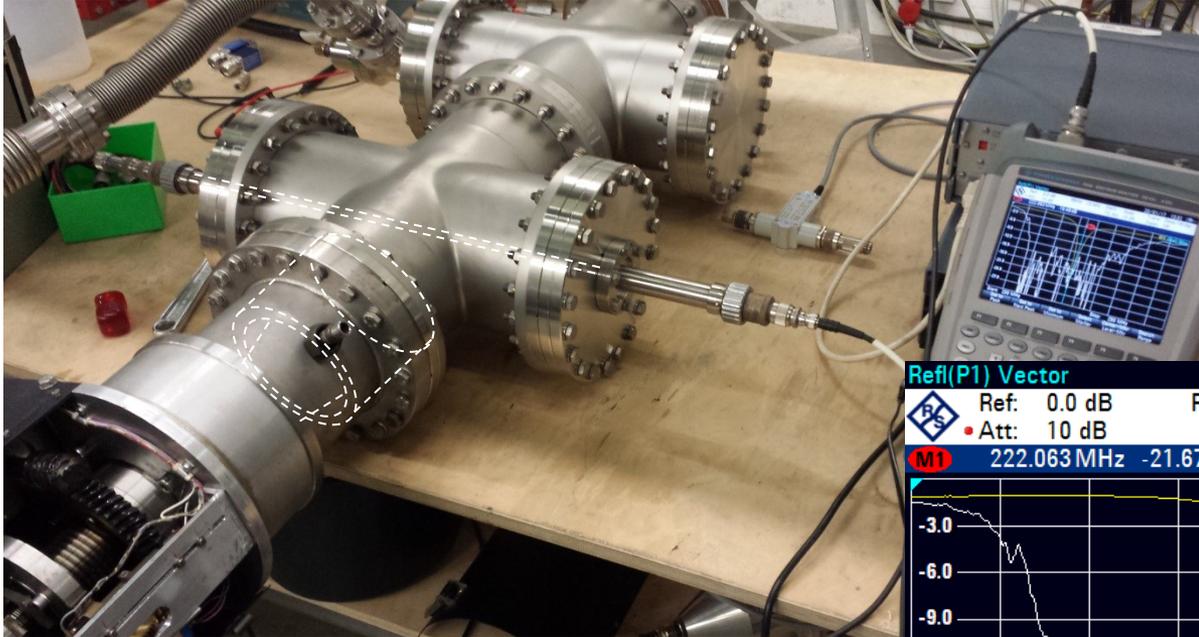
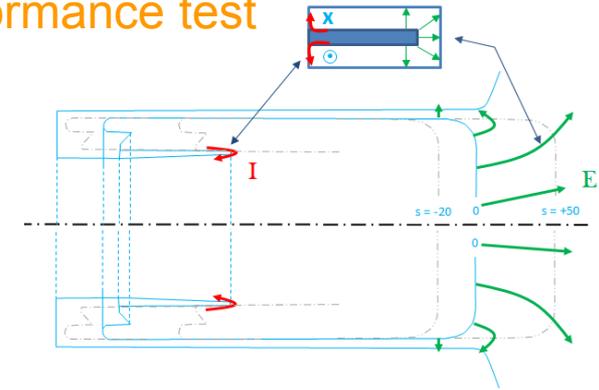
New invented plunger test-apparatus for survey and performance test

- > Plunger exited as coaxial $\lambda/4$ - resonator
- > Observation: Resonance is jumping up/down and back/forth during the plunger runs
- > This finding could be well explained by contact problems
- > **Question: How could we measure this with the plunger mounted on the cavity?**

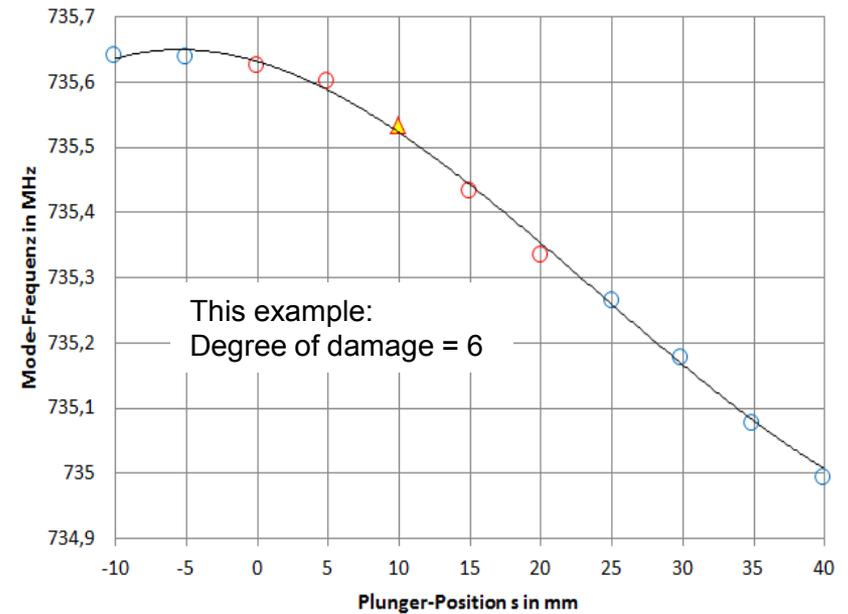
Plunger-SN 135 measured in Cavity-SN 48

degree of damage = sum of classification numbers

- kein Kratzen & Knacken hörbar (0)
- leichtes Kratzen & Knacken hörbar (1)
- △ Kratzen & Knacken gut hörbar (2)
- ◇ kräftiges Kratzen & Knacken hörbar (3) — Poly. ()

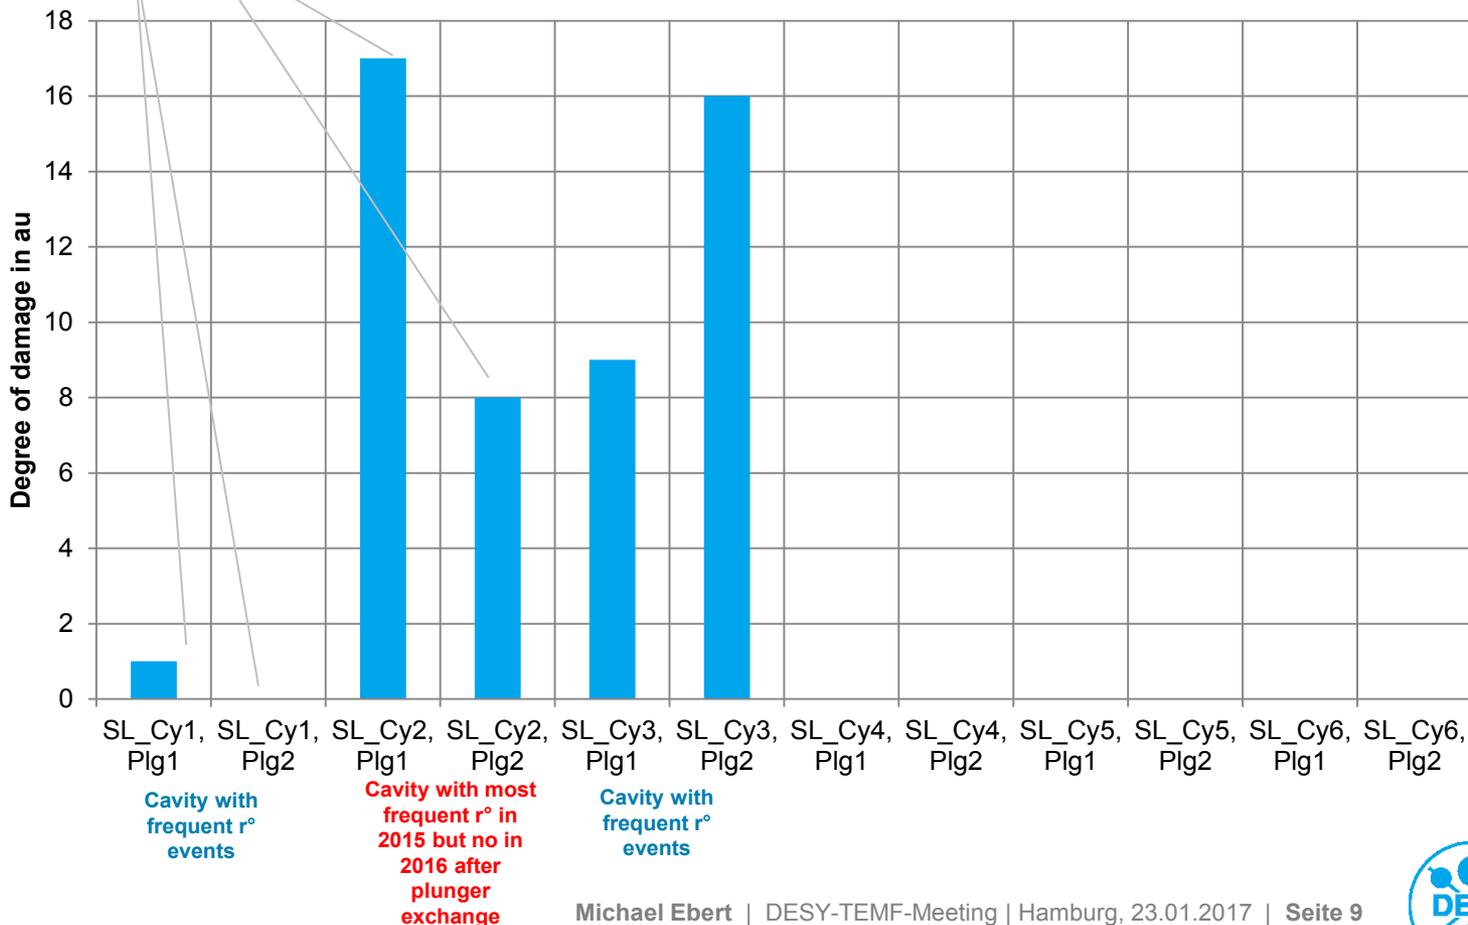
Plunger Contact Springs Degree of Damage

The result is completely unexpected and has potential for demotivation

It looks like Cavity 1 and Cavity 2 were swapped!?
