Aging Effects in the Central Jet Chamber of the H1 Experiment

Carsten Niebuhr

DESY, Notkestr. 85, 22607 Hamburg, Germany

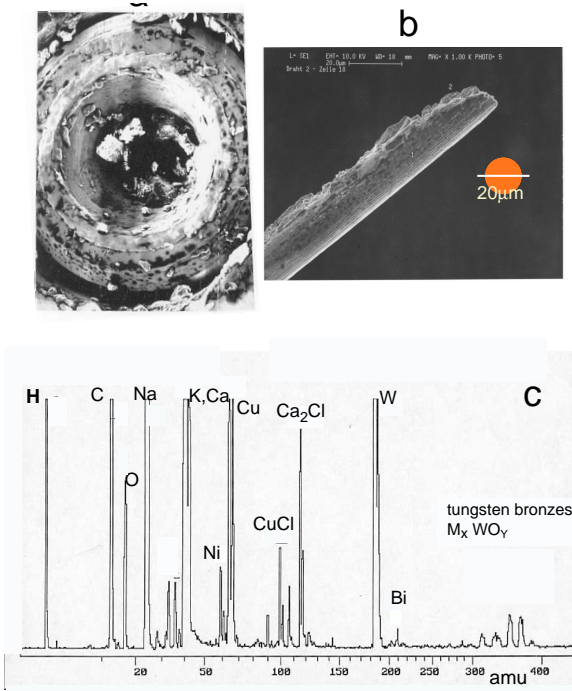
Figure 2a shows that there are lots of impurities around the 60 μm bore of the brass insert with sharp edges causing damage of the gold layer on the wire surface. The impurities are probably remnants from the gilding process of the crimp parts. The tungsten wire is therefore exposed to complex chemical reactions as can be inferred from the LAMMA spectrum in figure 2c of one of the wires which shows the presence of a large variety of chemical compounds involving other metals such as Na, Ca, and K. Particularly important are characteristic peaks between 300 and 400 atomic

Figure 2. (a) 60 μm bore of wire feedthrough with remnants from gilding process. (b) end of a broken wire. (c) LAMMA spectrum of wire end indicates the presence of hydrogen and tungsten bronzes.

mass units (amu) which suggest the formation of tungsten bronzes (of the form M_XWO_Y where M stands for the metal) and a peak at 1 amu which indicates the occurrence of hydrogen. Tungsten bronzes are known to become brittle when they dissolve sufficient amount of hydrogen. Taking also into account the observed fracture morphology (figure 2b) the most likely explanation for the effect is *hydrogen-induced brittle fracture* initiated by chemical reactions with remnants from the gilding process. However, it remains an open question why no such damage was observed in CJC 2 although the manufacturing process for both chambers was identical.

As a consequence, the whole production and cleaning process as well as the quality control of the crimp parts were significantly improved. In

the new design the brass inserts were replaced by jewels as are commonly used in watches. In the shutdown 1993/1994 all sense wires of CJC 1 were replaced and no further corrosive wire damage has been observed since then.

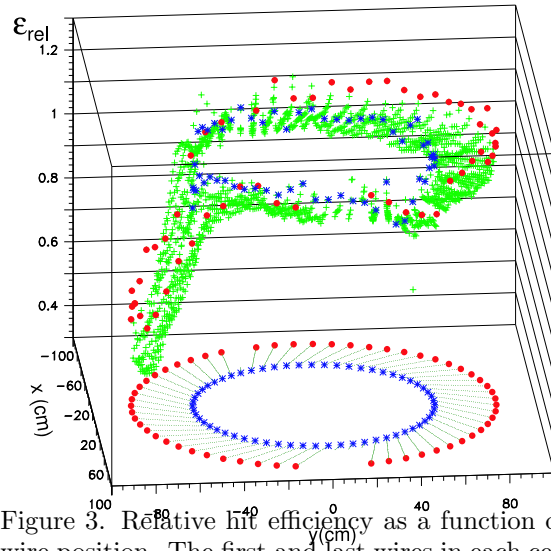
Figure 3. Relative hit efficiency as a function of wire position. The first and last wires in each cell (25 μm diameter) operate at lower gas gain and are shown with different symbols.

The situation at the end of the 1997 running period is graphically represented in figure 3, which shows the relative hit efficiency for CJC 2 wires as a function of their position in the chamber. A strong correlation between efficiency and y-coordinate (height) of the affected wire is observed. While for wires above $y = -30$ cm there is no sign of degradation visible, the wires below this level show an almost linear dependence of efficiency on height reaching relative hit efficiencies of about 30 % at the lowest point in the chamber. Wires were removed from the chamber and scanned using an electron microscope[5]. As an example, pictures of three wires together with a sketch indicating their original position in CJC 2 are shown in figure 4. The wires are coated

Although aging was only observed in the lower part of CJC 2, all sense wires of CJC 2 were replaced in the shutdown 1997/1998 making use of the improved design of the crimp parts devel-

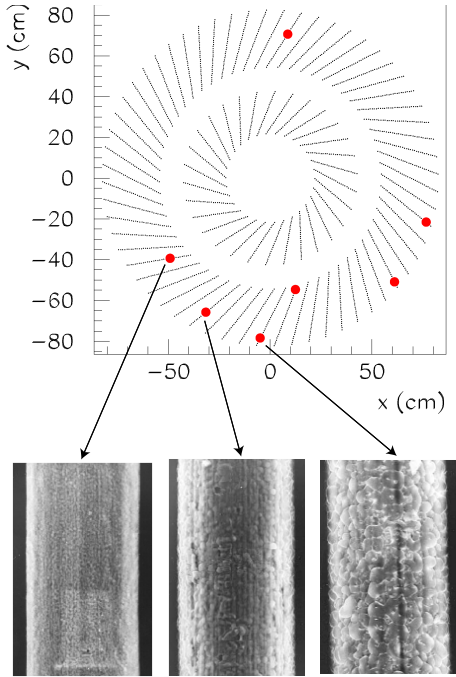
Figure 4. Wires from three different heights within the affected region of CJC 2. The amount of deposits depends on the height of the wire in the chamber.

with deposits, which get more prominent for wires closer to the bottom of the chamber. In order to quantify the effect, an energy-dispersive analysis of x-ray spectra was performed. Figure 5 shows the spectra of two different wires. Normally, just a prominent gold peak is observed while wires from the affected region of CJC 2 show additional clear peaks of carbon and oxygen. No evidence of silicon is found on the sense wires, nor are any deposits seen on the adjacent potential and cathode wires. The abundance of carbon and oxygen relative to gold was estimated by forming the peak ratios for a rough quantitative measure. A monotonous relationship between y-coordinate of the wire, hit efficiency and relative abundance of carbon and oxygen is observed and is displayed in figure 6. Some amount of carbon and oxygen is already detected on a wire close to the knee in the efficiency plot which does not yet show a degradation of hit efficiency.

oped for the repair of CJC 1 in 1993 (see section 2). The striking dependence of the amount of aging on the height of the wire in the chamber strongly suggests an influence of impurities in the gas with a gradient in concentration due to gravitational and/or temperature effects possibly in combination with an insufficient gas flow through the chamber. Until the end of 1997, the gas supply to CJC 2 (CJC 1) was done through 6(4) inlets at the outer circumference of the chamber which were connected to a single gas supply ring. In the same way the gas was taken out on the other side of the chamber. This setup did not allow the gas flow through the individual gas inlets/outlets to be controlled, nor did it enable separate gas analyses of gas coming from different regions of the chambers. However, the routinely performed gas analyses done with the gas chromatograph, which is part of the gas system, did not show any impurities above the sensitivity of this device of 300 ppm. In order to investigate the possibility of an contamination induced from parts of the gas system, a dedicated analysis of gas samples taken during the 1997/1998 shutdown without the chamber in the gas circuit was done using a highly sensitive setup available at CERN [6] involving a mass spectrometer (MSD, sensitivity $\mathcal{O}(\text{ppm})$) and an electron capture device (ECD, sensitivity $\mathcal{O}(\text{ppb})$). This analysis did not yield conclusive results but as a preventive measure the gas supply rings were replaced with individual gas pipes equipped with flow meters in order to guarantee a more homogenous gas distribution within the entire chamber volume. A disadvantage of this modification was a further reduction of the overall gas flow through the chamber (for possible consequences see section 5).

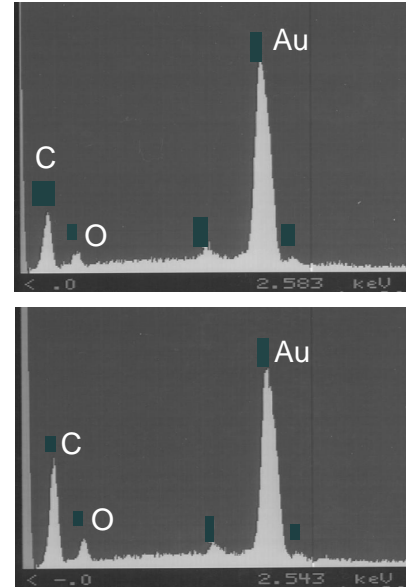
Figure 5. Energy-dispersive analysis of X-ray spectra (EDAX) taken from two different wires.

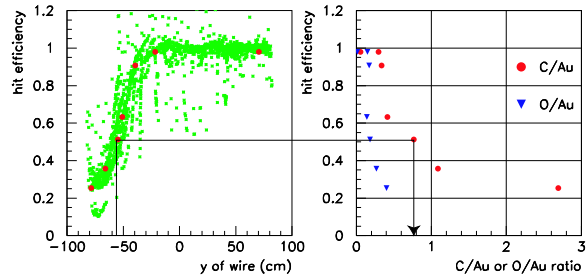
Figure 6. Correlation of hit efficiency with y-coordinate of wires in CJC 2 (a) and with the observed fraction of carbon or oxygen to gold in the corresponding x-ray spectra (b). In (a), wires which have been investigated with the electron microscope are marked with full circles.

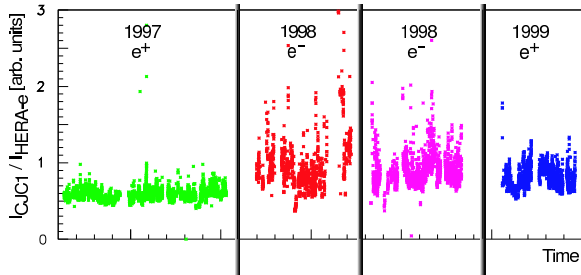
the chamber current and the positron (electron) current in HERA is used as a measure of the background conditions. As can be seen in figure 7, where the ratio is plotted as a function of time, the background situation was much worse when HERA was filled with electrons. As a result, in several regions of CJC 1 and CJC 2 sudden steps in the cell current of the order of $1 - 2 \mu\text{A}$ were observed in 1998. Simultaneously increased currents were also seen in the two adjacent cells on both sides, which immediately disappeared once the central cell was disconnected from high voltage. This was done to prevent more damage for further data taking. Analysis of some data taken with the increased cell current revealed that in a localized area in $r \times \varphi \times z$ no proper chamber signals were recorded. The observations made are consistent with the Malter effect occurring on the cathode wires. As a practical remedy, before an access to the chamber was possible, the 0.1% additive of H_2O was replaced with 0.8% of $\text{C}_2\text{H}_5\text{OH}$ starting in May 1999 (no attempt was made to increase the water content beforehand). Except for the region where the Malter effect showed up first and therefore an increased current was drawn for an extended period before being noticed, all other regions could be put back into operation again this way. Subsequent visual inspection revealed black deposits on an area of a few cm^2 of the cathode wire planes of the problematic areas.

Figure 7. CJC 1 chamber current normalised to the positron- (electron-) current in the HERA-e ring as a function of time showing a strong increase in background when HERA operation was changed from e^+p to e^-p mode.

At the end of the 2000 data taking period an indication of a possible gain drop was seen again at the bottom of CJC 2. As a preventive measure the sense wires in the lower part of the chamber as well as all wires in a region around the areas where Malter effect had been observed were replaced. In the future CJC 1 and CJC 2 will be connected to identical but separated gas circuits in order to allow an increased gas flow through both chambers.
