# First results of an aging test of a full scale MWPC prototype for the LHCb muon system

Aging studies for a multi-wire proportional chamber of the LHCb muon system have been performed using the CERN Gamma Irradiation Facility. The irradiated four-gap chamber corresponds to a full-size prototype with 1500 cm<sup>2</sup> sensitive area and has been operated with an Ar/CO<sub>2</sub>/CF<sub>4</sub> (40:50:10) gas mixture. A linear charge of  $\sim 0.25$  C/cm for 100 m anode wire length has been accumulated over a period of 6 months, which corresponds to the charge collected in 5 LHCb years. The observed aging effects do not prohibit the use of these chambers in the LHCb experiment.

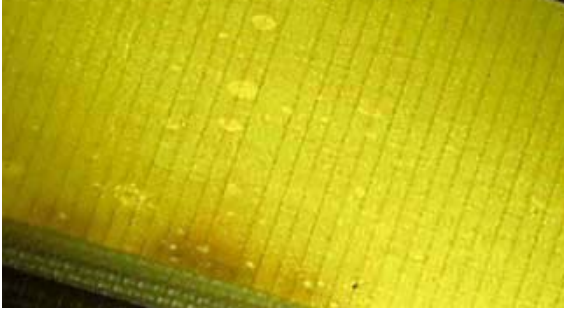
The test was ended on July 27, 2001, after collecting a maximal charge equivalent to five LHCb years in gap B2. The reasons for interrupting the test were a broken wire in gap A2 close to the wire fixation bar occurring on June 4 and a high voltage instability of the gap A1, which appeared suddenly on July 16.

The chamber was opened to replace the broken wire and to investigate the current instability in gap A1. As the wire tension of only 60 g is far from the elasticity limit (140 g), the wire breakage is probably a random event.

The cathodes show some minor deposits after the irradiation. The deposits are often correlated with the wiring structure. Typically, this deposit starts at a distance larger than 10 mm from the gap border. There are also two brownish spots located near the gap border on the wired planes. One spot is located in the A2 gap close to the broken wire, the other in the A1 gap where the HV instability occurred (Fig. 5).

The anode wires do not show any strong aging effect. Two small groups of wires ( $\sim 100$  wires or 8% of the total amount) located over the two brownish cathode spots mentioned above have small black dots. However, the relative total area of this covering is less than  $10^{-3}$ , hence will have negligible influence on the chamber.

Figure 5. The photo shows the position of the broken wire and some dark spots underneath, indicating some sparking at that position.

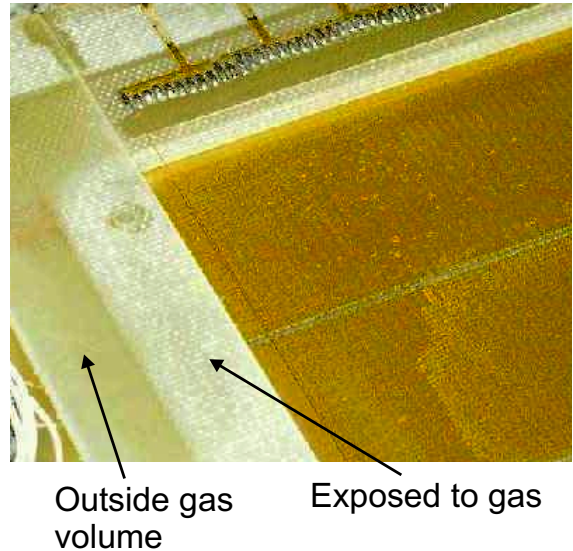
Some chemical activity of the gas in the irradiated gaps appears as etching of FR-4 bar surfaces exposed to the gas. This effect is absent in the reference gap B1. It has not been observed be-

Figure 6. The FR-4 bars show clearly some change in surface color due to etching

fore and needs additional investigation. Others have reported [5] anode and cathode etching effects due to the fluorine in the gas mixture, which have been moderated by adding a few hundred ppm of water vapour to the gas mixture. Similar solutions should be tried for our chambers.
