Aging Effects in the Central Jet Chamber of H1

- Introduction to H1 Tracking System
- 1) Corrosive Damage of Wires
- 2) Aging due to Sense Wire Deposits
- 3) Malter Effect on Cathode Wires

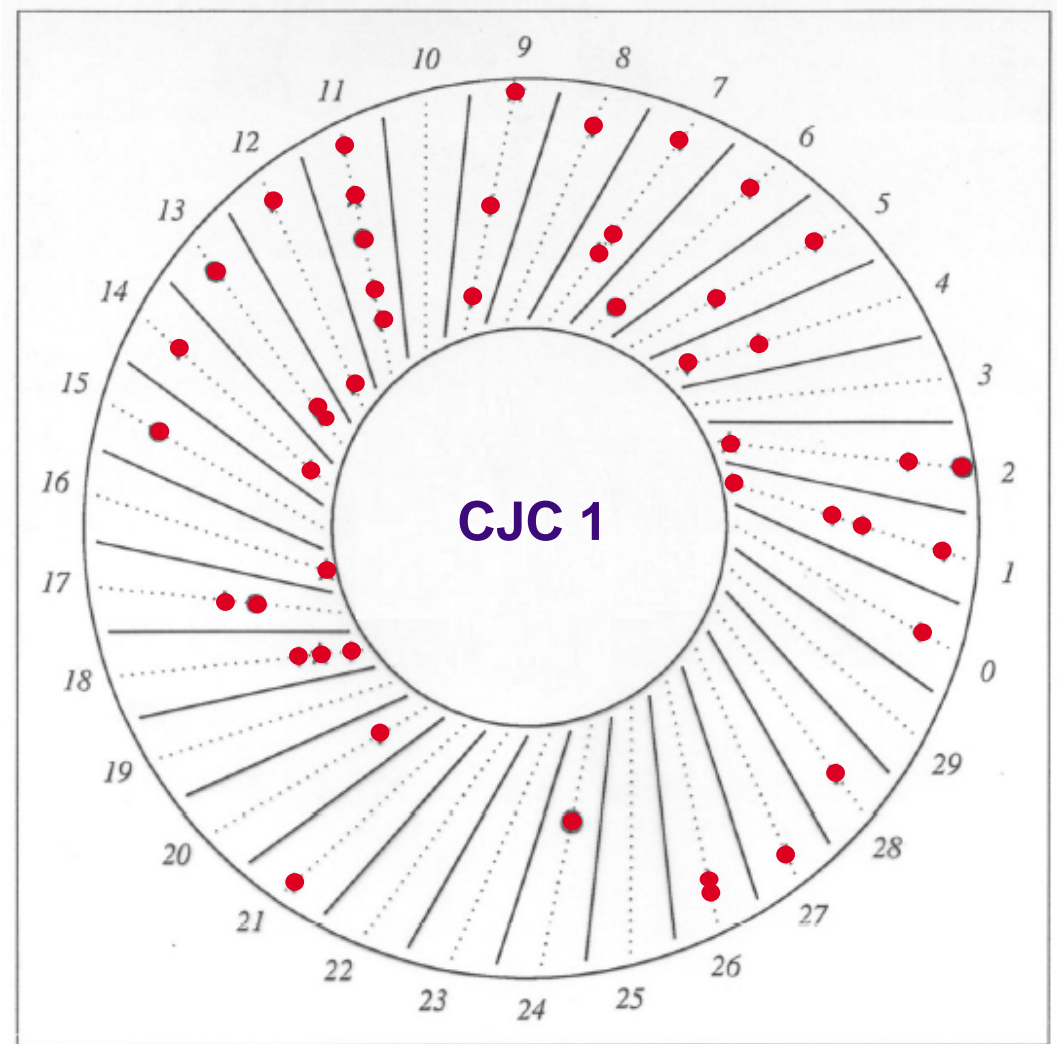
Already after the first period of HERA operation, in the shutdown Dec 92, sense wires started to break spontaneously in CJC 1

Until Jun 93 in total 48 wires were broken

Randomly distributed in CJC 1

No broken wire in CJC 2 !

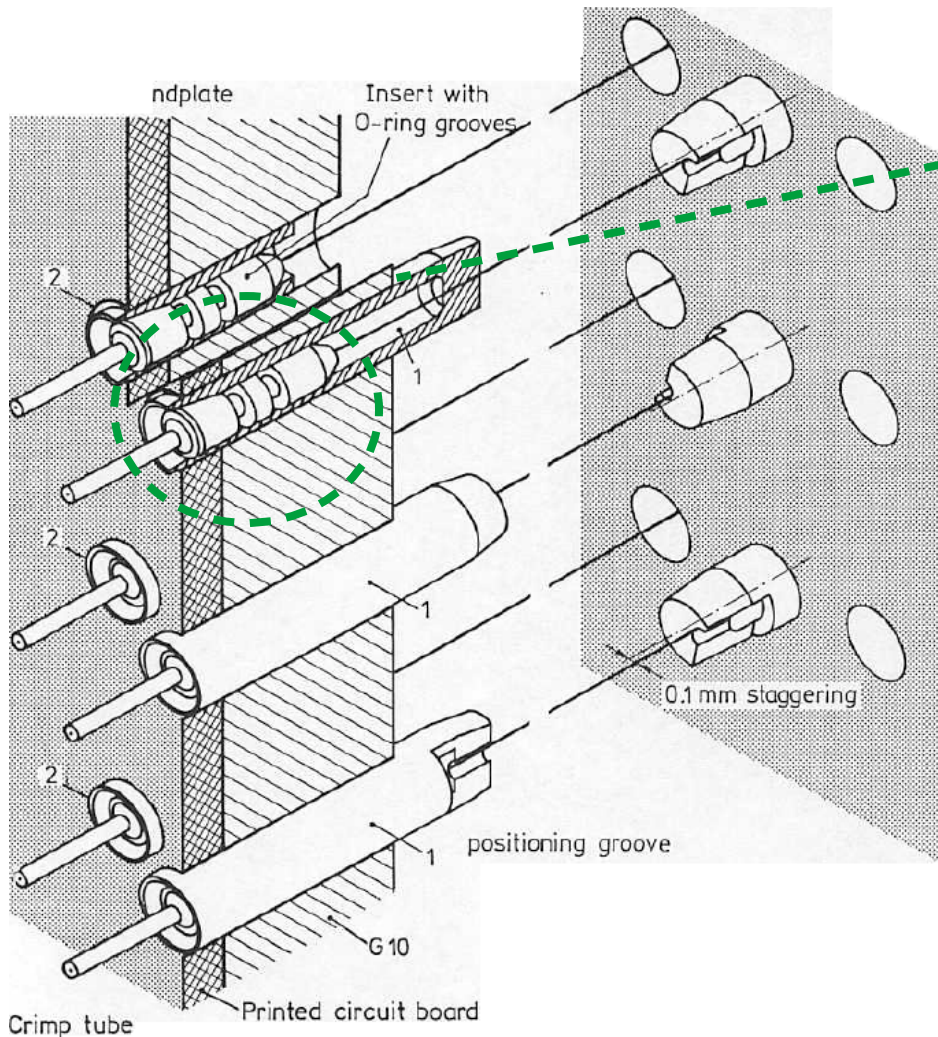
Principle of Wire Fixation

All wires broken close to the wire ends !

60 μm diameter bore for wire

Brass insert

Remnants from gilding process of wire feed through -> sharp edges cause damage of gold layer on wires

- replace all sense wires of CJC 1
- improve quality control during production process of crimp tubes
- replace brass inserts in wire feed through by **jewel**

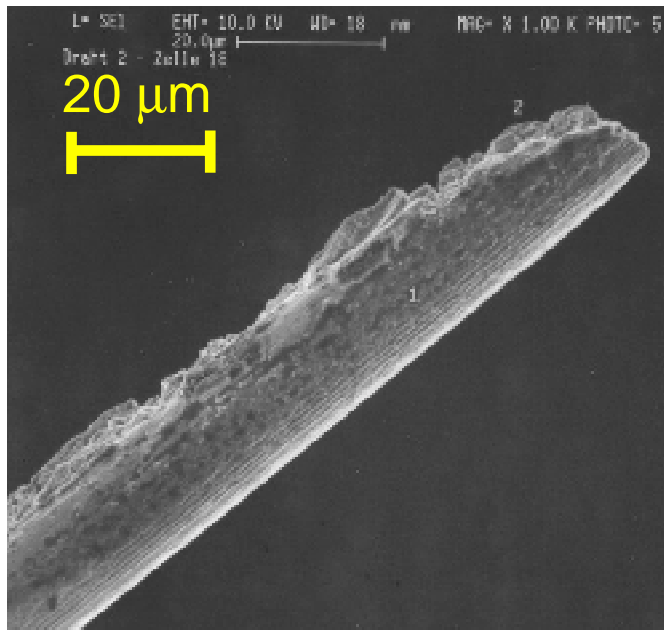
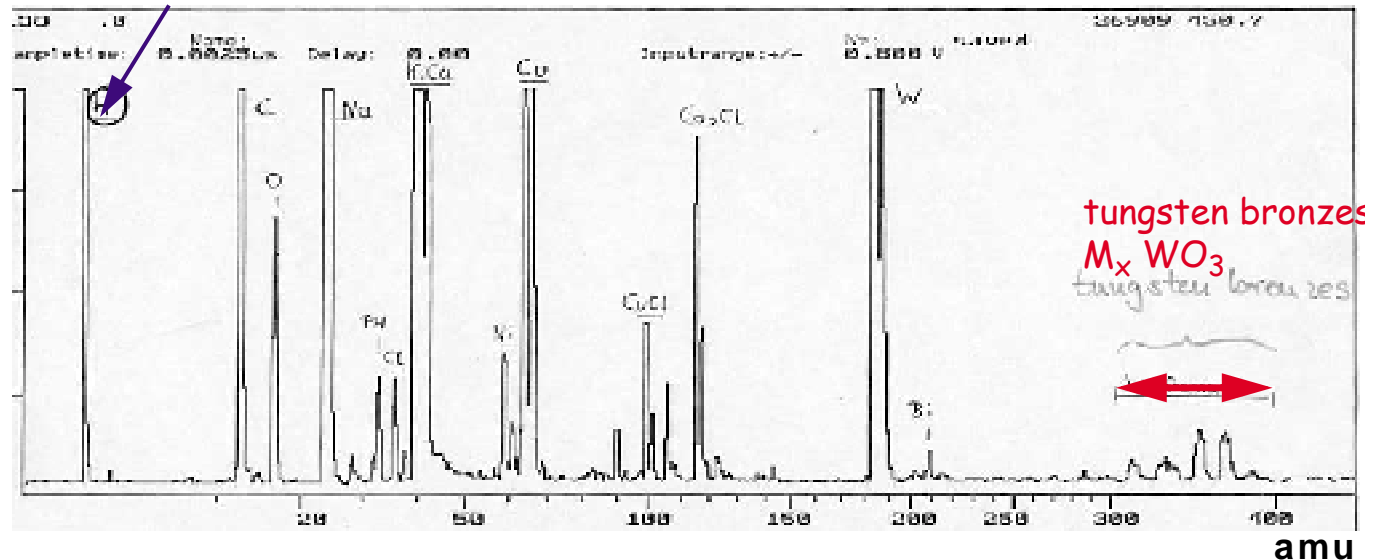
LAMMA spectrum

- gold layer on wire damaged by sharp edges
- W partially missing
- clear evidence for complex chemical reaction
- fracture morphology + occurrence of H and W bronzes
=> most likely explanation: **H induced brittle fracture**

Hydrogen

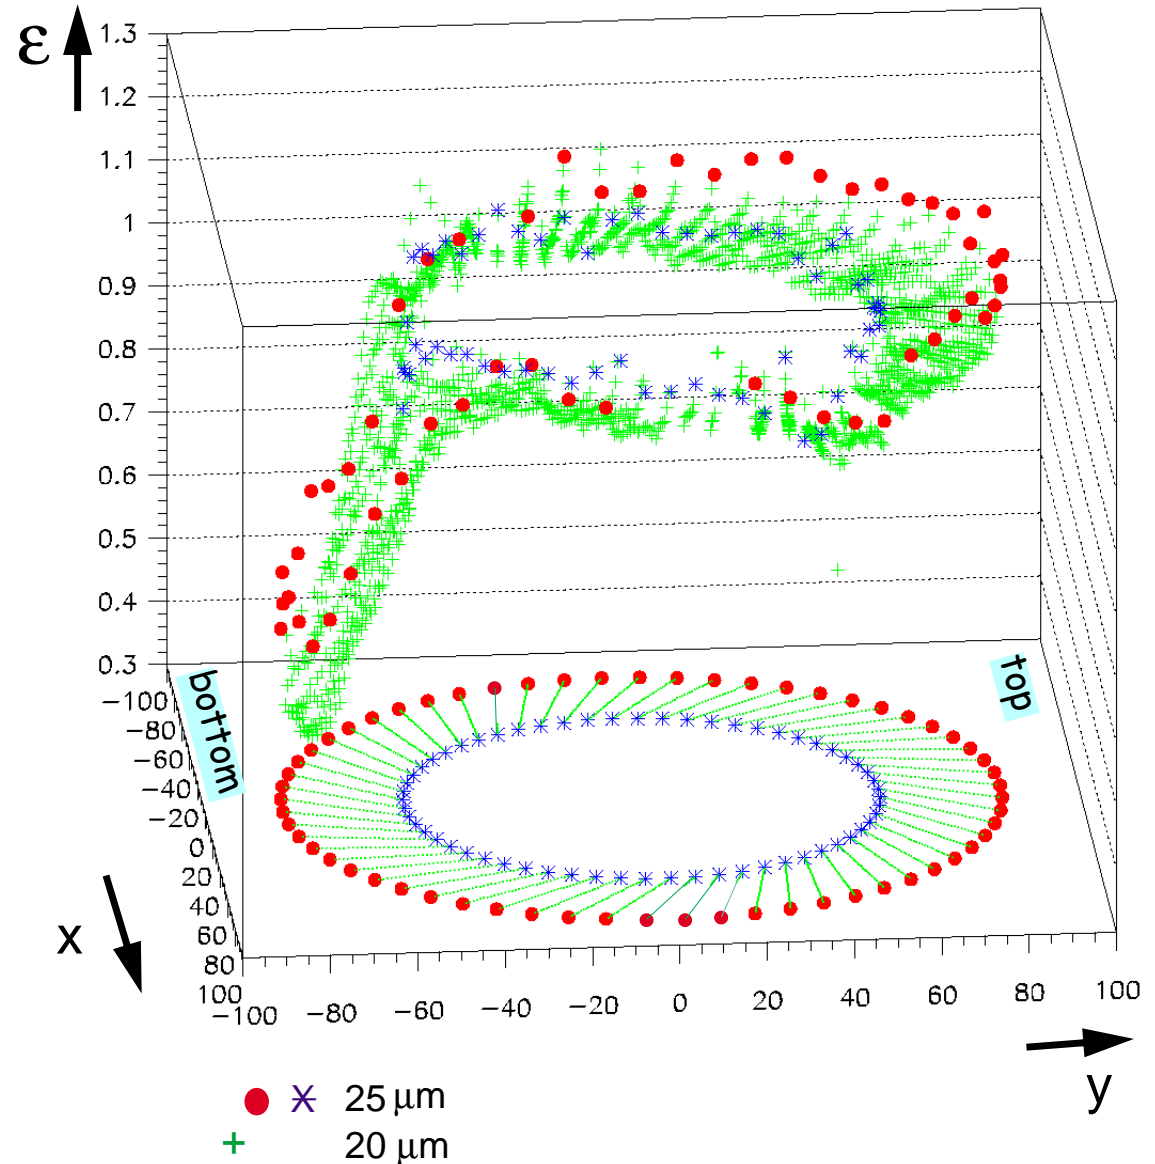
Wire efficiency vs. position end of 1997

- In 1996 a small φ dependence of the gain was observed in CJC 1 & CJC 2
- This was partly expected from top bottom temperature gradient in the tracking volume ($\approx 15^\circ \text{C}$)
=> local compensation by HV adjustment in summer 96
- During 96/97 top-bottom asymmetry aggravated continuously in CJC2 although corresponding integrated charge on wires still rather low:
< 0.01 C/cm
- Strong correlation observed between hit efficiency and y-coordinate (height) of the affected wire

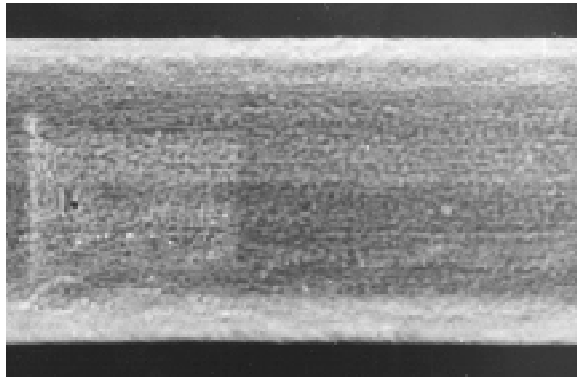
deposits
invisible?

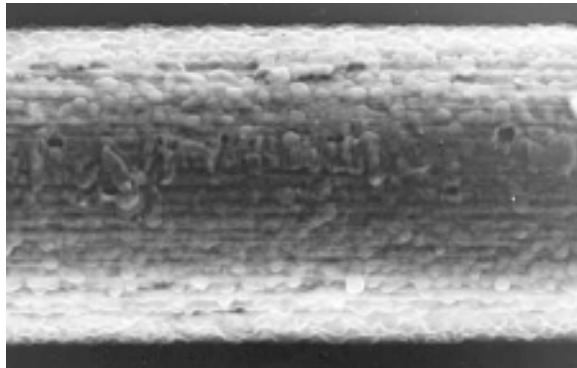
deposits
visible

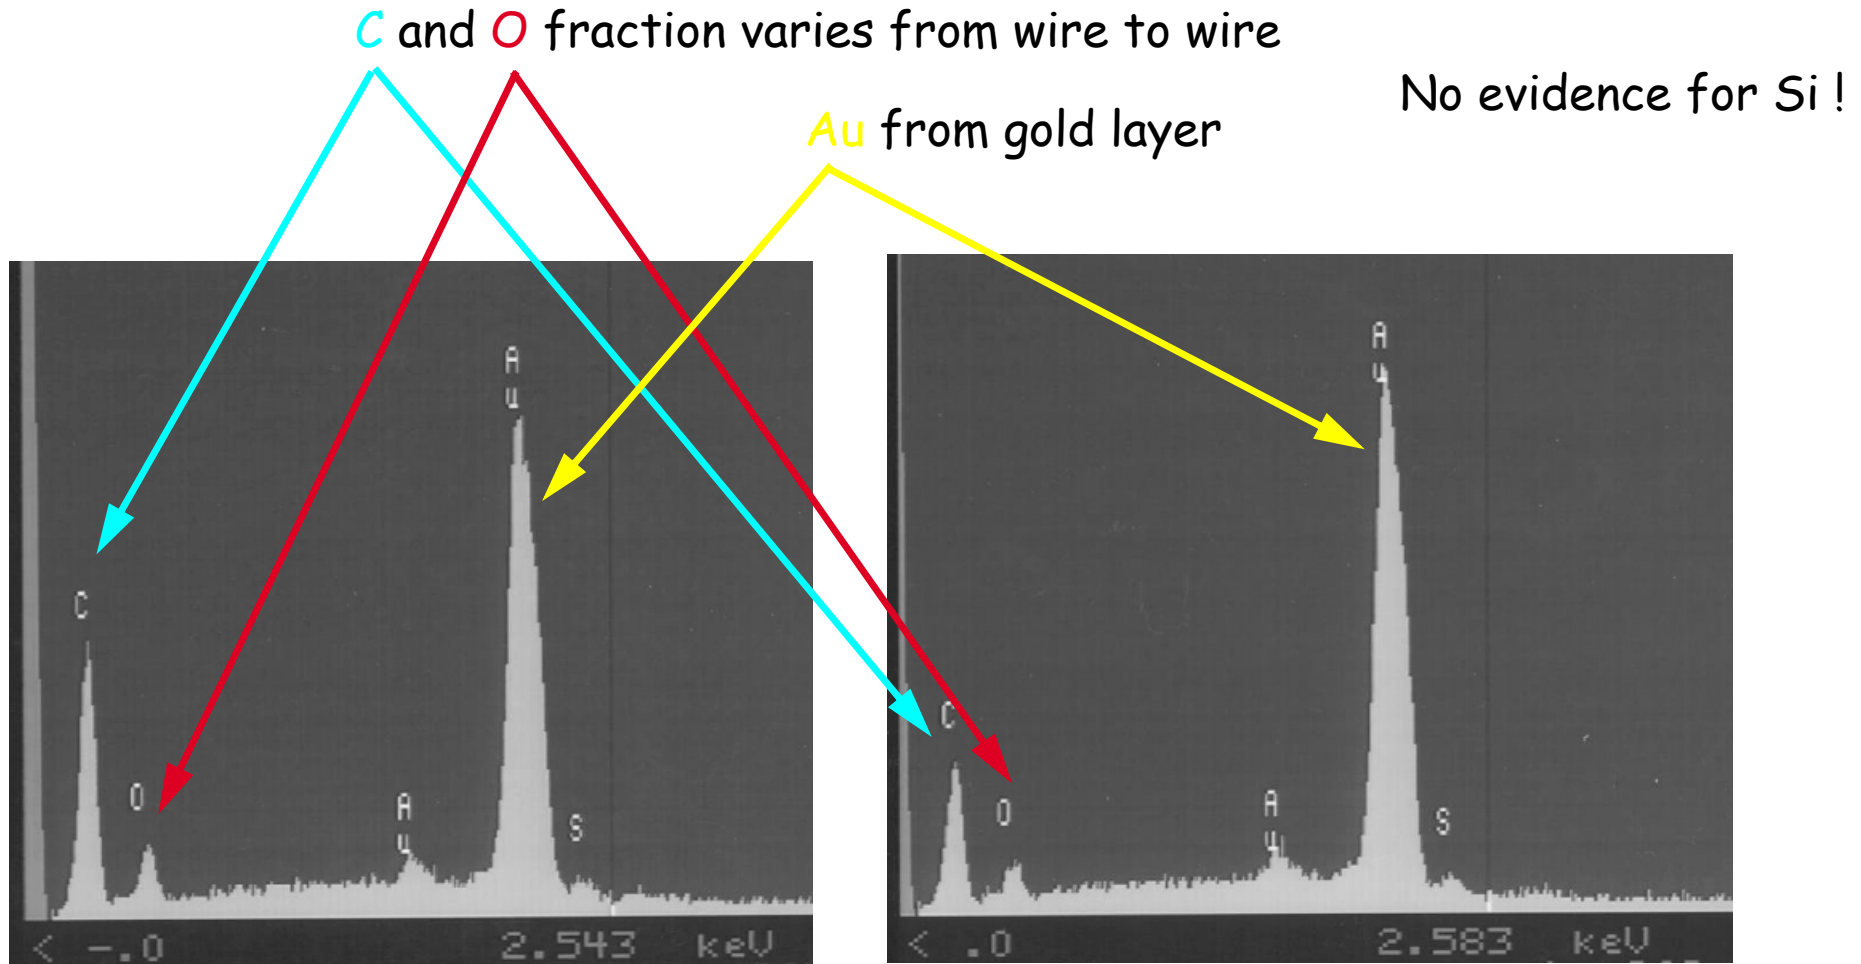
EDAX spectra from two different wires

REM with EDAX probe allows rough decomposition of deposits and quantification:

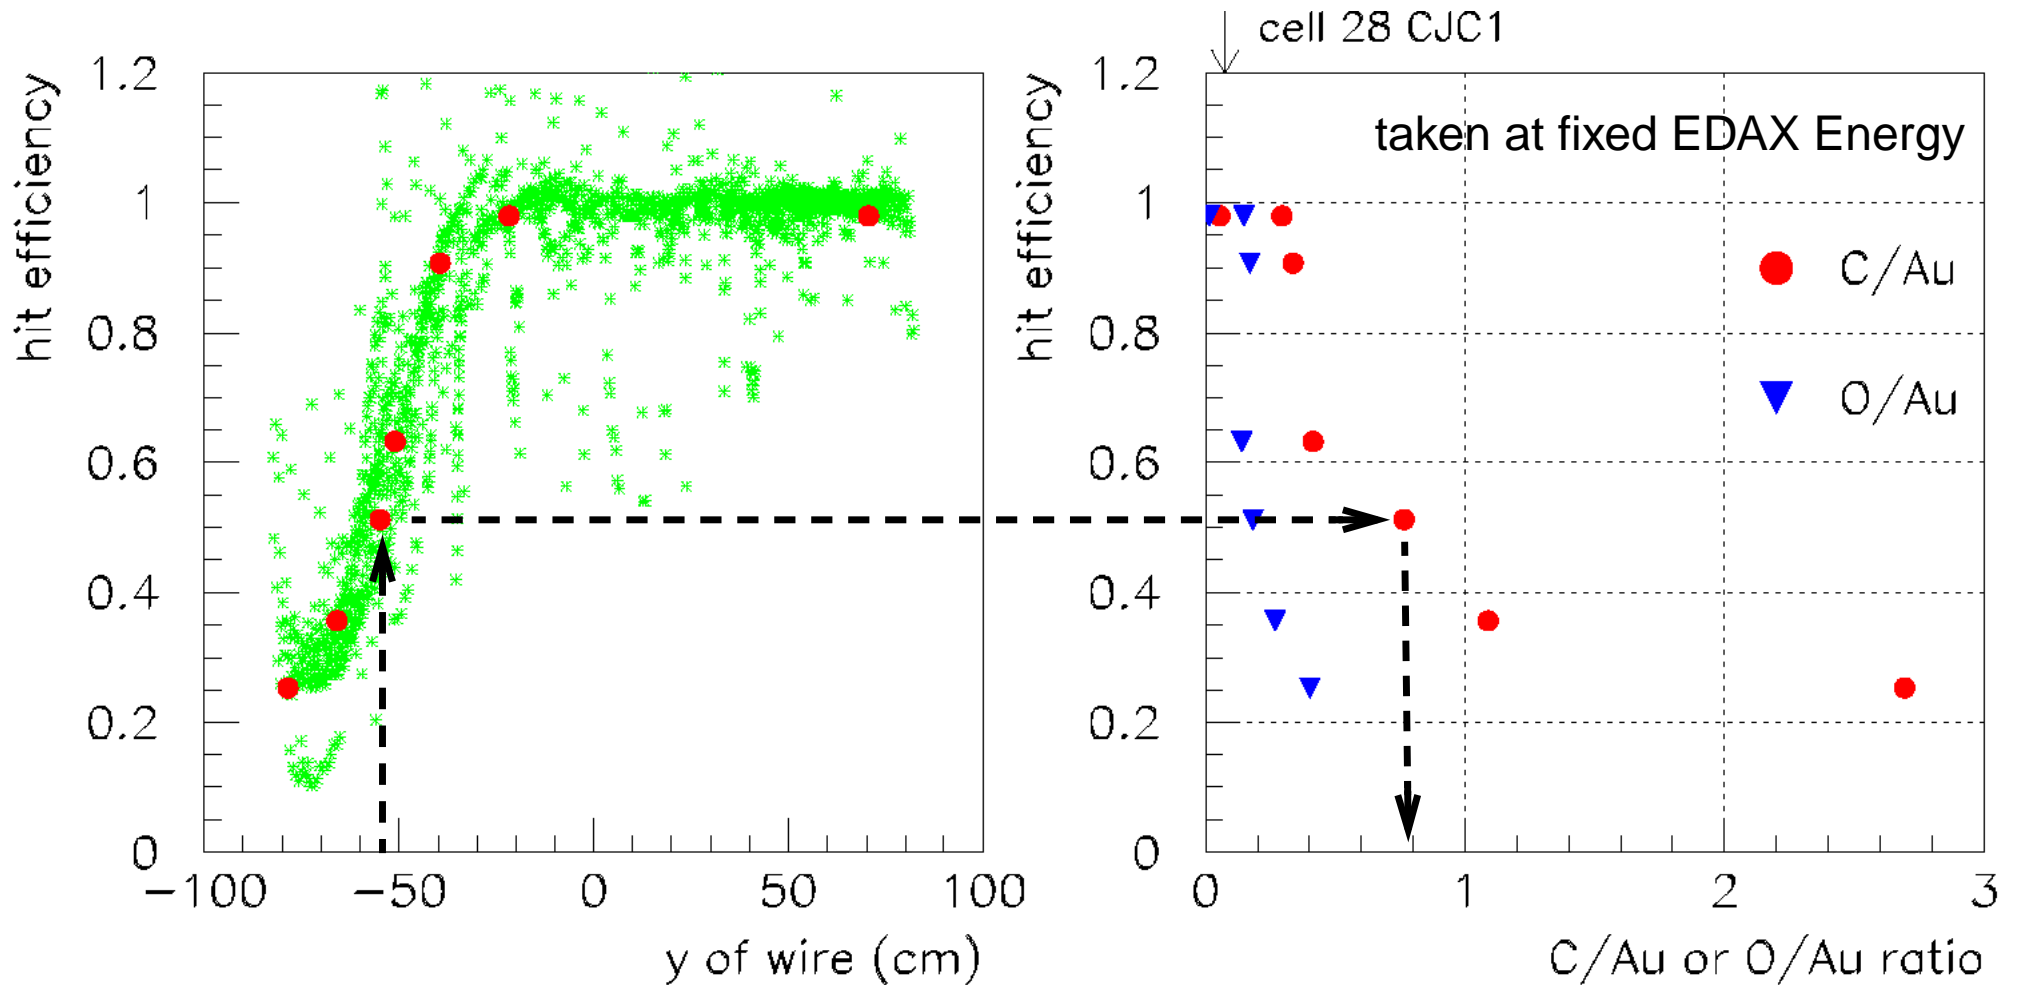
Correlation with Hit Efficiency

Clear correlation with hit efficiency observed

Traces of C and O already found when no significant degradation is seen on wire

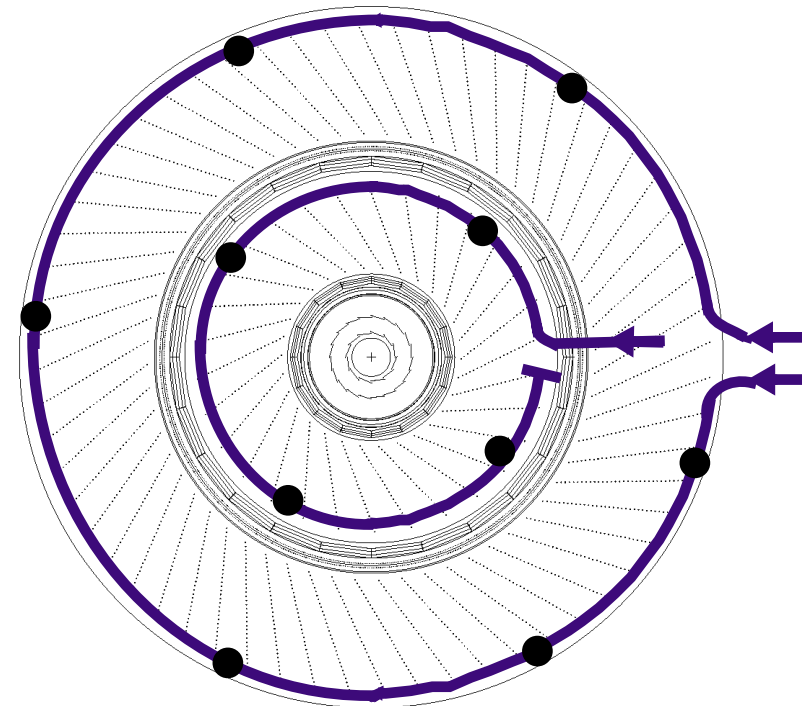
Gas distribution 1992-97

- internal origin - from chamber itself ?
CJC1 and *CJC2* made from identical components (except outer Al-cylinder in *CJC2*)
- external origin
CJC1 and *CJC2* connected to same gas circuit
- accumulation due to non-uniform gas circulation?
potential problem might be **gas distribution ring** which is not common for *CJC1* and *CJC2*

=> gas distribution modified in shutdown 97/98 :

gas rings replaced with individual pipes equipped with flow meters
in order to guarantee homogenous gas distribution for all inlets

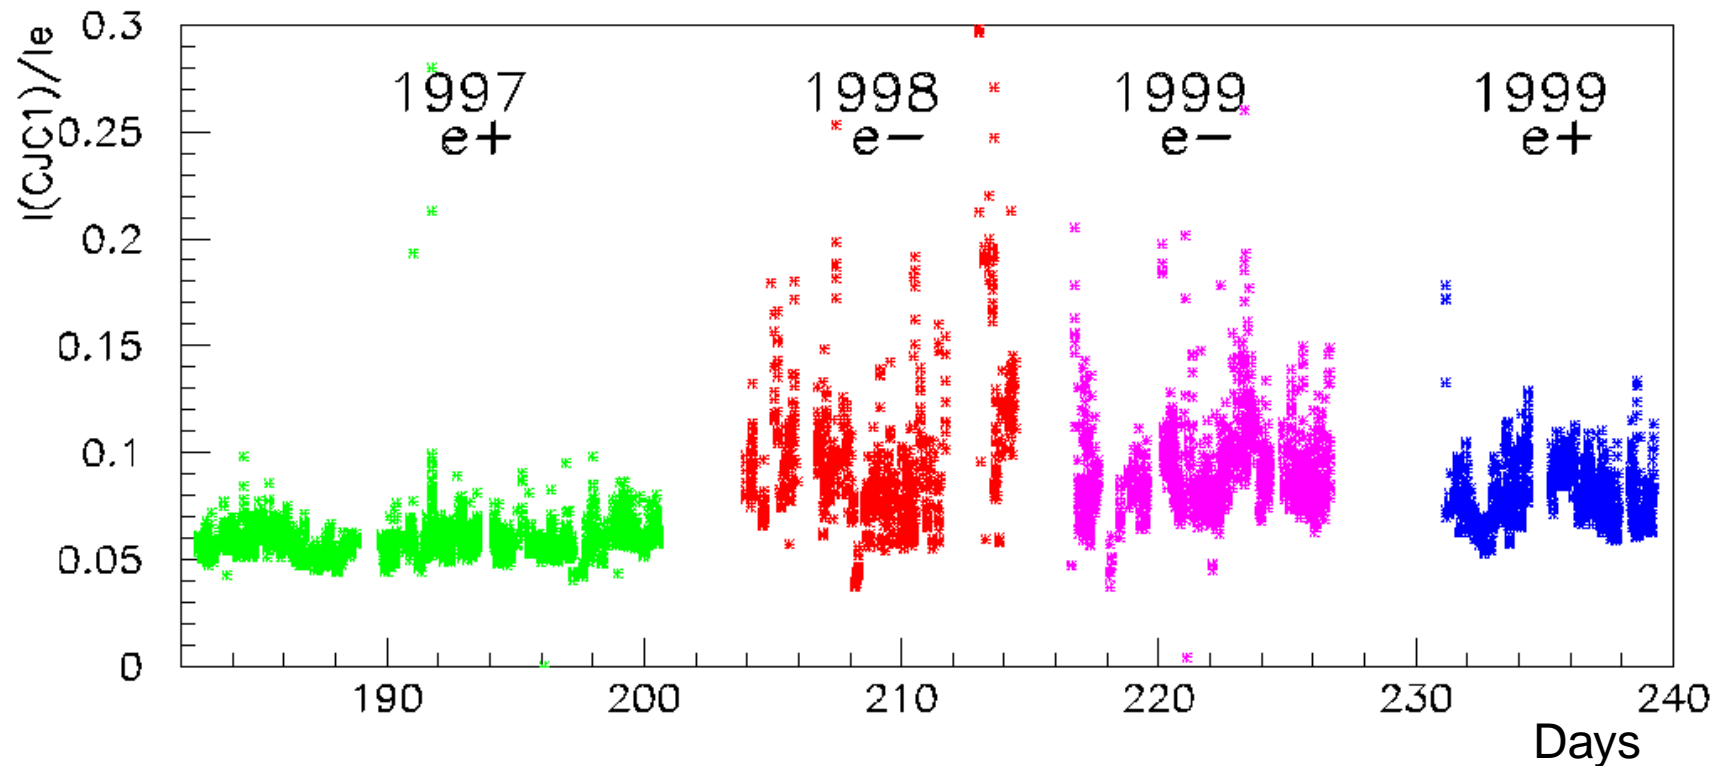
Chamber Current normalized to HERA-e current vs. Time

Starting in 1998 HERA was operated in e^-p mode leading to increased background levels in the H1 interaction region

=> significantly increased normalized CJC current 1998/1999 compared to 1997

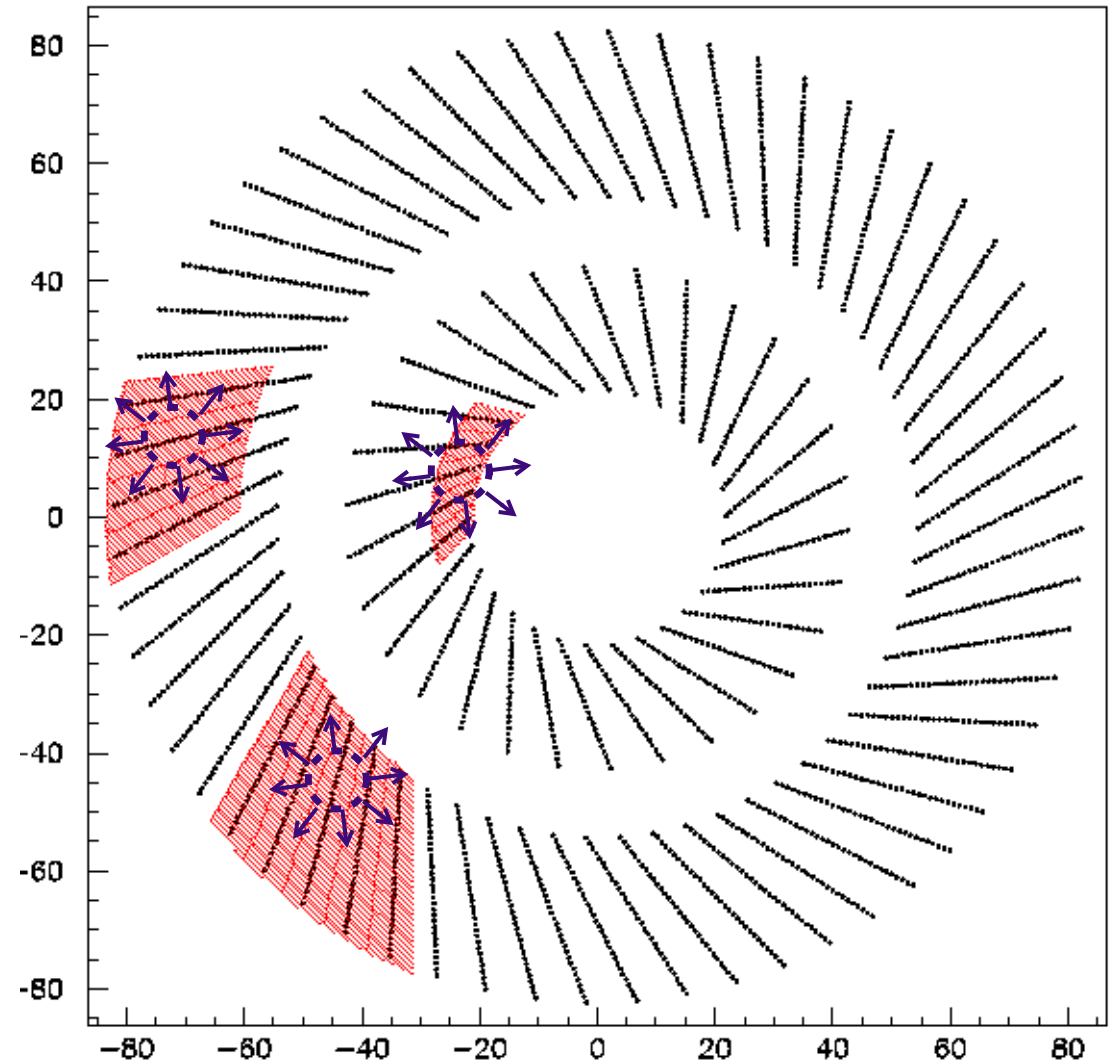
Cells with increased currents

Evidence for Malter Effect :

- sudden step in cell current of 1-2 μA
- simultaneously seen in \approx two adjacent cells on both sides
- if central cell is disconnected from HV current disappears in adjacent cells
- if operated for longer period further step in dark current can occur
=> **HV instabilities**
- subsequent visual inspection revealed large spots (\approx few cm^2) of **black deposits** on cathode wires in the problematic areas
- replacing additive H_2O (0.1%) with $\text{C}_2\text{H}_5\text{OH}$ (0.8%) in May99 cured the problem

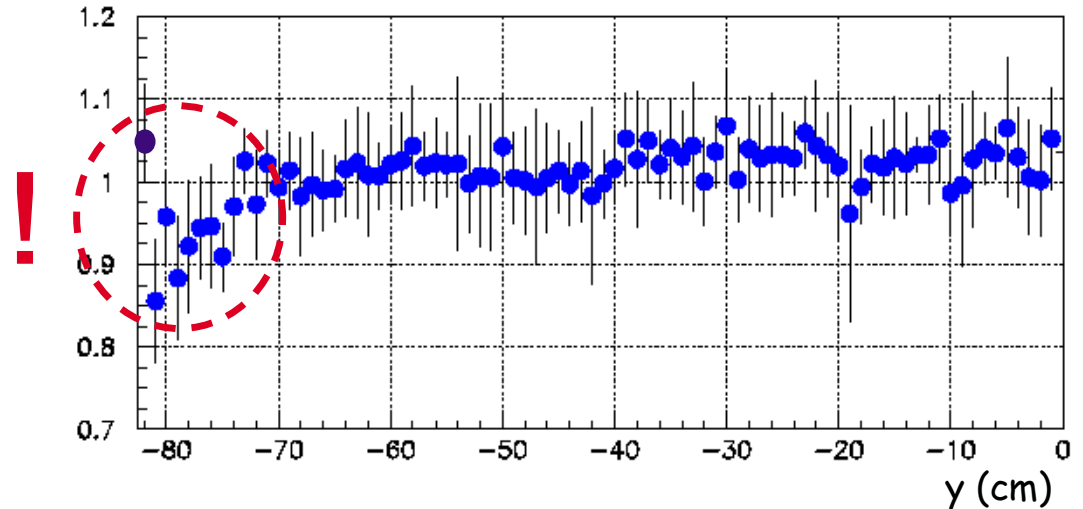
Gain July 2000 / Gain July 1999

- replace all wires (cathode and sense) that were affected by Malter effect
- indications for gain drop during 2000 period again in lower part of CJC 2 => as a preventive measure sense wires in lower cells also replaced
