Agieng studies for
the ATLAS
Transition Radiation
Tracker (TRT)

Contents

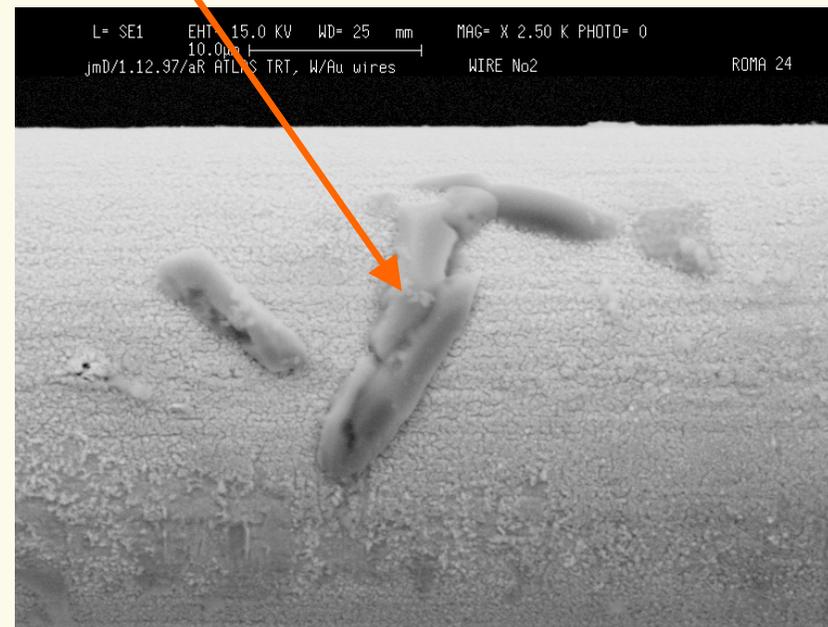
In some cases WO deposit was observed!

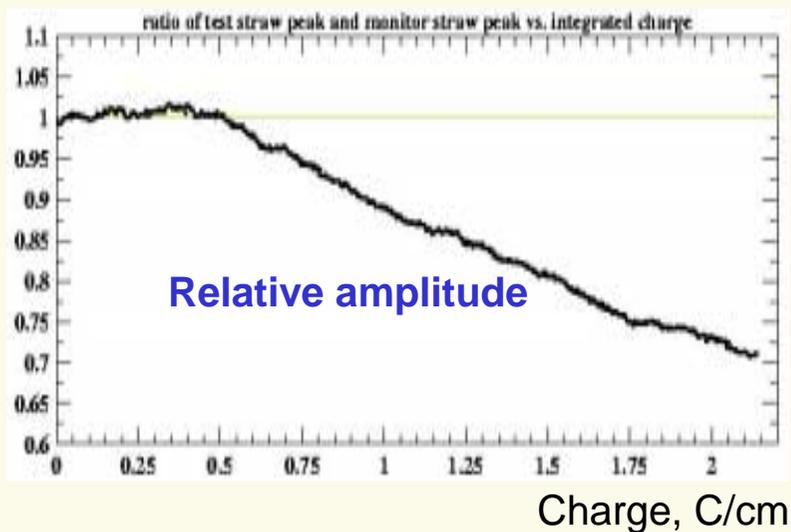
Effective wire diameter increased by ~2 μm

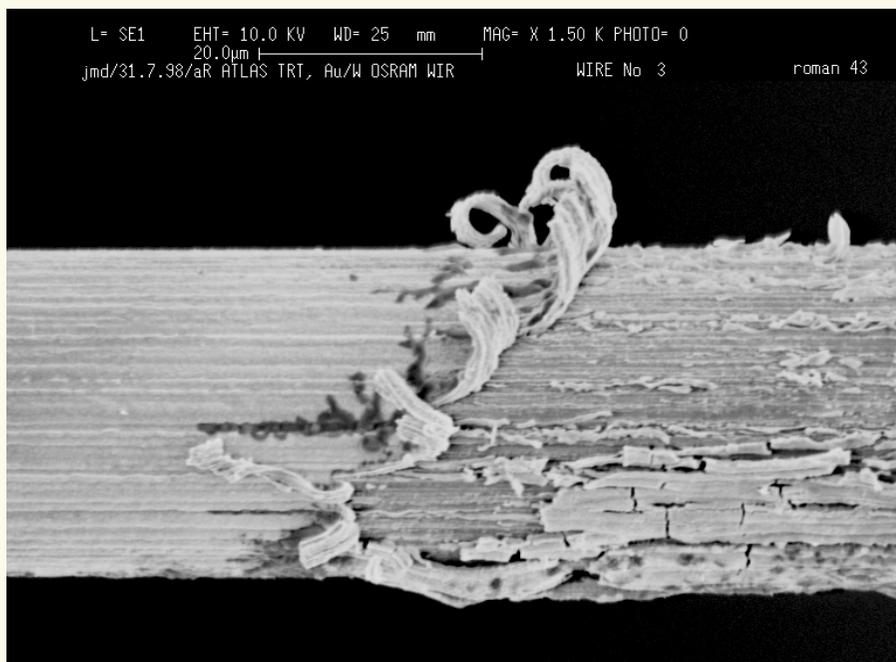
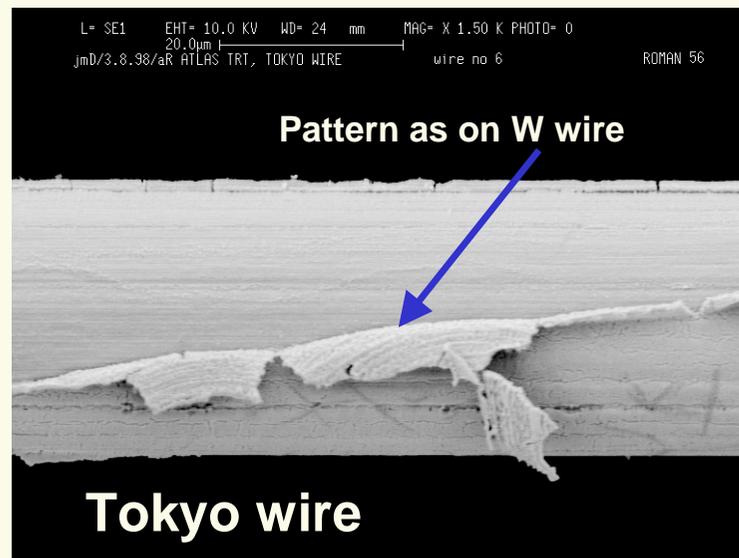
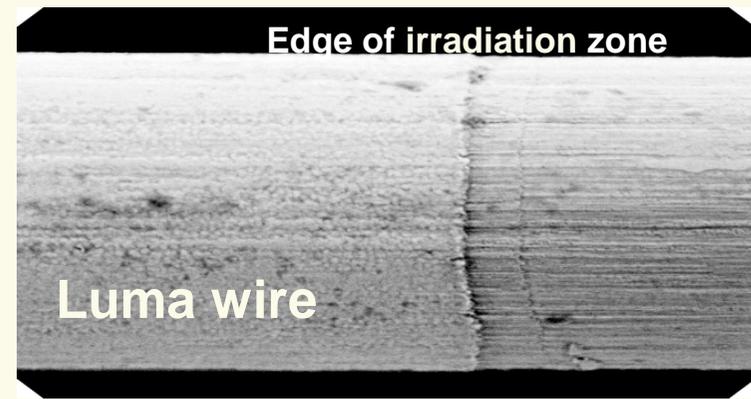
Edge of irradiation zone

Wire: **OSRAM**

Mixture: **standard**

Current: **5 μ A/cm**

Total charge: **~6 C/cm**

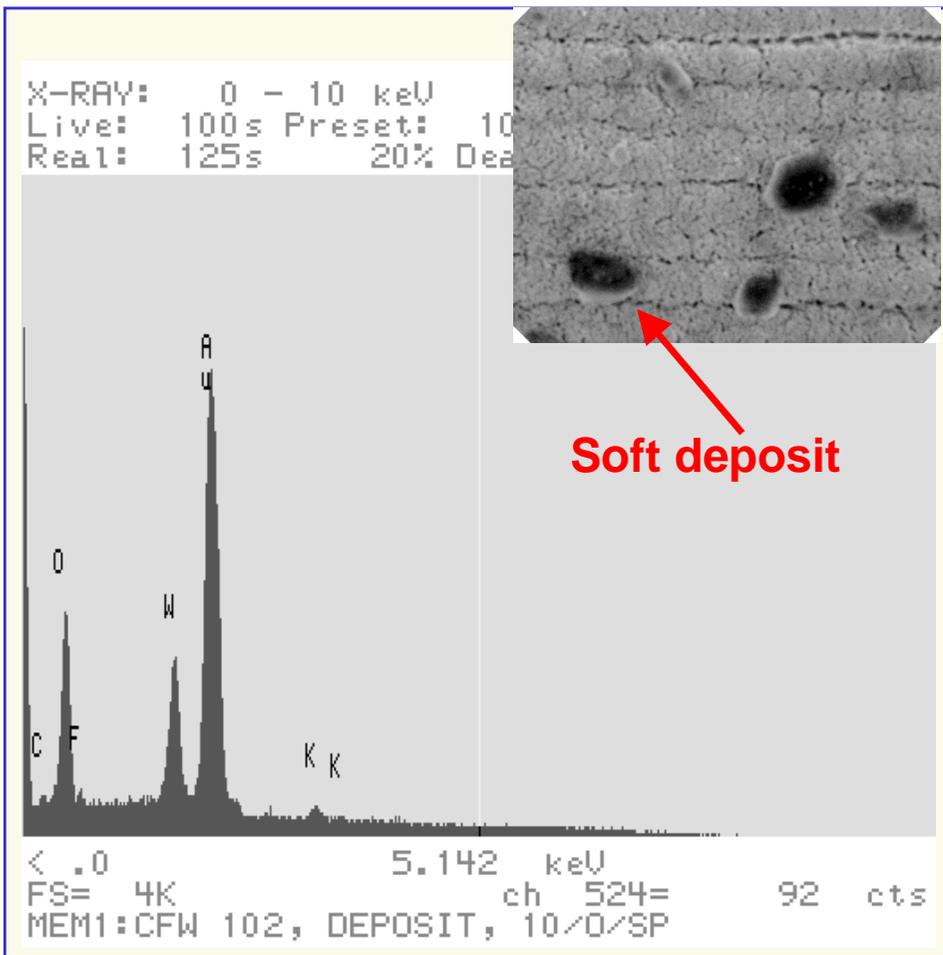
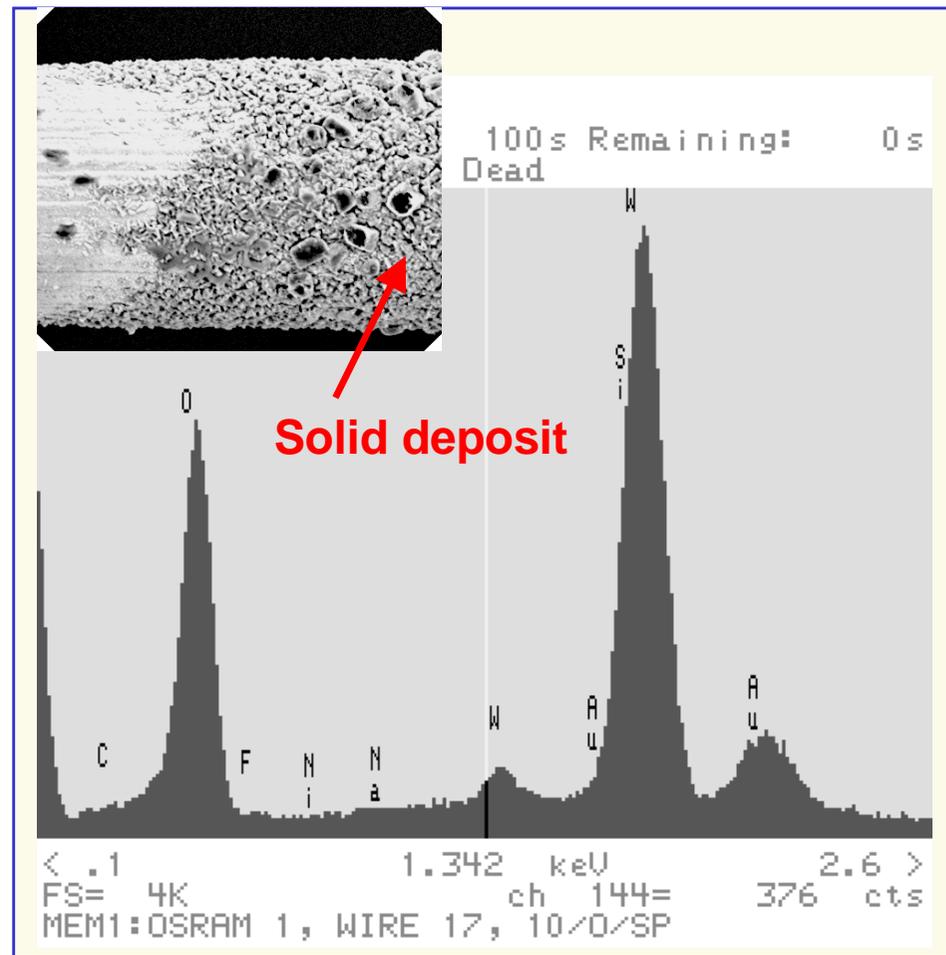
Different types of deposits

- observed but **not very regular**
- happen very often **outside** irradiation zone and are larger downstream
- are sometimes very **soft** (disappear under EM electron beam), but sometimes **solid**

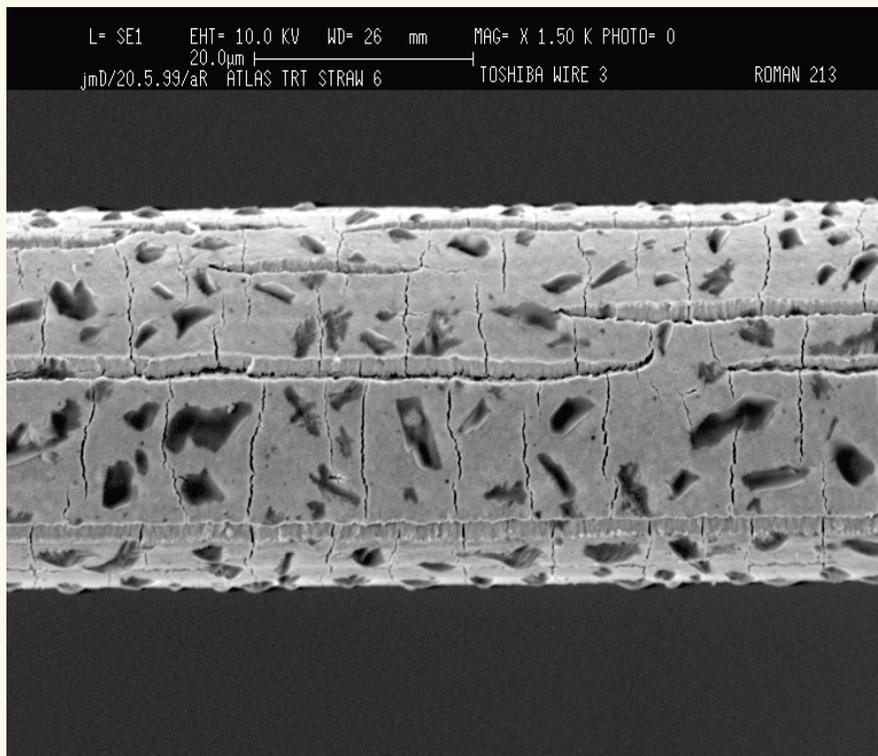
Toshiba W wire (1 μm Au)
Standard mixture +1.2% H₂O
6.5 C/cm

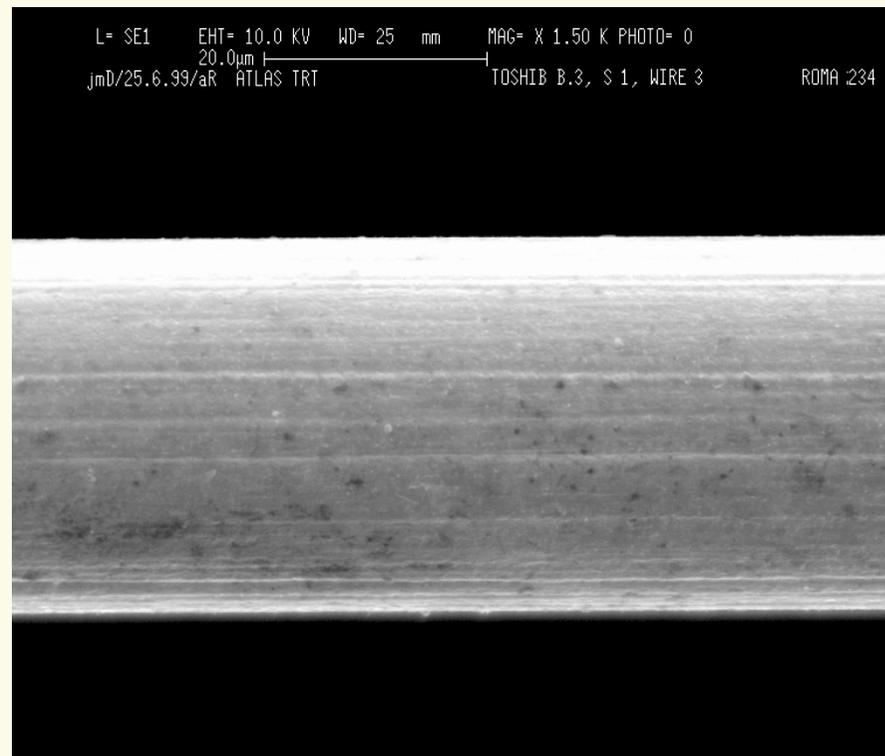
Toshiba W wire (1 μm Au)
Standard mixture +1.5% O₂ (NO H₂O)
6.5 C/cm

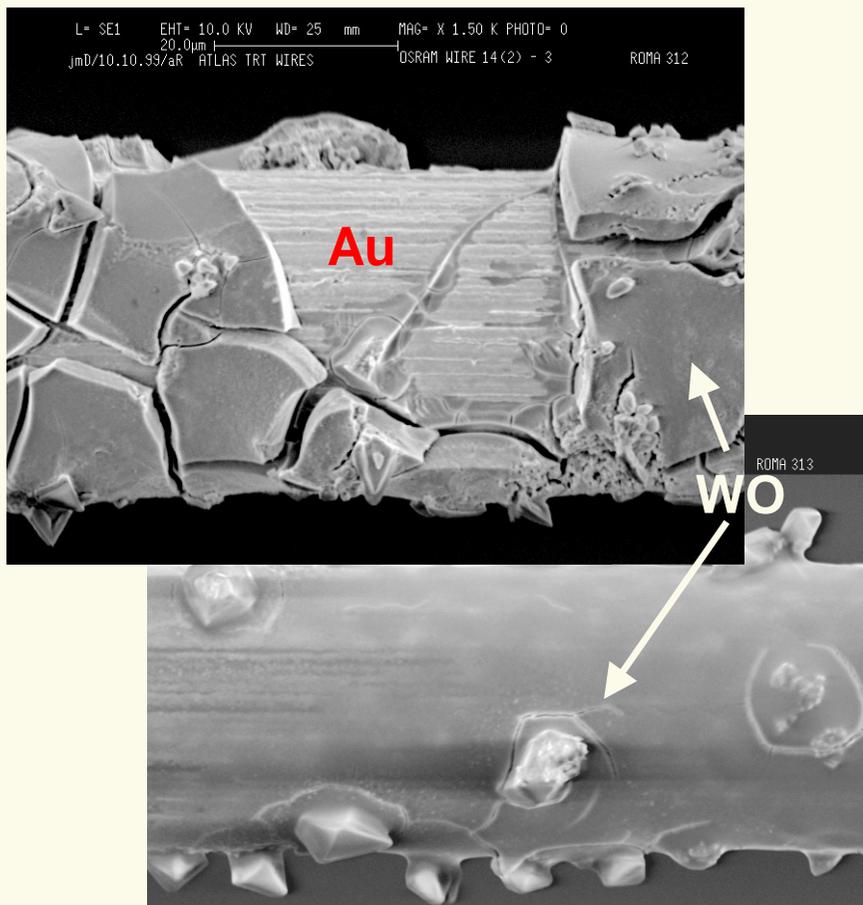
OSRAM wire, 3 % Au
Standard mixture +1.2% H₂O and 1.5%O₂
Total dose: **0.5 C/cm**

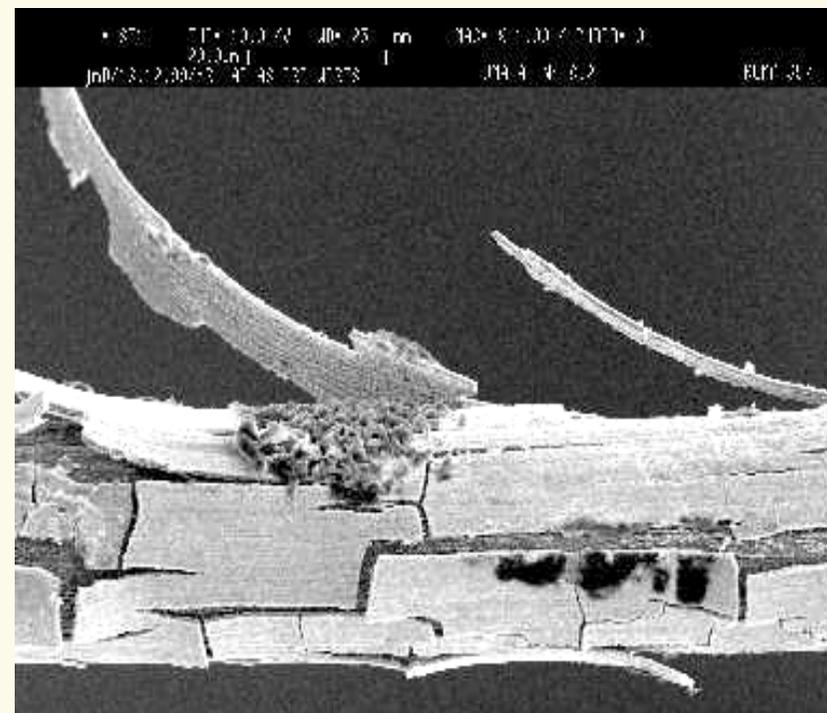
Luma wire, 5 % Au,
Ni-substrate
Standard mixture +1.2% H₂O and 1.5%O₂
Total dose: **~3 C/cm**

Presence of molecular Oxygen makes processes more complicated!

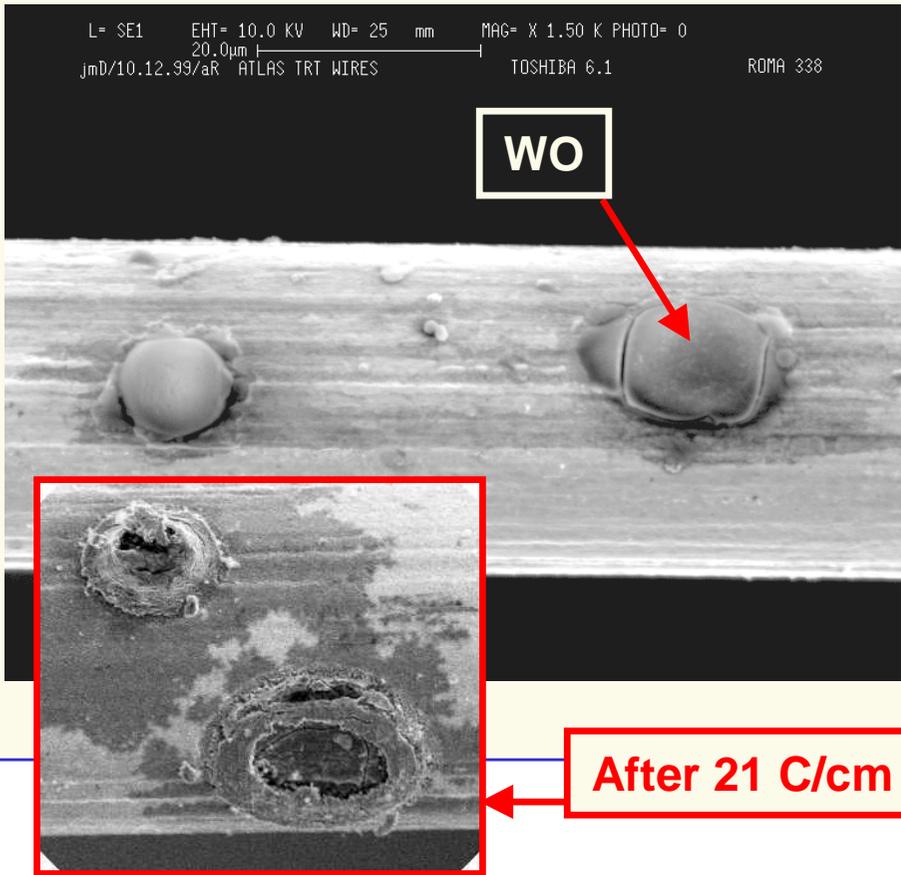
Toshiba wire, 7% Au,
Standard mixture + ~0.4% H₂O (NO O₂),
5 C/cm

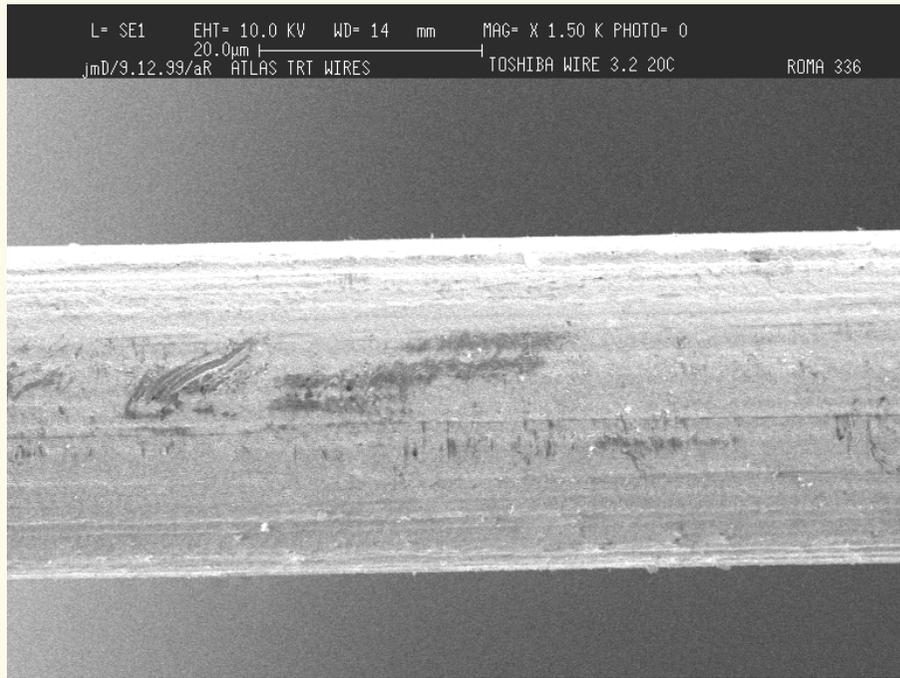
Toshiba wire, 7% Au,
Standard mixture + <0.1% H₂O (NO O₂),
20 C/cm

Wire choice for TRT:
Toshiba 30 μm W wire,
7-9% gold plating

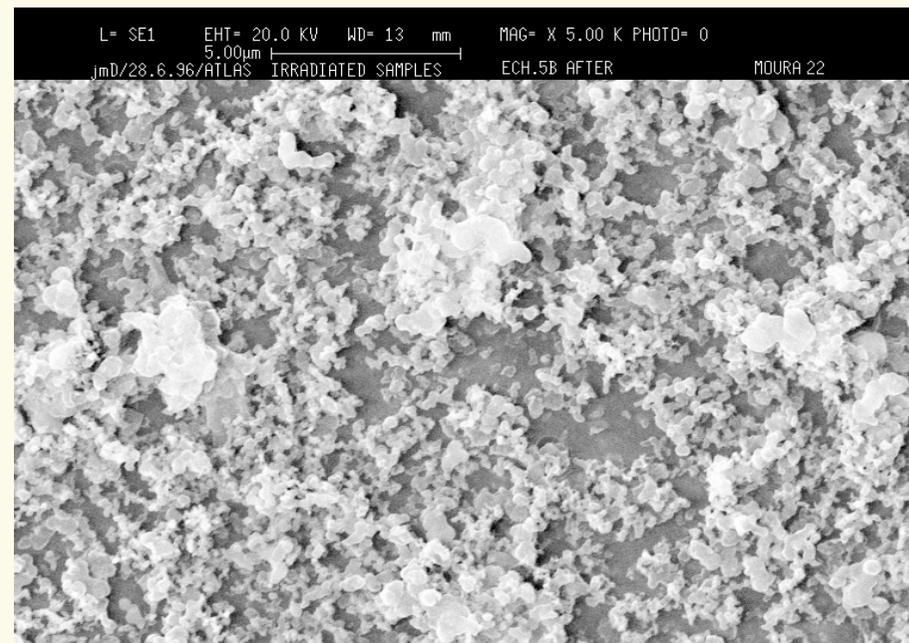
Straw cathode after 20 C/cm of accumulated charge

Some amount of polyimide was etched off after 20 C/cm but **NO** deposit on wire observed!

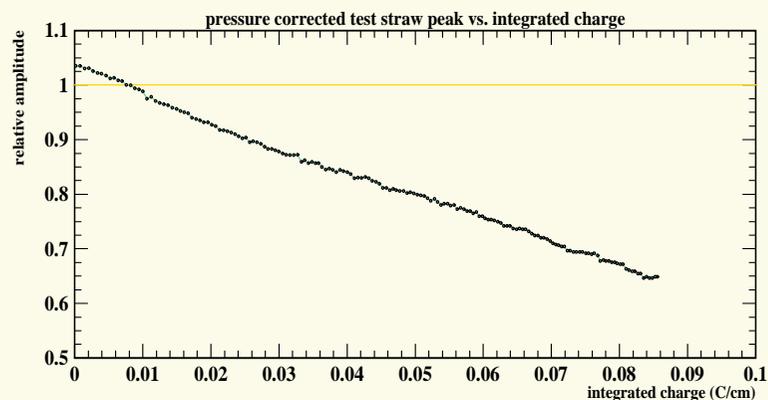
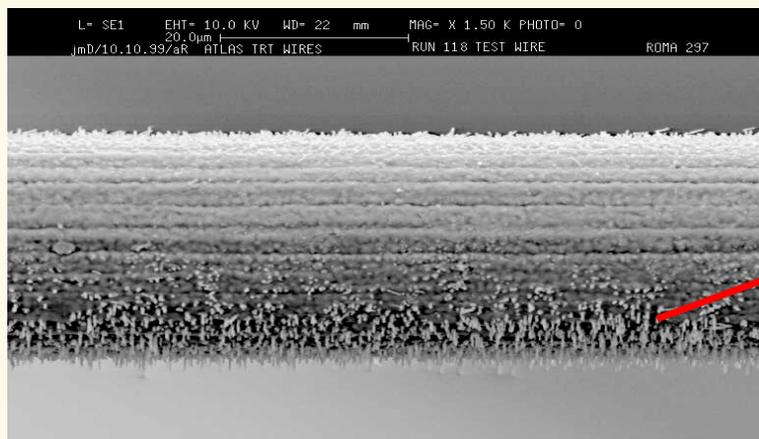
Run 118 - Test Peak Position vs. Integrated Charge

Comments

- Current 0.1 $\mu\text{A}/\text{cm}$
- Straw contained traces of **Si-based lubricant** by chance used by straw producer (occasionally)
- Amplitude drop is very fast $\sim 10\%$ per day!

Control manufacturing process in details!

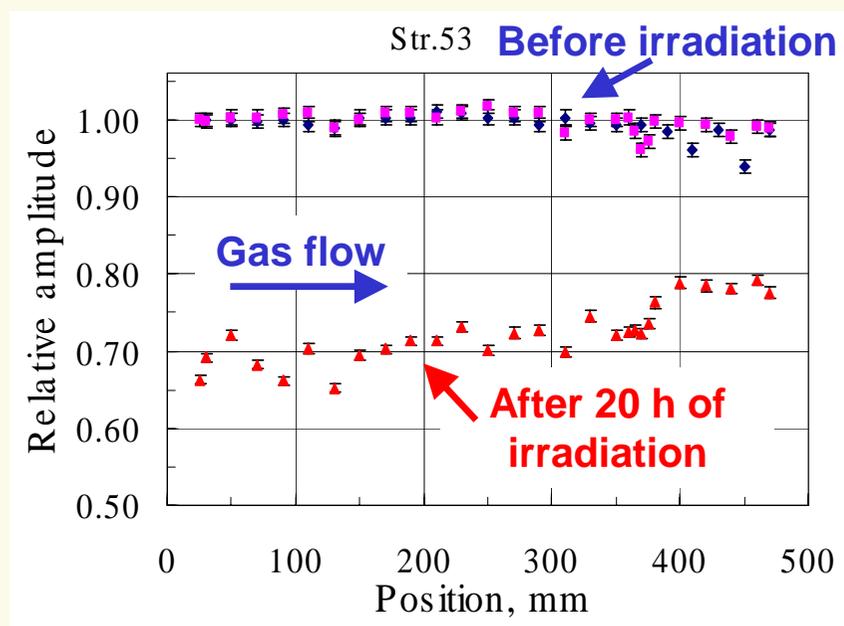
Amplitude along the wire for a straw connected to a gas system containing a large amount of Si

Both weak and strong Si sources are very dangerous!

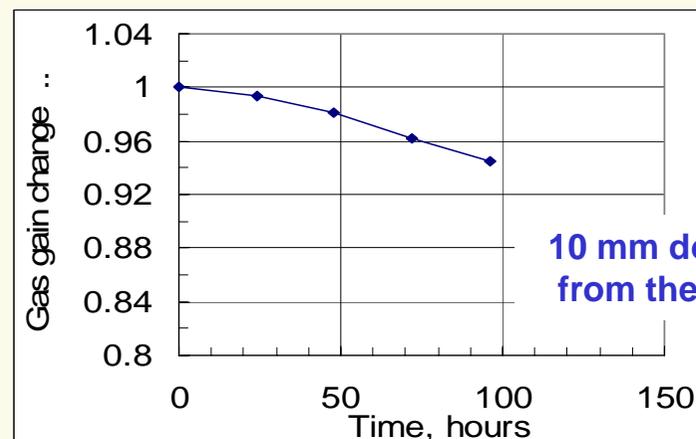
70 hours was enough to pollute some parts of the straw!

10 mm downstream from the test point

- “Vogtlin” rotameter (ageing rate of 10-15% in 100 hours). **No ageing** in 220 hours after cleaning in ultrasonic bath (see Mar’s talk).

- “Vogtlin” rotameter used in test shown in previous slide. **No ageing** during 500 hours after DME flushing through it during **1 week (few l/h)**. The same results for **0.8 l/h and 20 hours of flushing**.
- Small closed-loop gas-system prototype typical ageing in 200 hours ~10%. **No ageing** during 600 hours after **2 weeks operation with pure DME with 0.6 l/h gas exchange**.

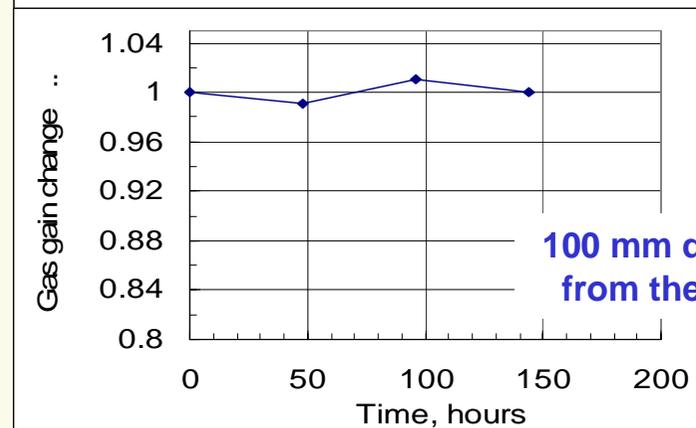
100 mm downstream from the test point

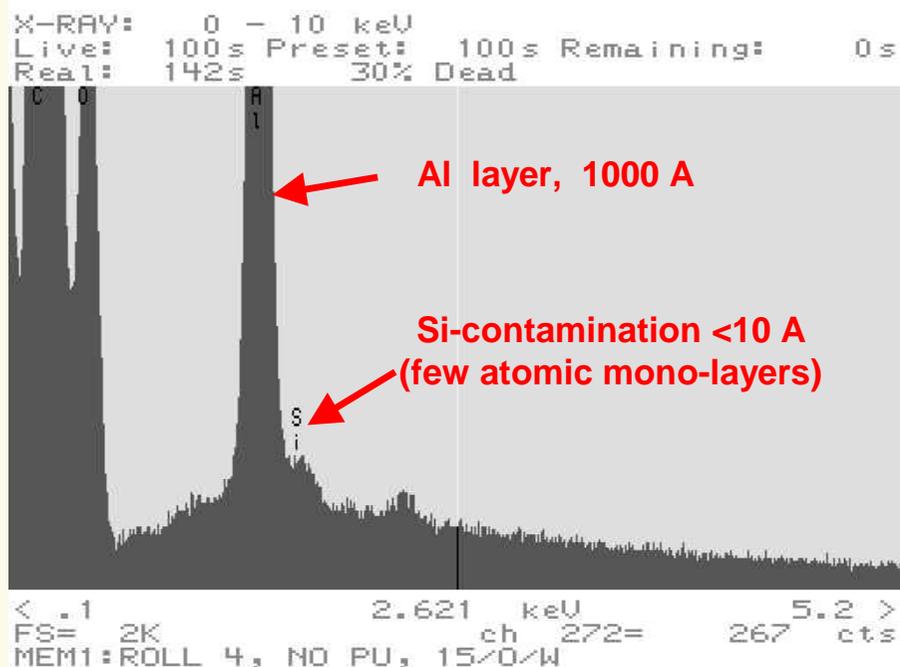
EDX spectrum of straw cathode. Small traces of Si are observed. This Si is actually part of C-loaded polyimide layer

Under specific conditions this Si may produce some ageing effects (~5-10 % amplitude drop in 150 hours).

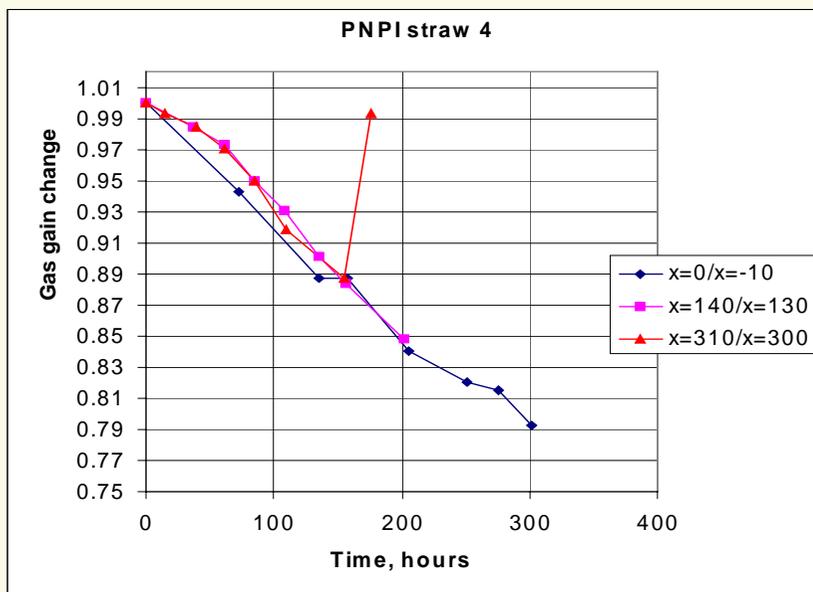
Amplitude as a function of exposure time at different source positions along the straw

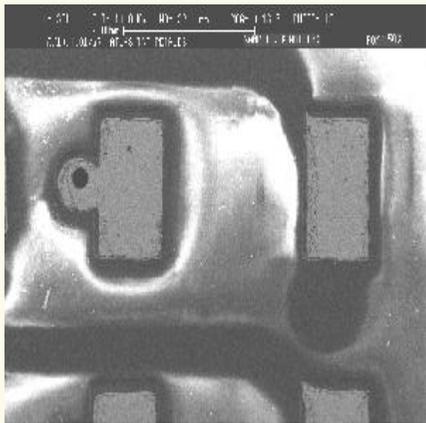
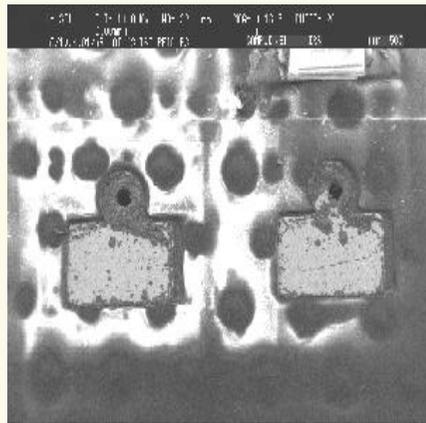
Etching of coverlay on PCB
Before exposure After exposure

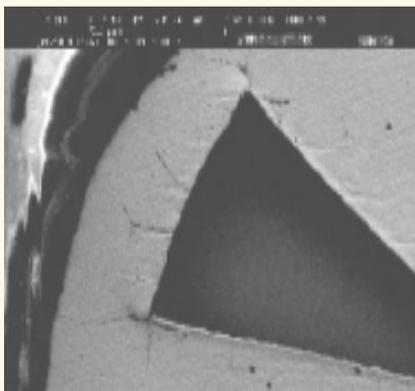
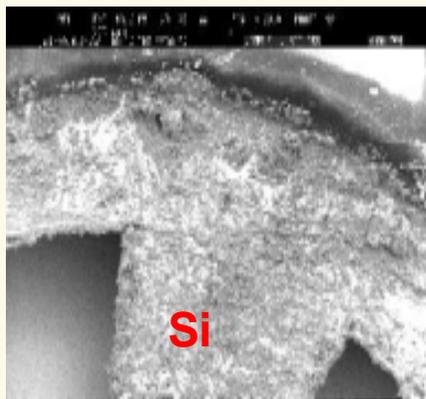
Si deposit on gold-plated surfaces!
Before exposure After exposure

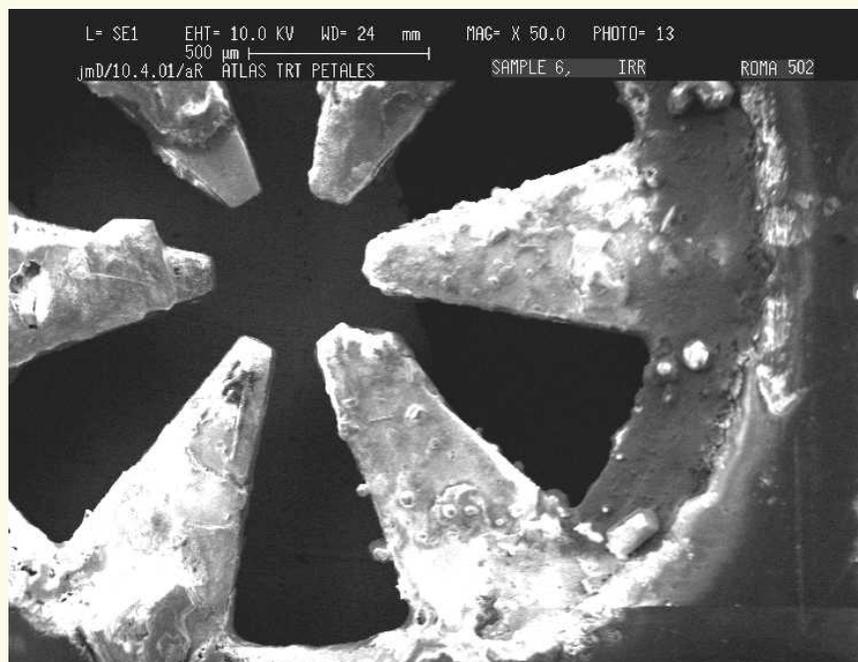
Si crystals gold-plated metallic surface

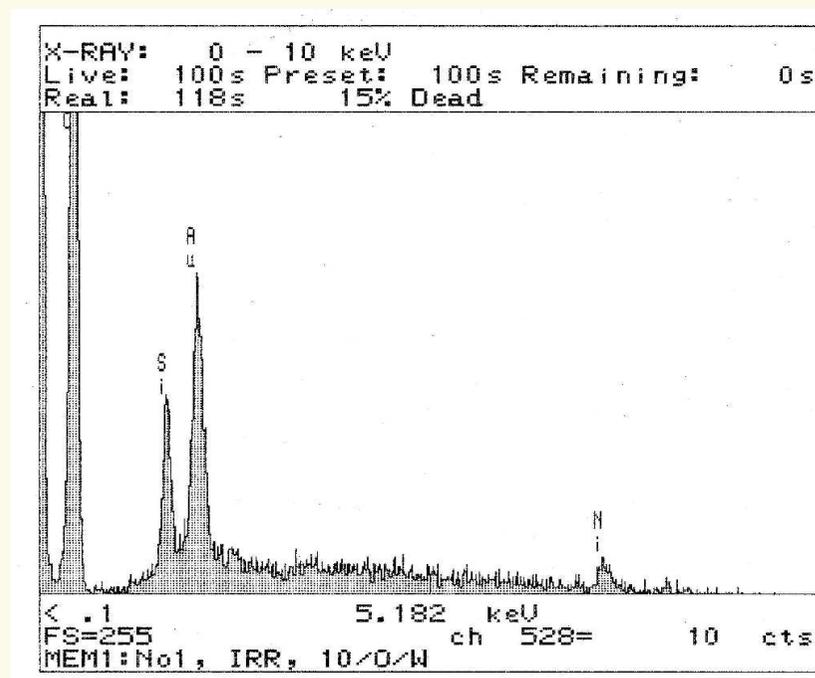
EDX spectrum of the deposit
