# X-Radiography of archaeological sample

Kirsi Leppänen  
University of Helsinki

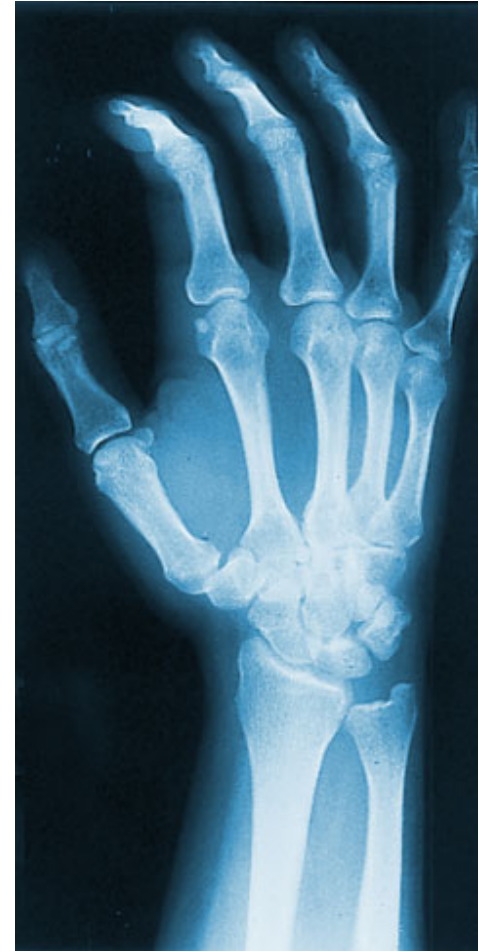
- Sample is exposed by X-ray beam
- Image is generated by the variations in absorption due to thickness and composition of the sample

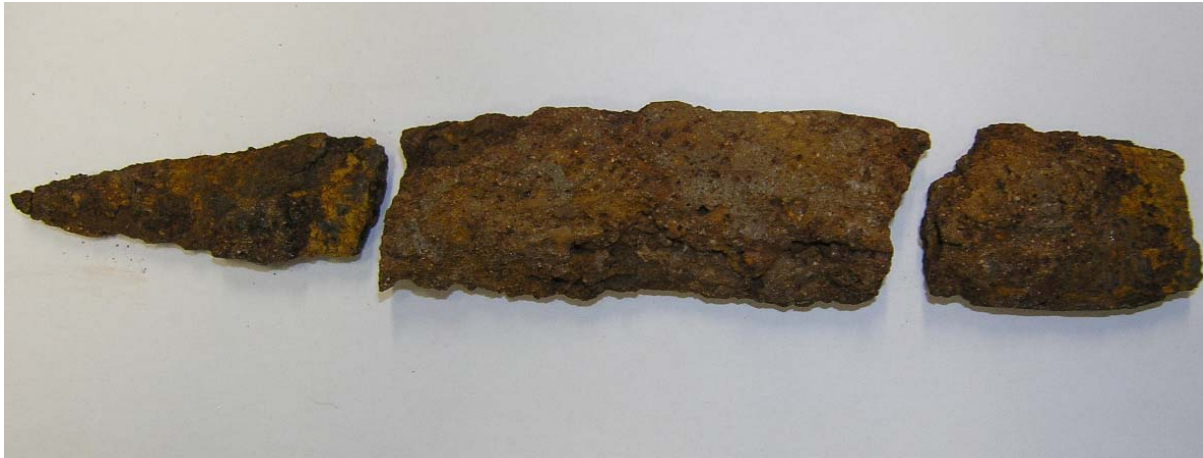
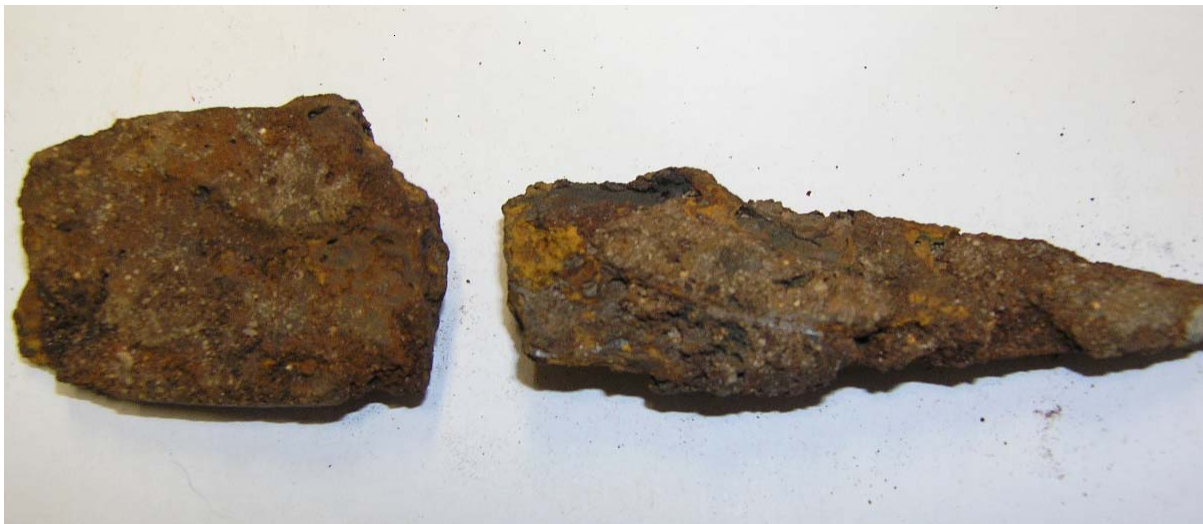
# Samples

- Iron spear head from Poland
- Owner:  
Archaeological Museum, Warsaw;  
professor Wladyslaw Weker
- It was found in the grave in Czersk
- The grave might belong to  
Masovian prince from 12th century

- Three pieces: one bigger part, one smaller part and the top of the spear head
- All of them are under a thick layer of corrosion products and organic substances

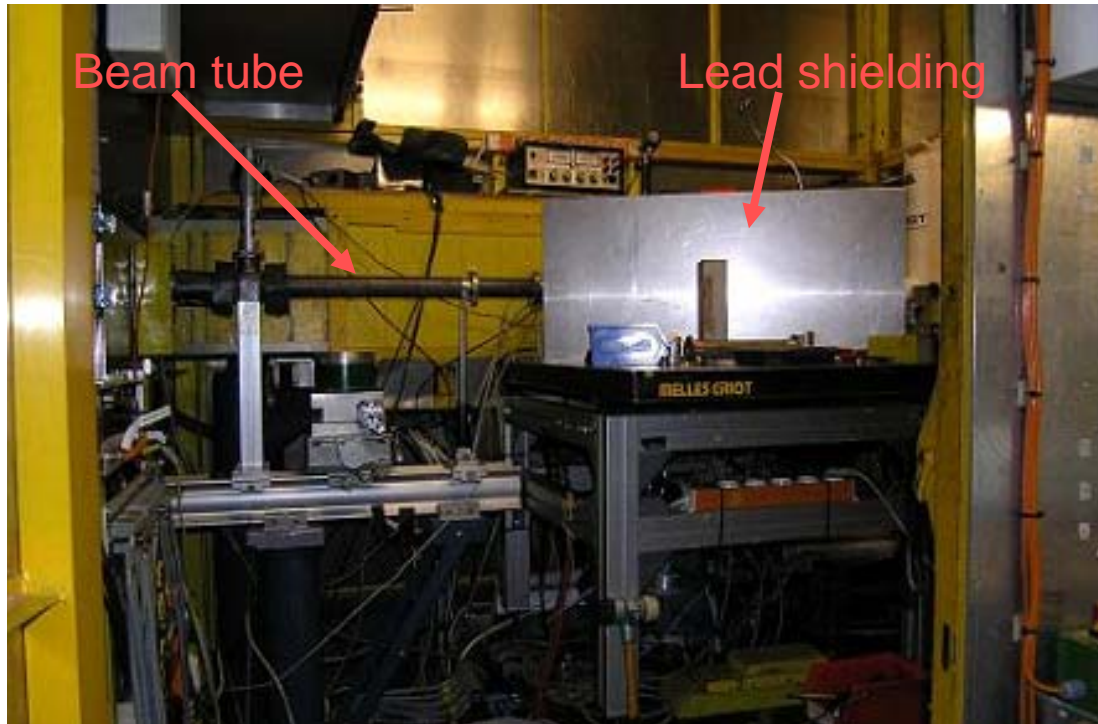
- HASYLAB beamline F3
- **White beam**=includes all the x-ray wavelengths
- Testing polycapillaries between the sample and detector to suppress the scattering
- Both image plates and x-ray films were used as detectors

This is how the hutch looks like:

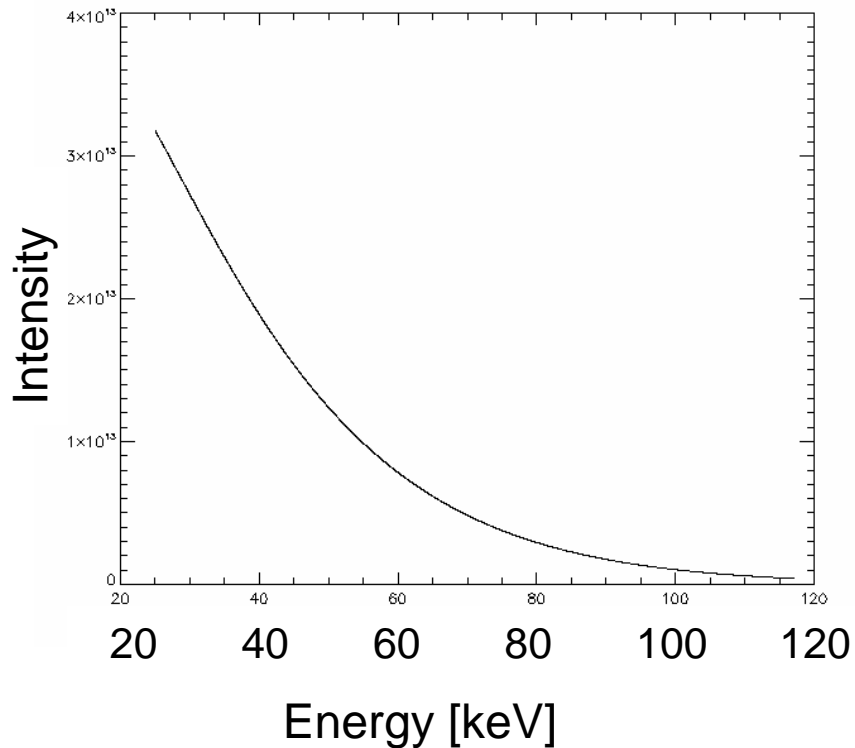
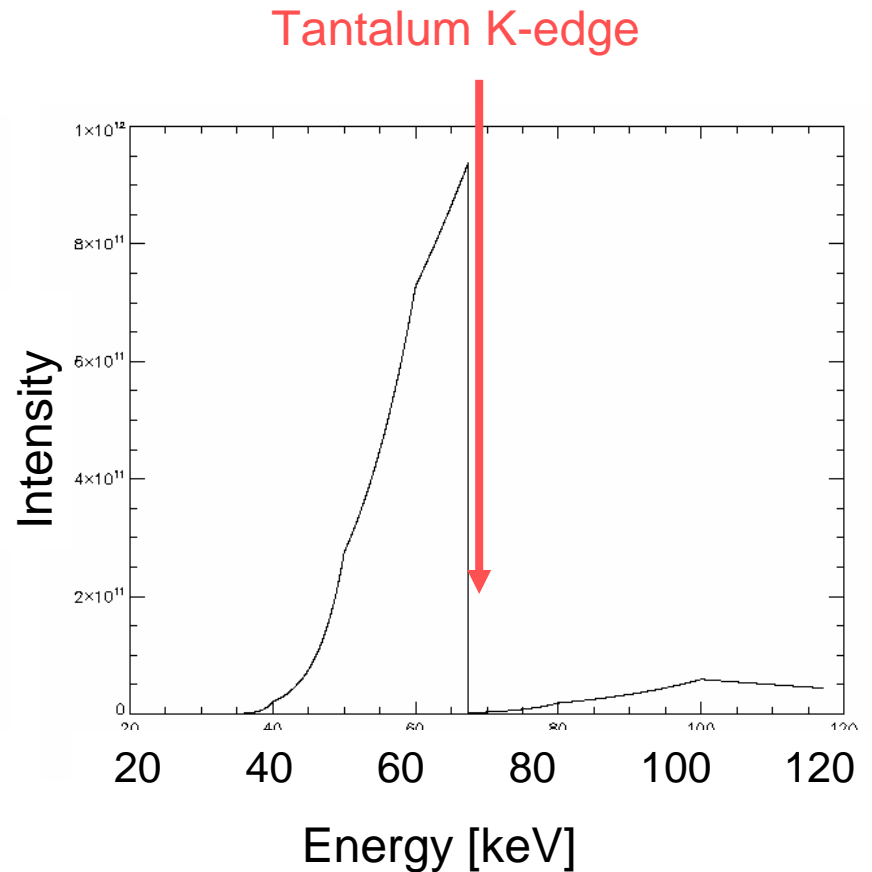
# Beam spectrum before and after 0.4 mm tantalum

- High intensity caused severe problems with image plate and film saturation: they were too sensitive.
- Solution: thin tantalum plate in front of the beam
- the beam was no more white beam, because the low energy part of spectrum was cut off.

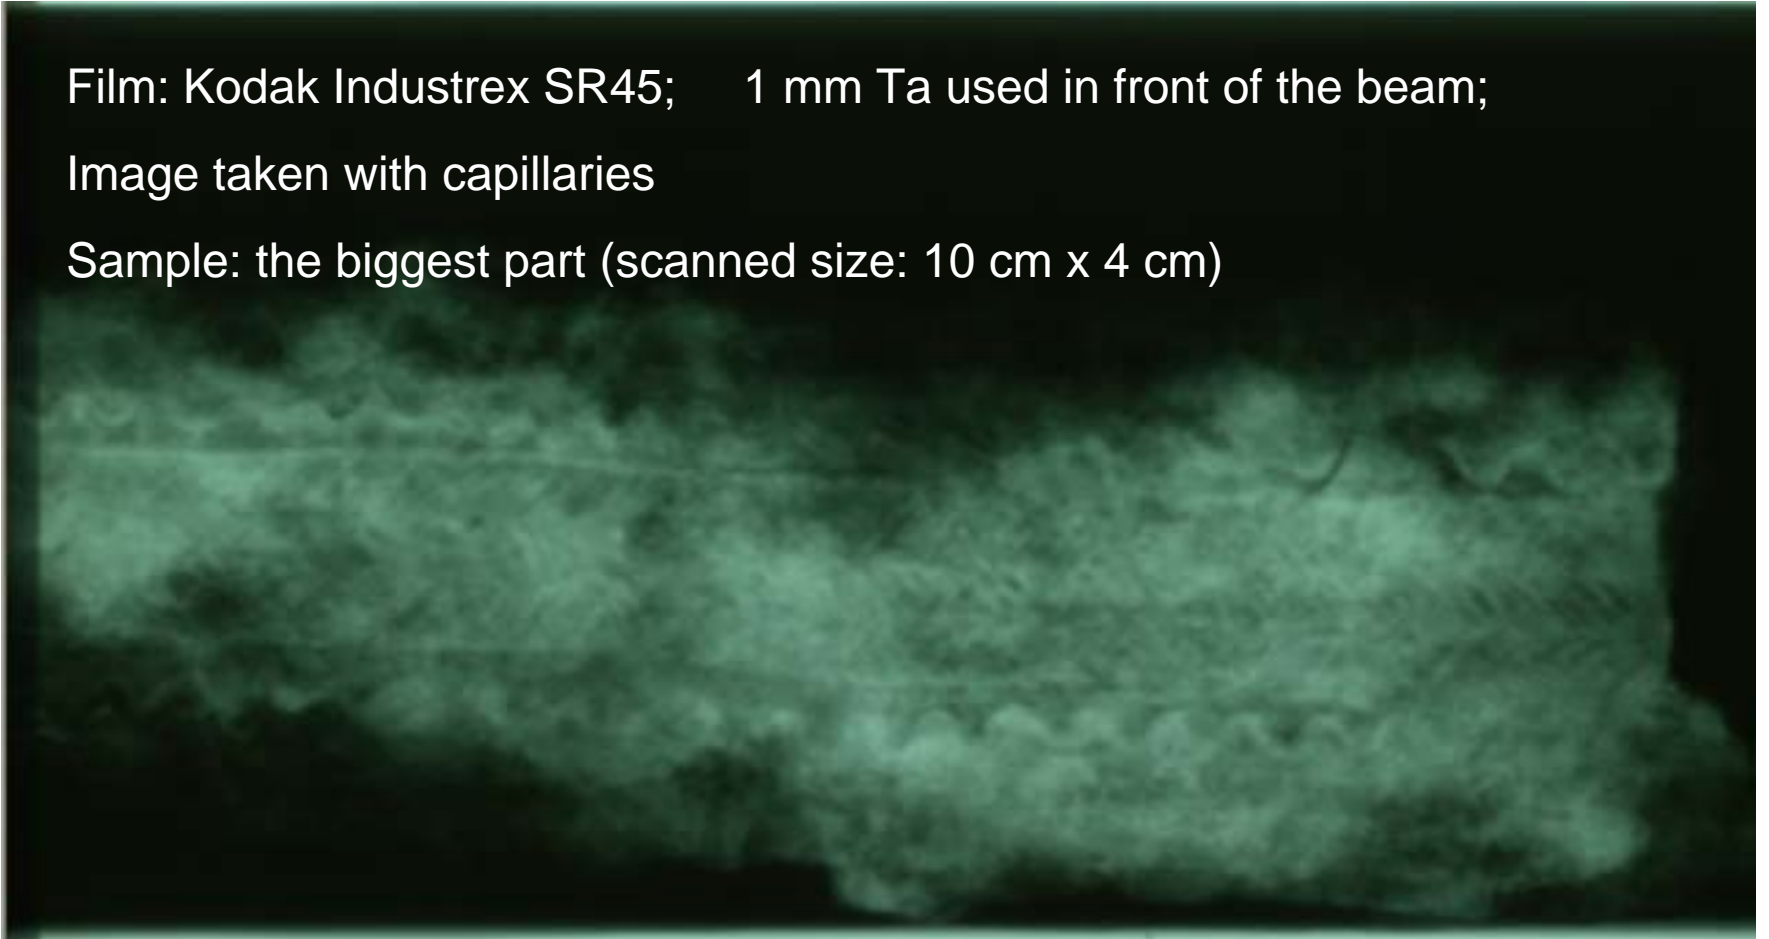
# 1. Film result

Film: Kodak Industrex SR45; 1 mm Ta used in front of the beam;

Image taken with capillaries

Sample: the biggest part (scanned size: 10 cm x 4 cm)

- Good results by using X-ray films, image plate was too sensitive
- No need for polycapillaries in this case, because there was no huge amount of scattering. That was due beam hardening by tantalum.
