ZEUS 19 Apr 2005

Background history in
the week after BU SR
repair

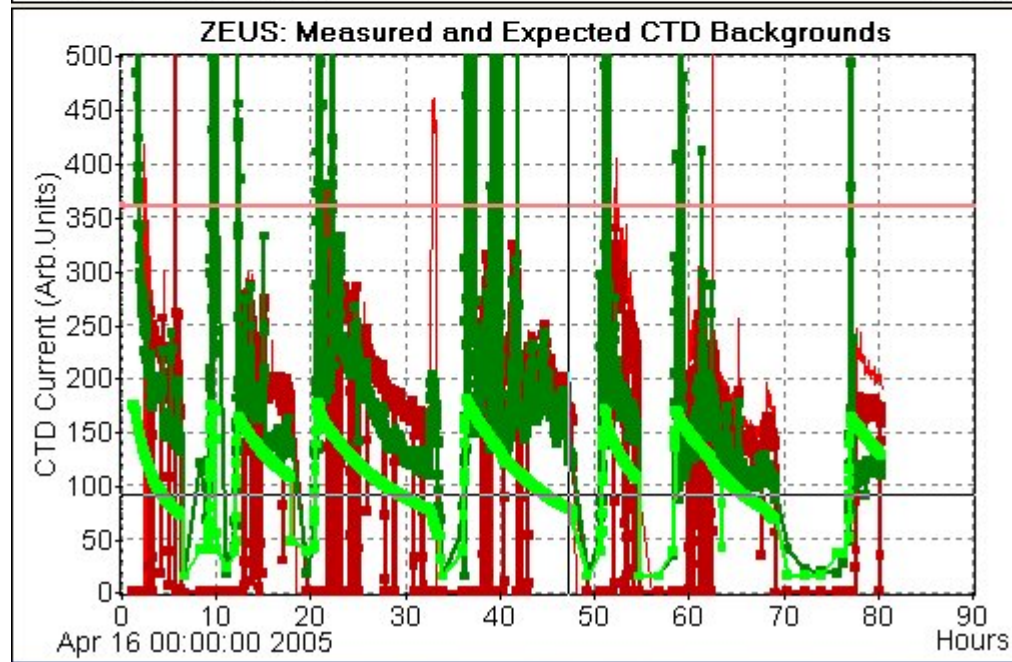
TSP

p vacuum

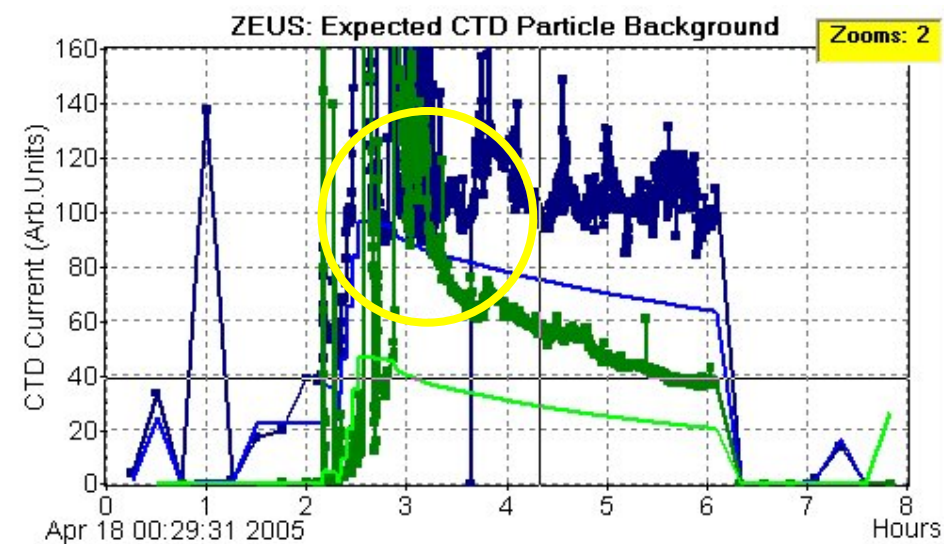
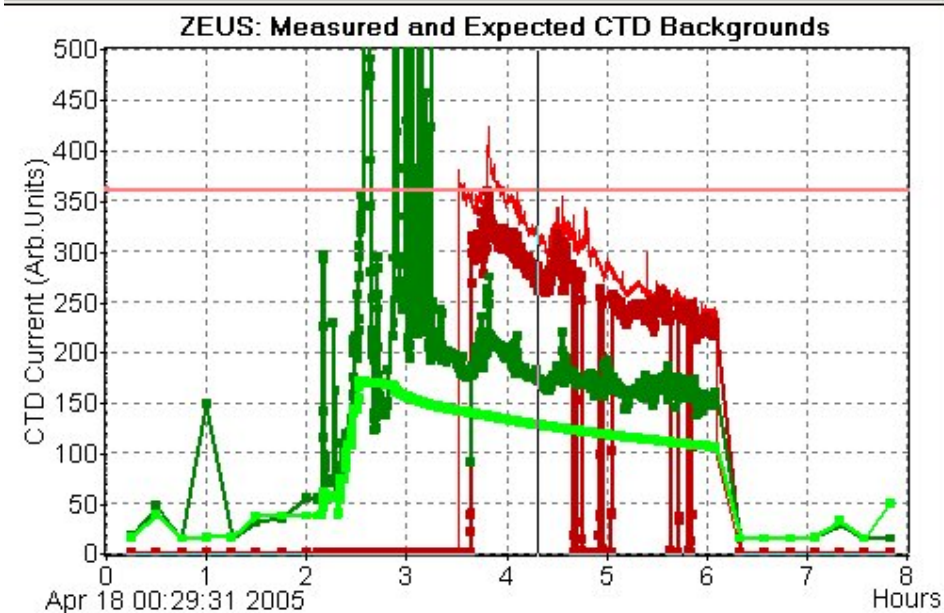
before TSP regeneration

after TSP regeneration

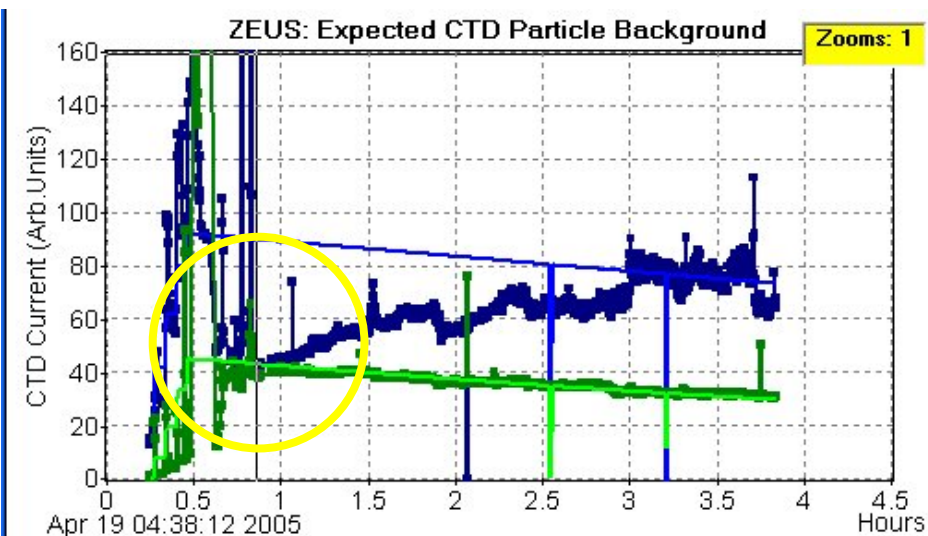
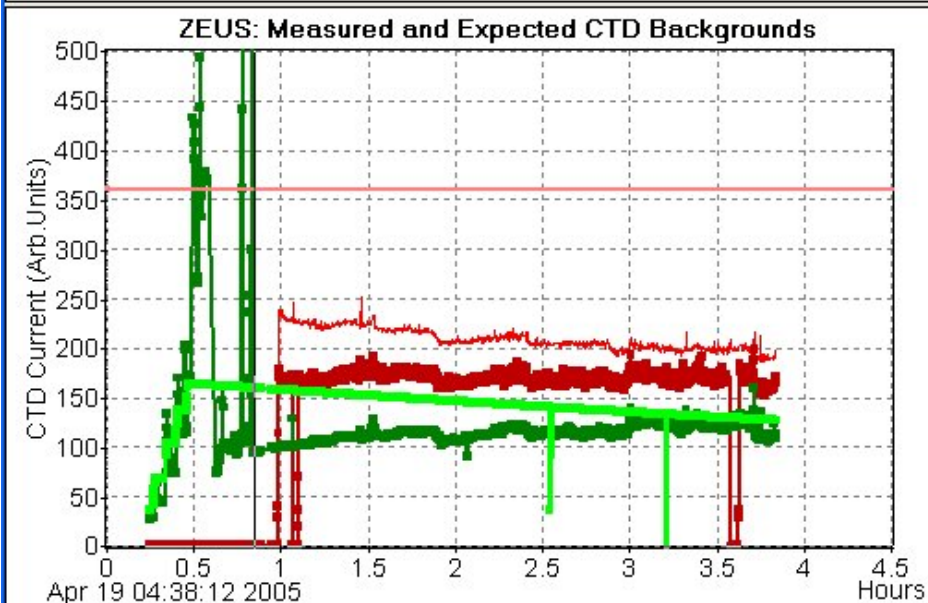
before BU SR repair

good fill

bad fill

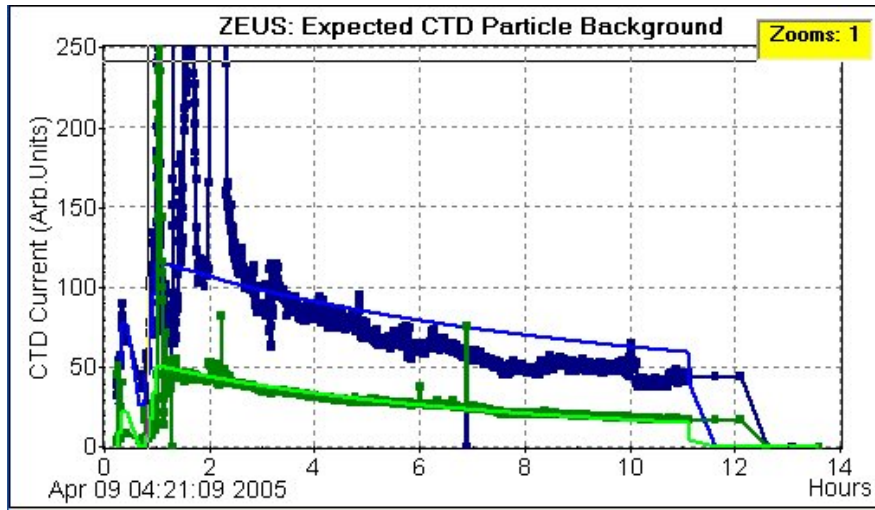
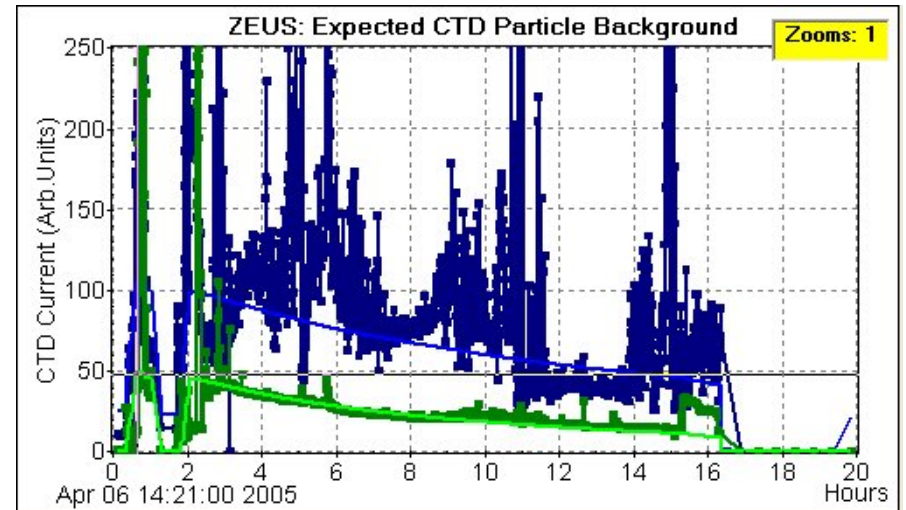
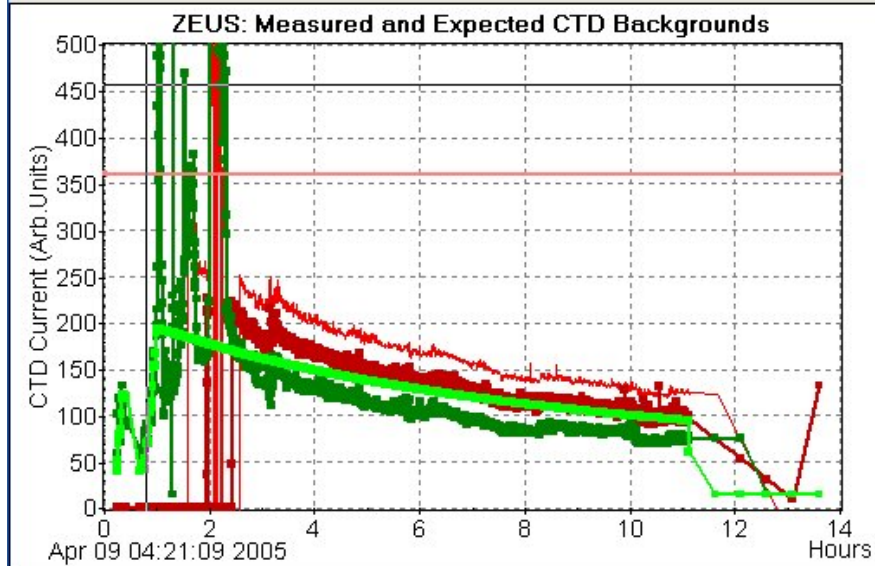
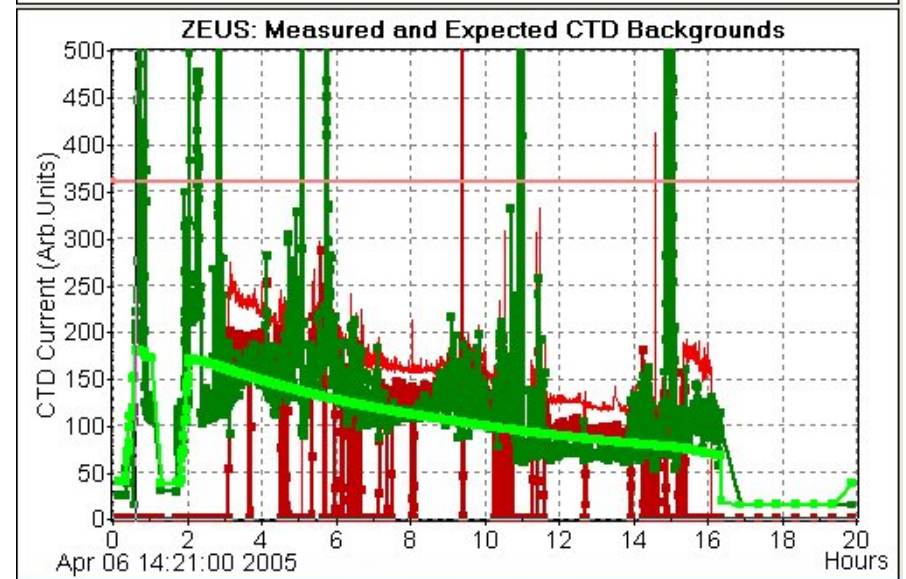
high dead time

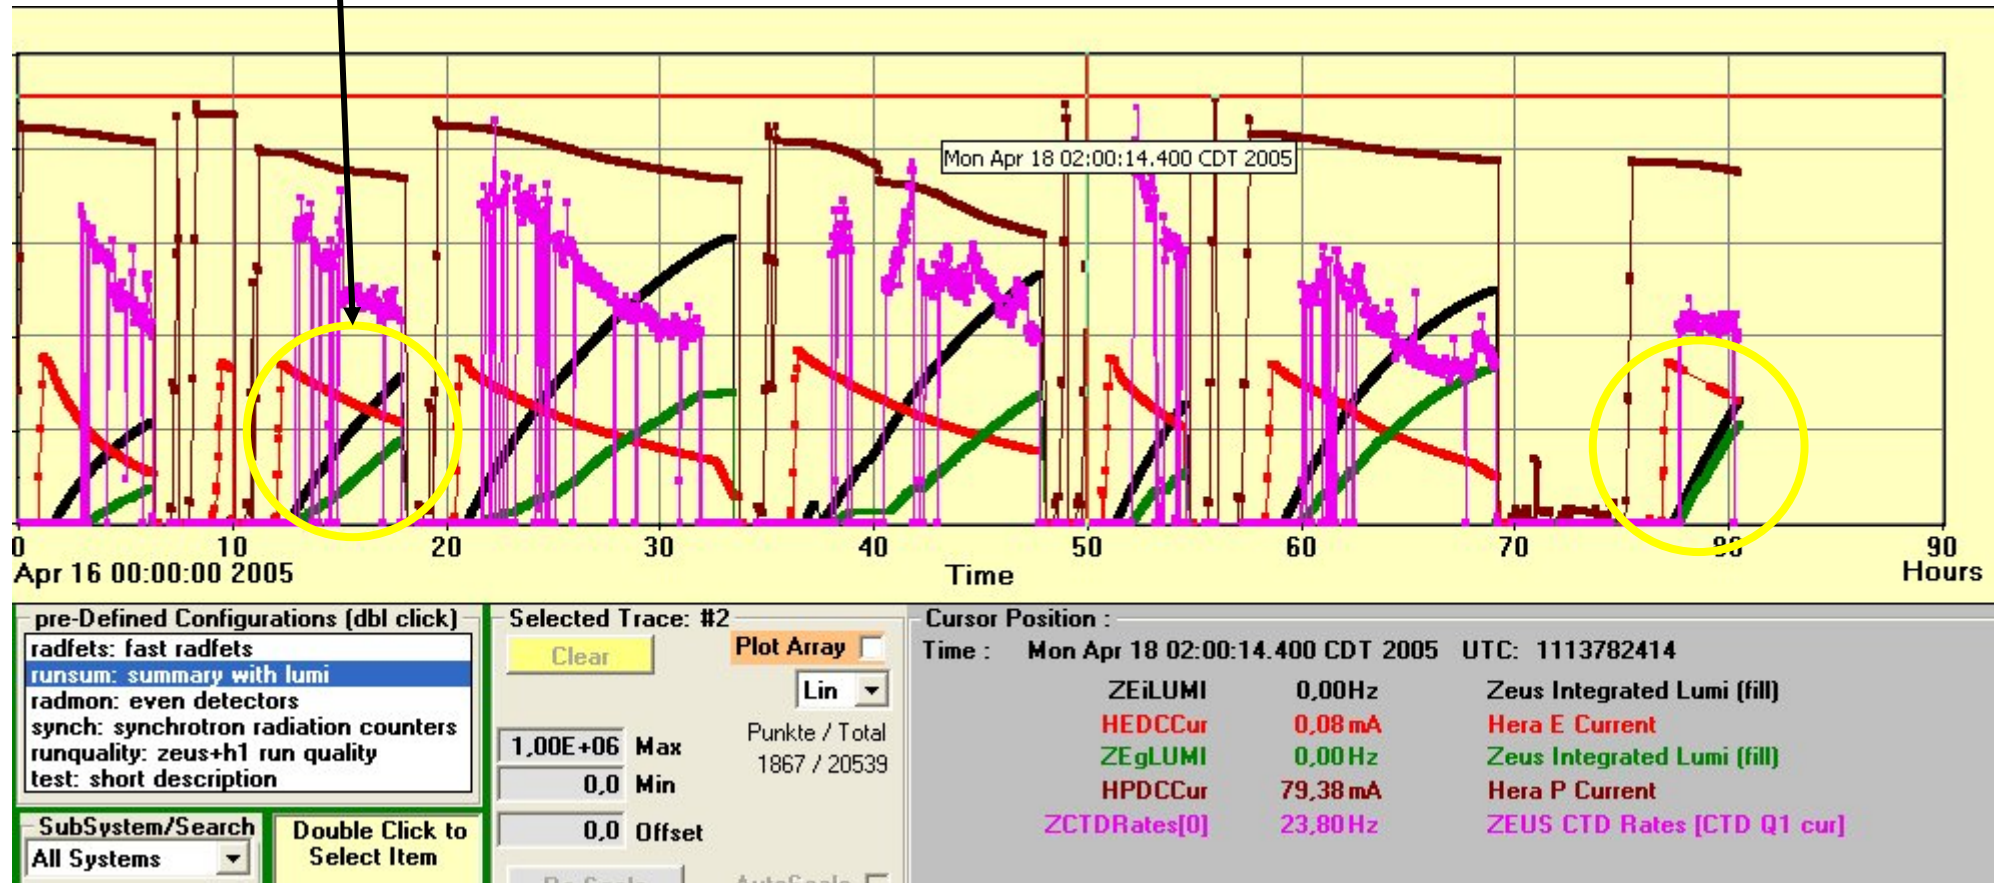
HV efficiency and dead dtime is improving
