HERA Experiment Meeting, May 24<sup>th</sup>, 2005

# Vacuum Leak NR 15

Joachim Keil, MPY

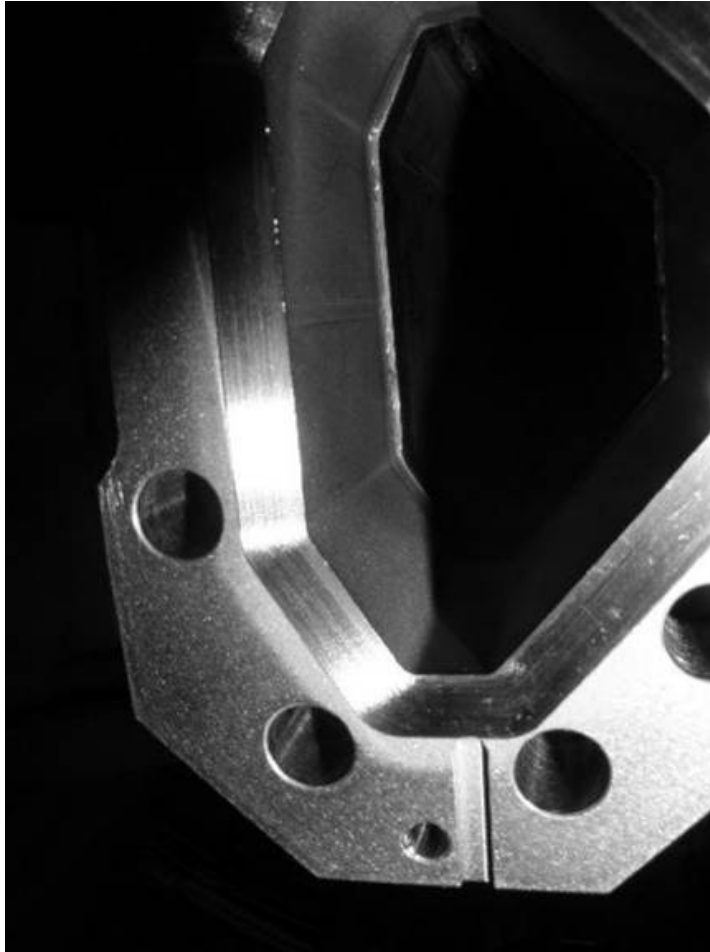
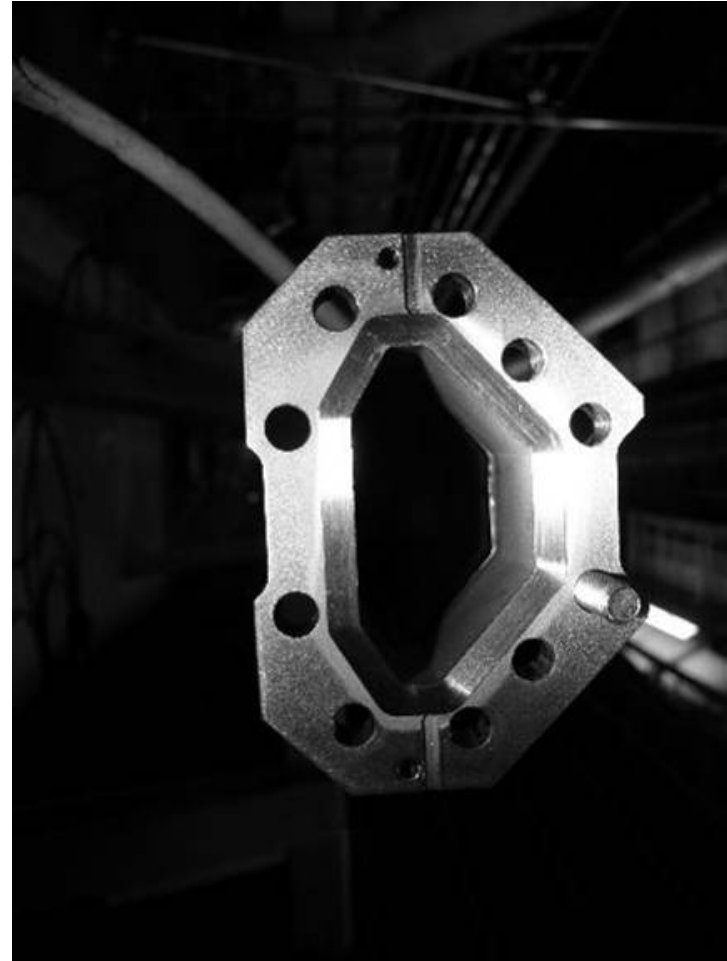
# Proton Vacuum Chamber at NR15

Out-of-tolerance manufacturing  $\Rightarrow$  welding seam  $\Rightarrow$  local heating ?!
