Aging in Large CDF Tracking Chambers

International Workshop on Aging Phenomena in Gaseous Detectors

Presented by:
Morris Binkley, Fermilab

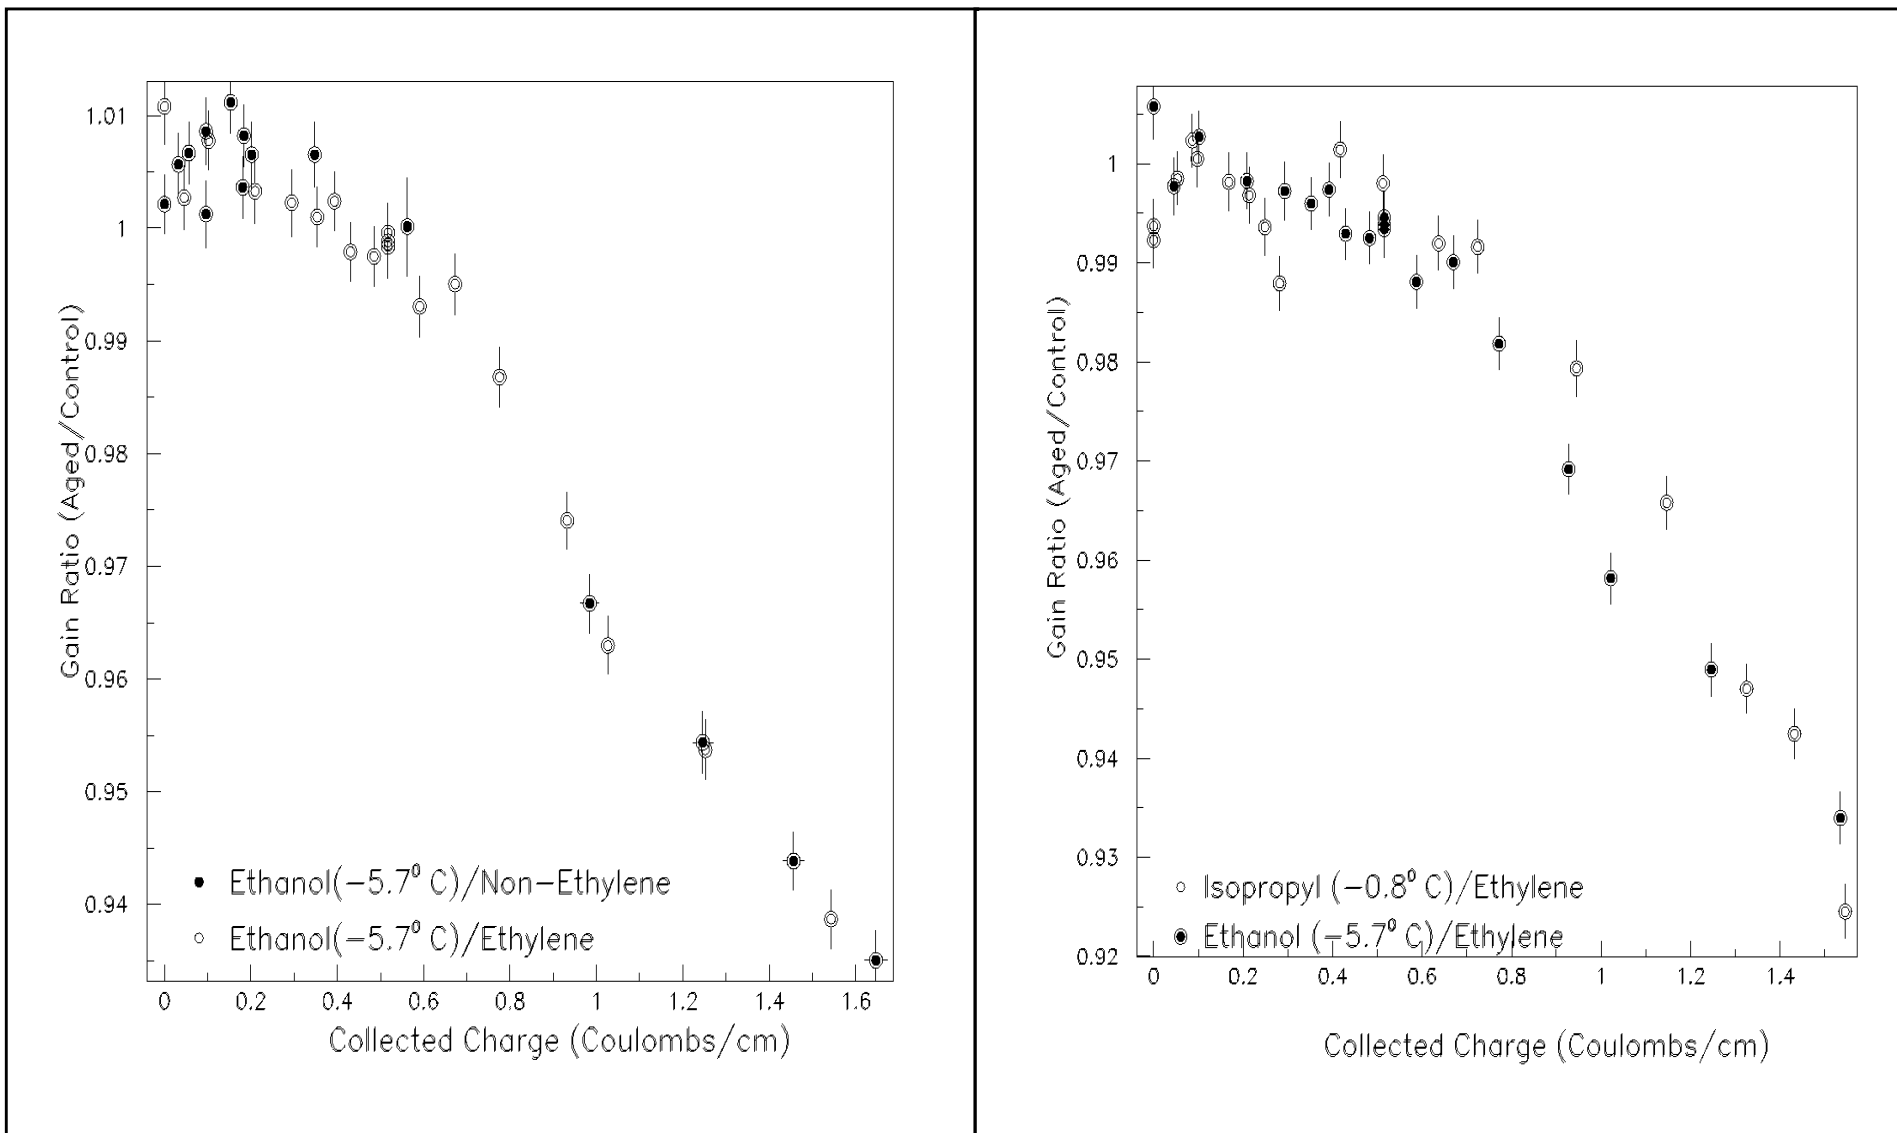
Aging results with ethylene and alcohol

- Prior to Run 1, tests on prototype chambers indicated aging rates $< 10\%/C/cm$.
 - Using regular Argon/Ethane gas from CDF supply tanks.
- Near the end of Run 1 (early 1995), much larger aging effects ($1000\%/C/cm$) were noticed in the CTC.
 - This large aging rate was consistent with starting in early 1994 coincident with two unrelated occurrences:
 - There was a change in ethane supply (much more ethylene).
 - There was a significant increase in instantaneous luminosity.
- Aging effect of ethylene was measured before the change.
 - Without alcohol, aging rate with ethylene about $80\%/C/cm$.
 - With ethyl or isopropyl alcohol, aging rate about $5\%/C/cm$.

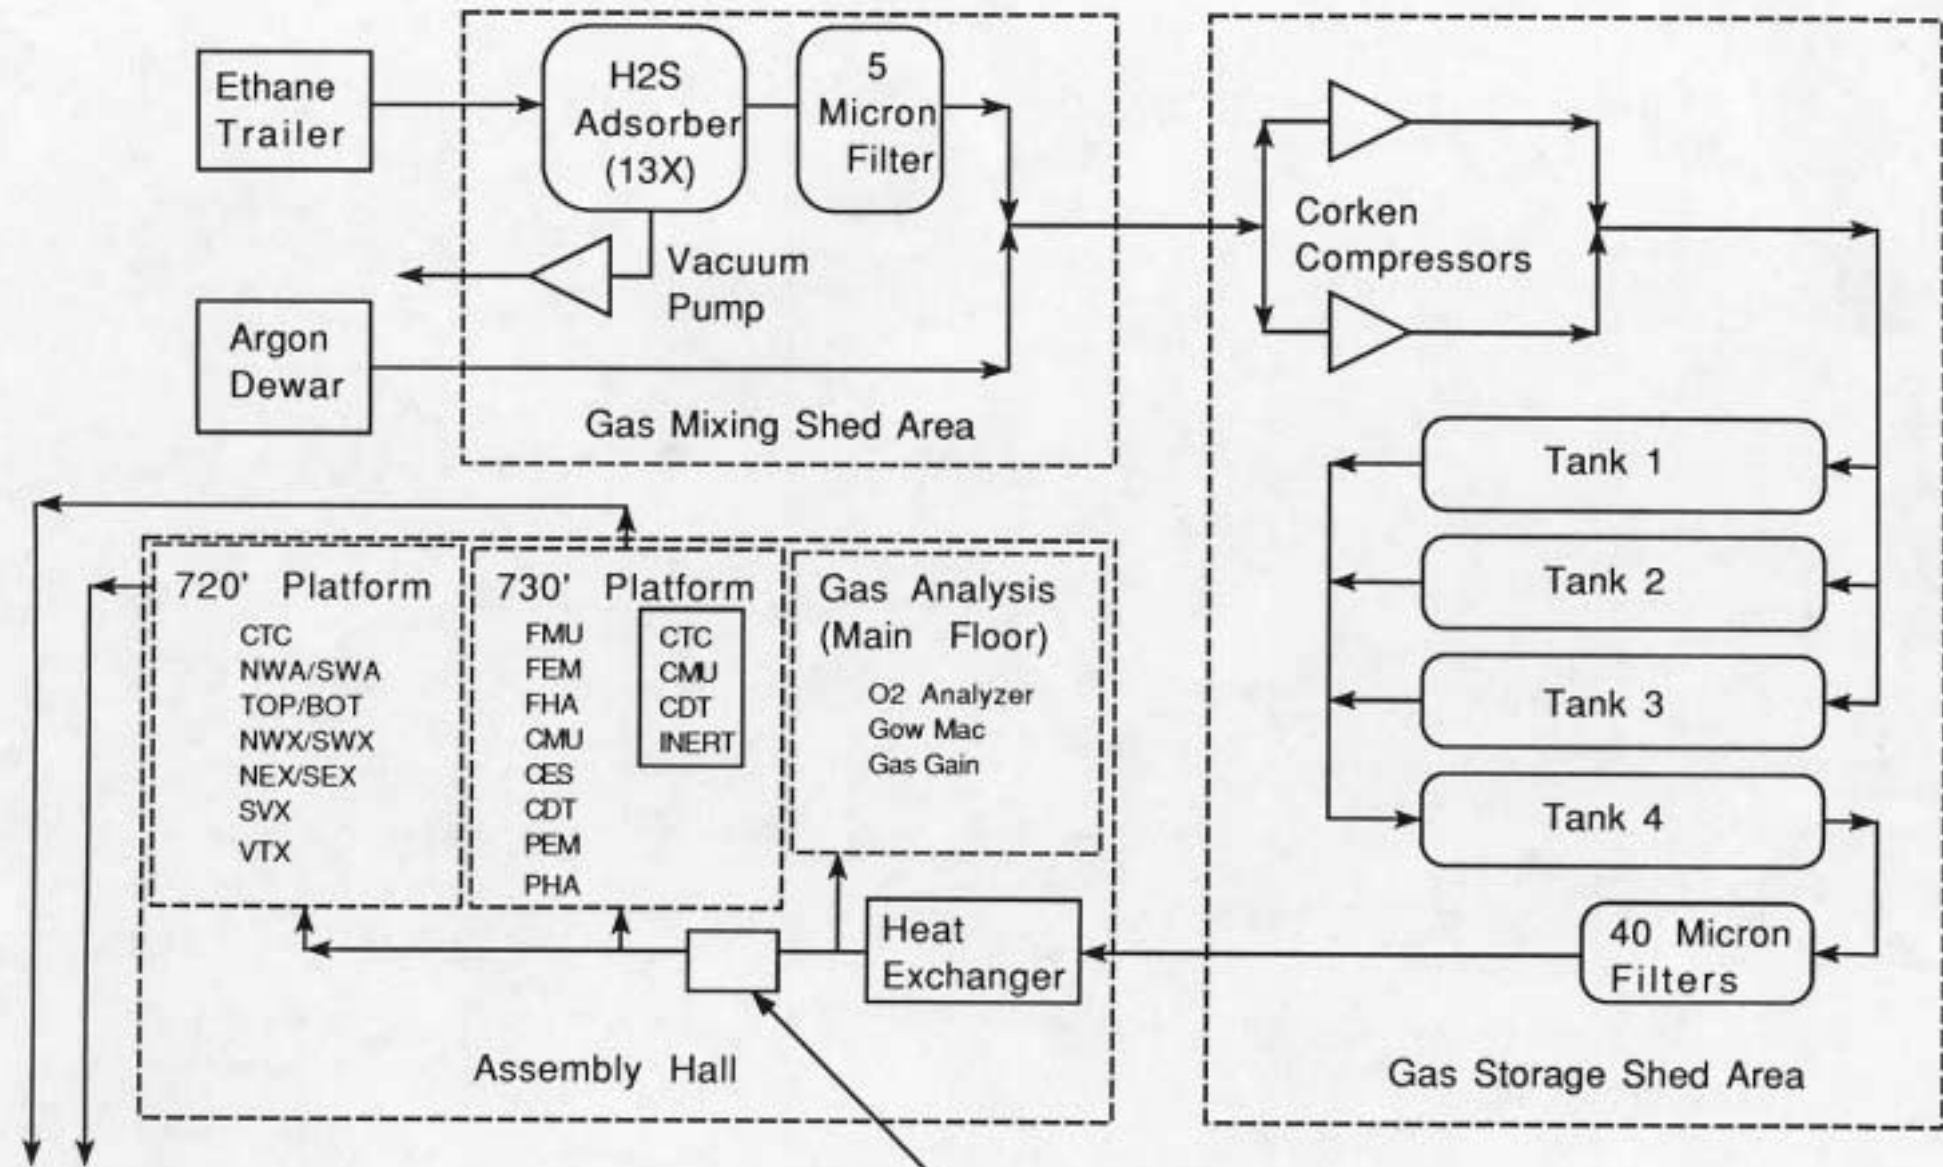
Figure 1. CDF Gas System Simplified Diagram

- **March-April 1995 CTC parts of gas system cleaned.**
 - Mineral oil inlet pressure relief replace by mech. valve.
 - Alcohol bubbler backflushed and refilled (silicone and glycol found); many valves on the gas platform cleaned.
 - Molecular sieve cleaned of HYVAC oil; plumbing fixed.
- **After above cleaning, monitor chambers were inserted into the CTC gas flow.**
 - Sr^{90} sources were used as the source of aging.
 - Fe^{55} sources were used to measure gains.
 - MC's are 3 tubes in parallel and SS's a single tube.
 - Each chamber took the take full CTC gas flow.
 - Source exposure over 2 to 3 inches; current $\sim 1\mu\text{a}$.

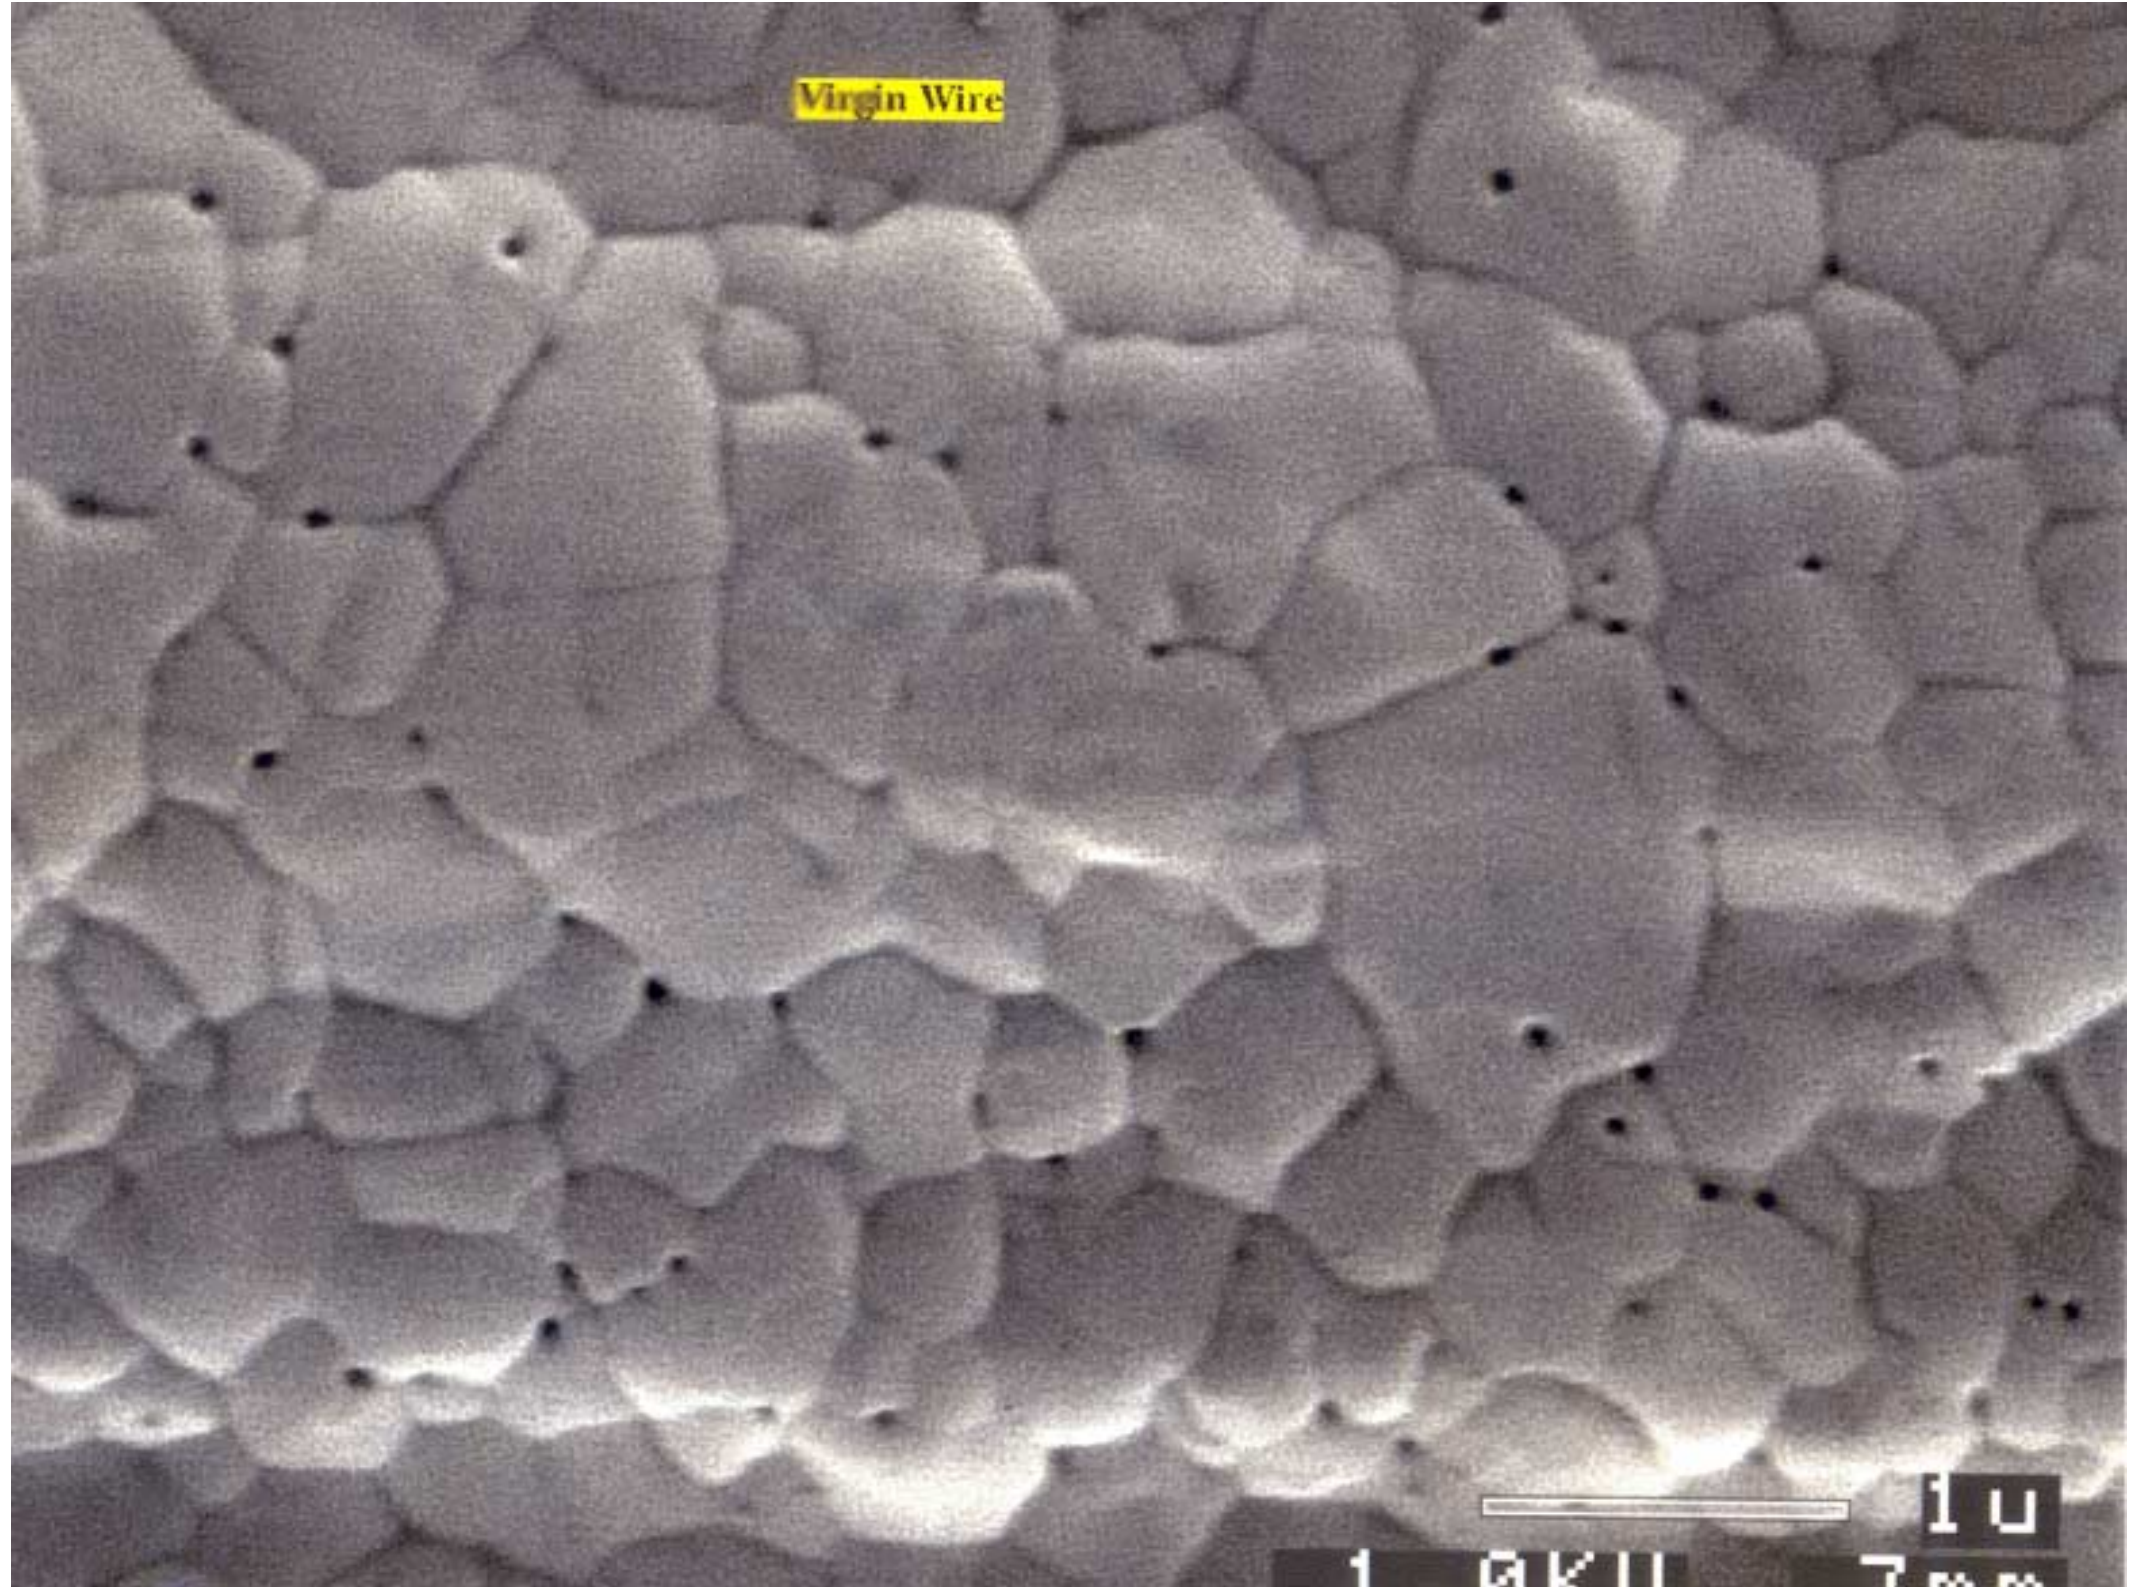
Virgin Wire

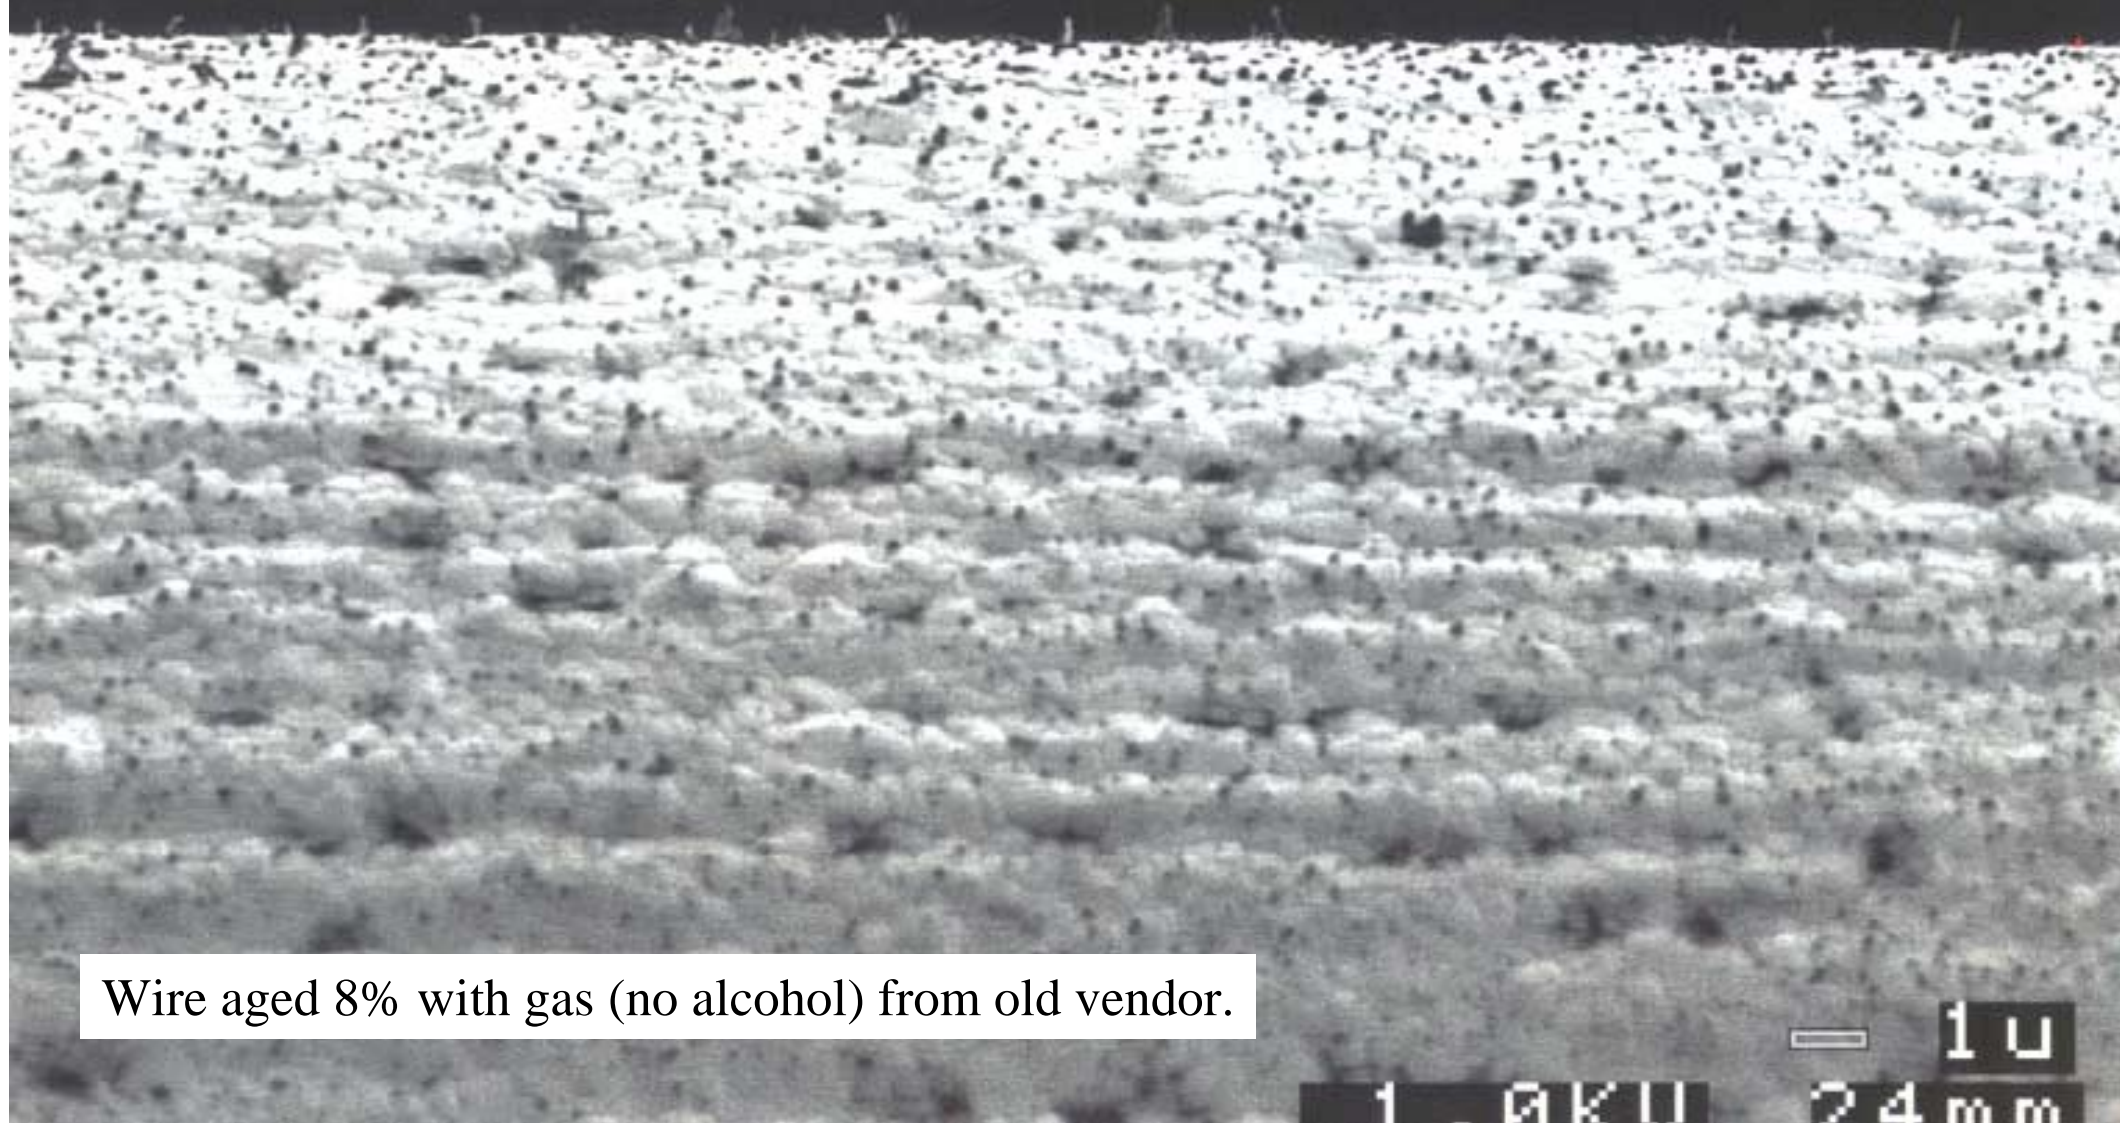
T-2 Wire at Foil (source)

Wire aged 8% with gas (no alcohol) from old vendor.

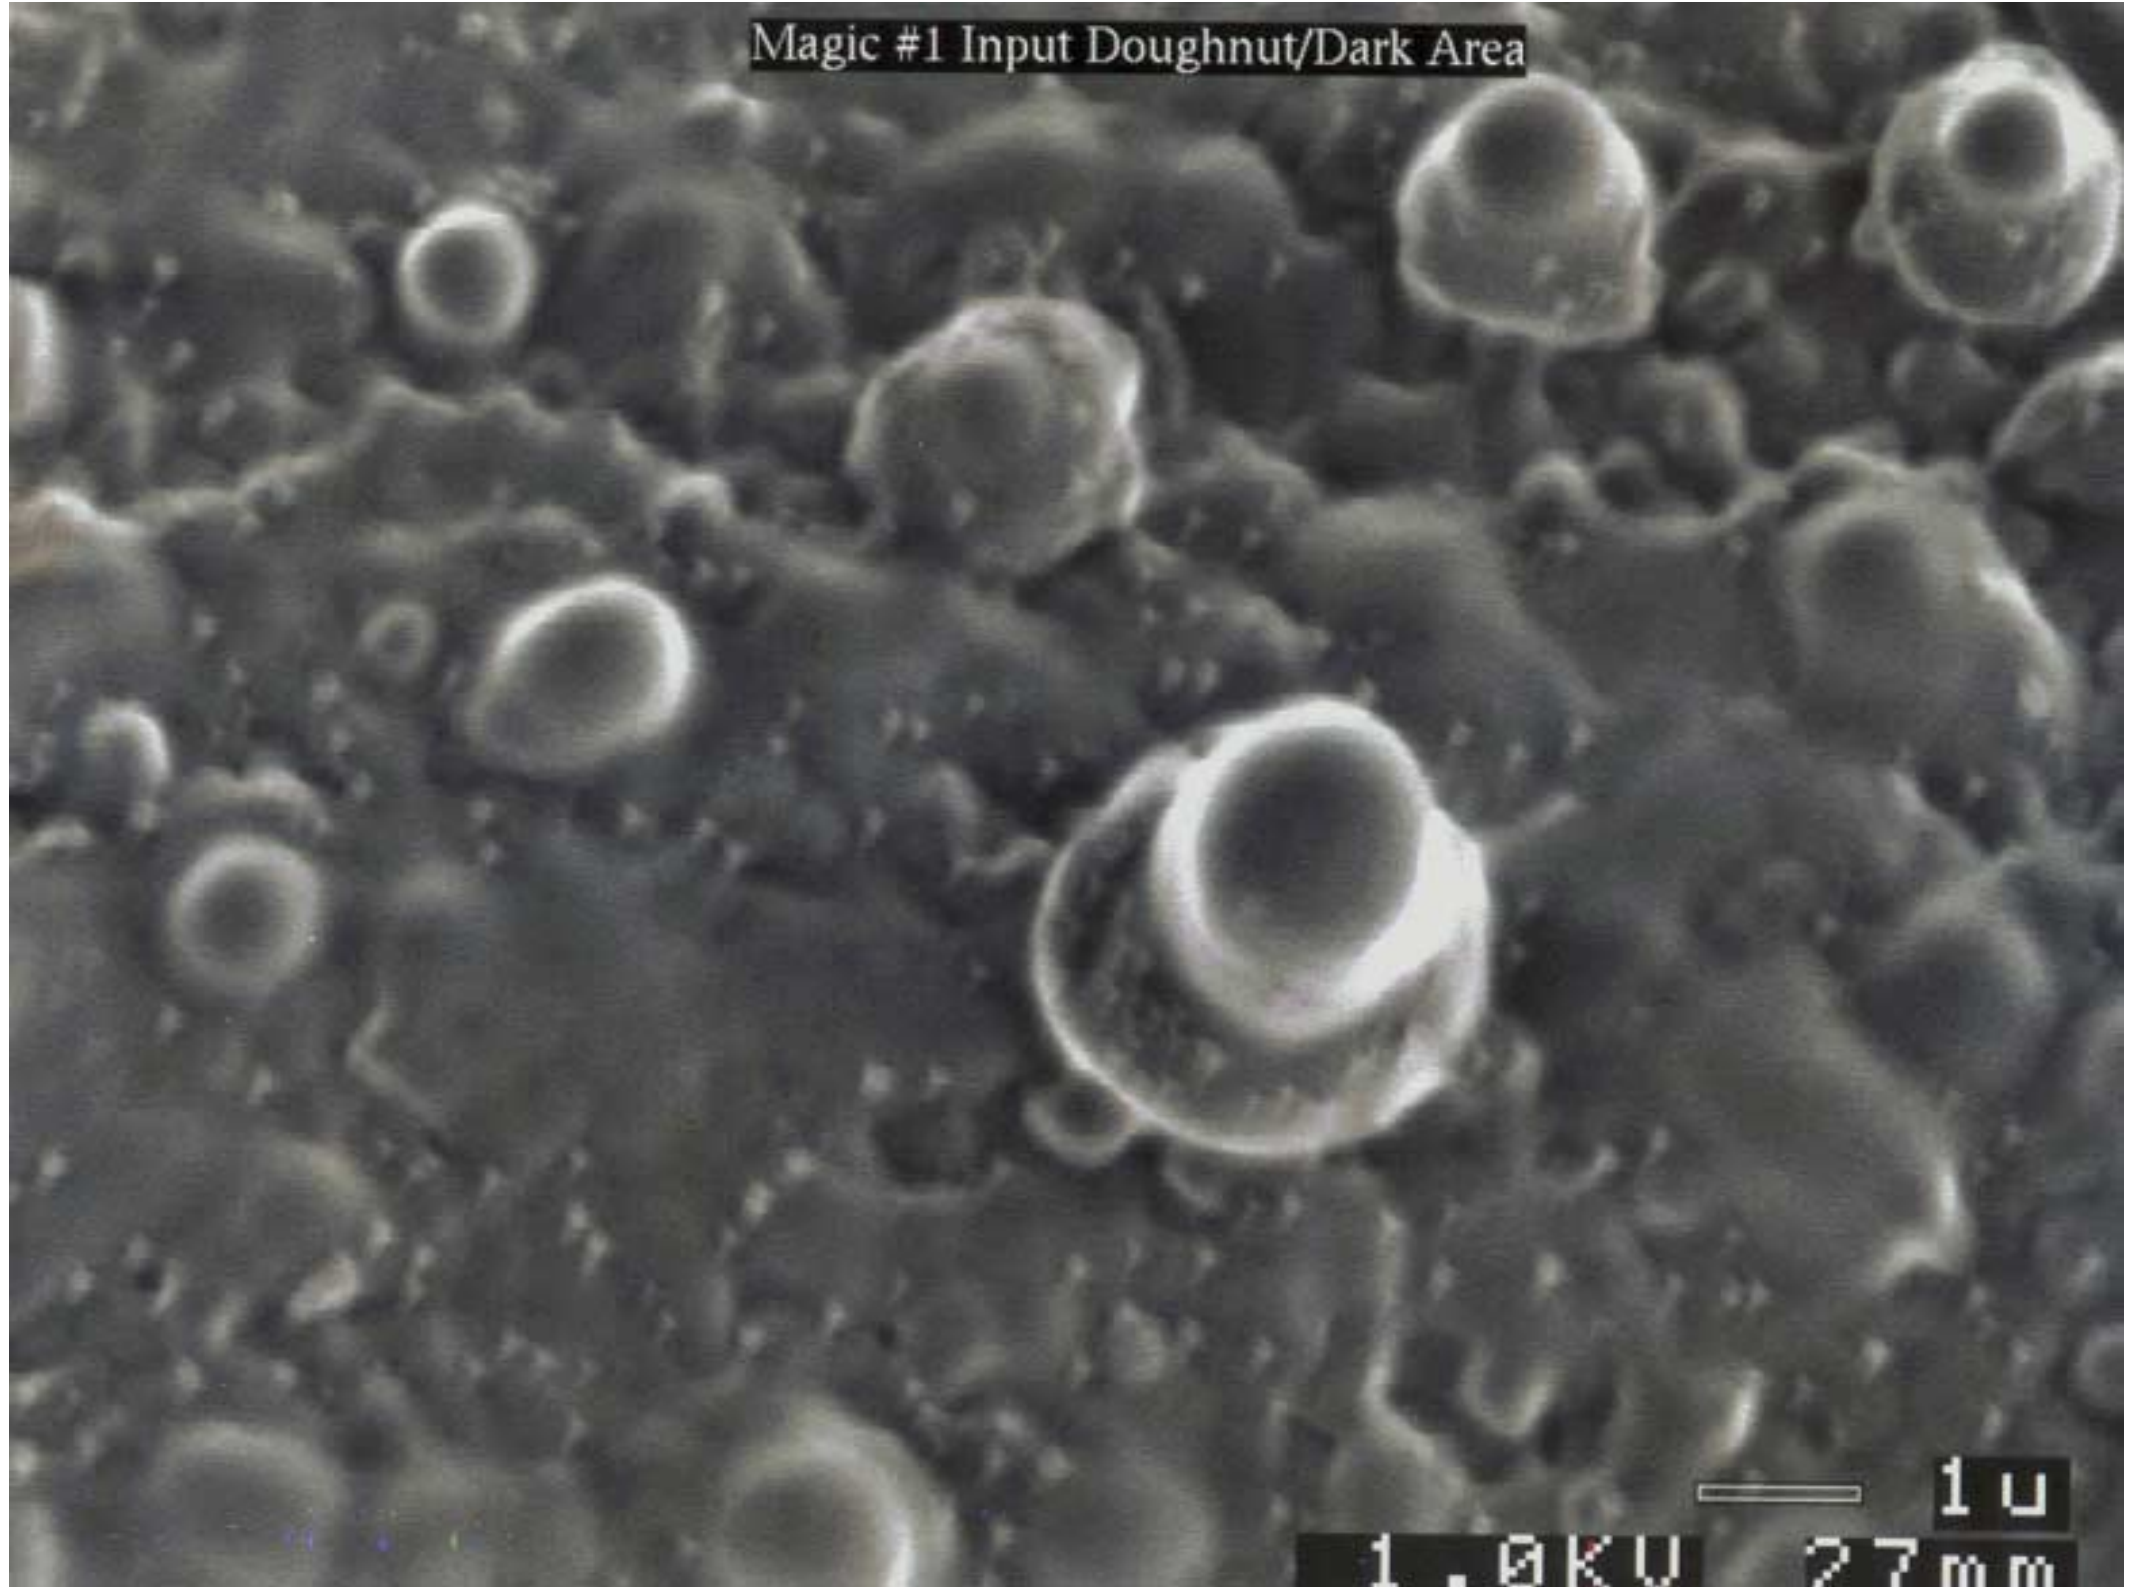
Wire with 50% gain loss. Analysis shows mostly long-chain aliphatic hydrocarbon polymer similar to wire at bubbler.

Magic #1 Input Doughnut/Dark Area

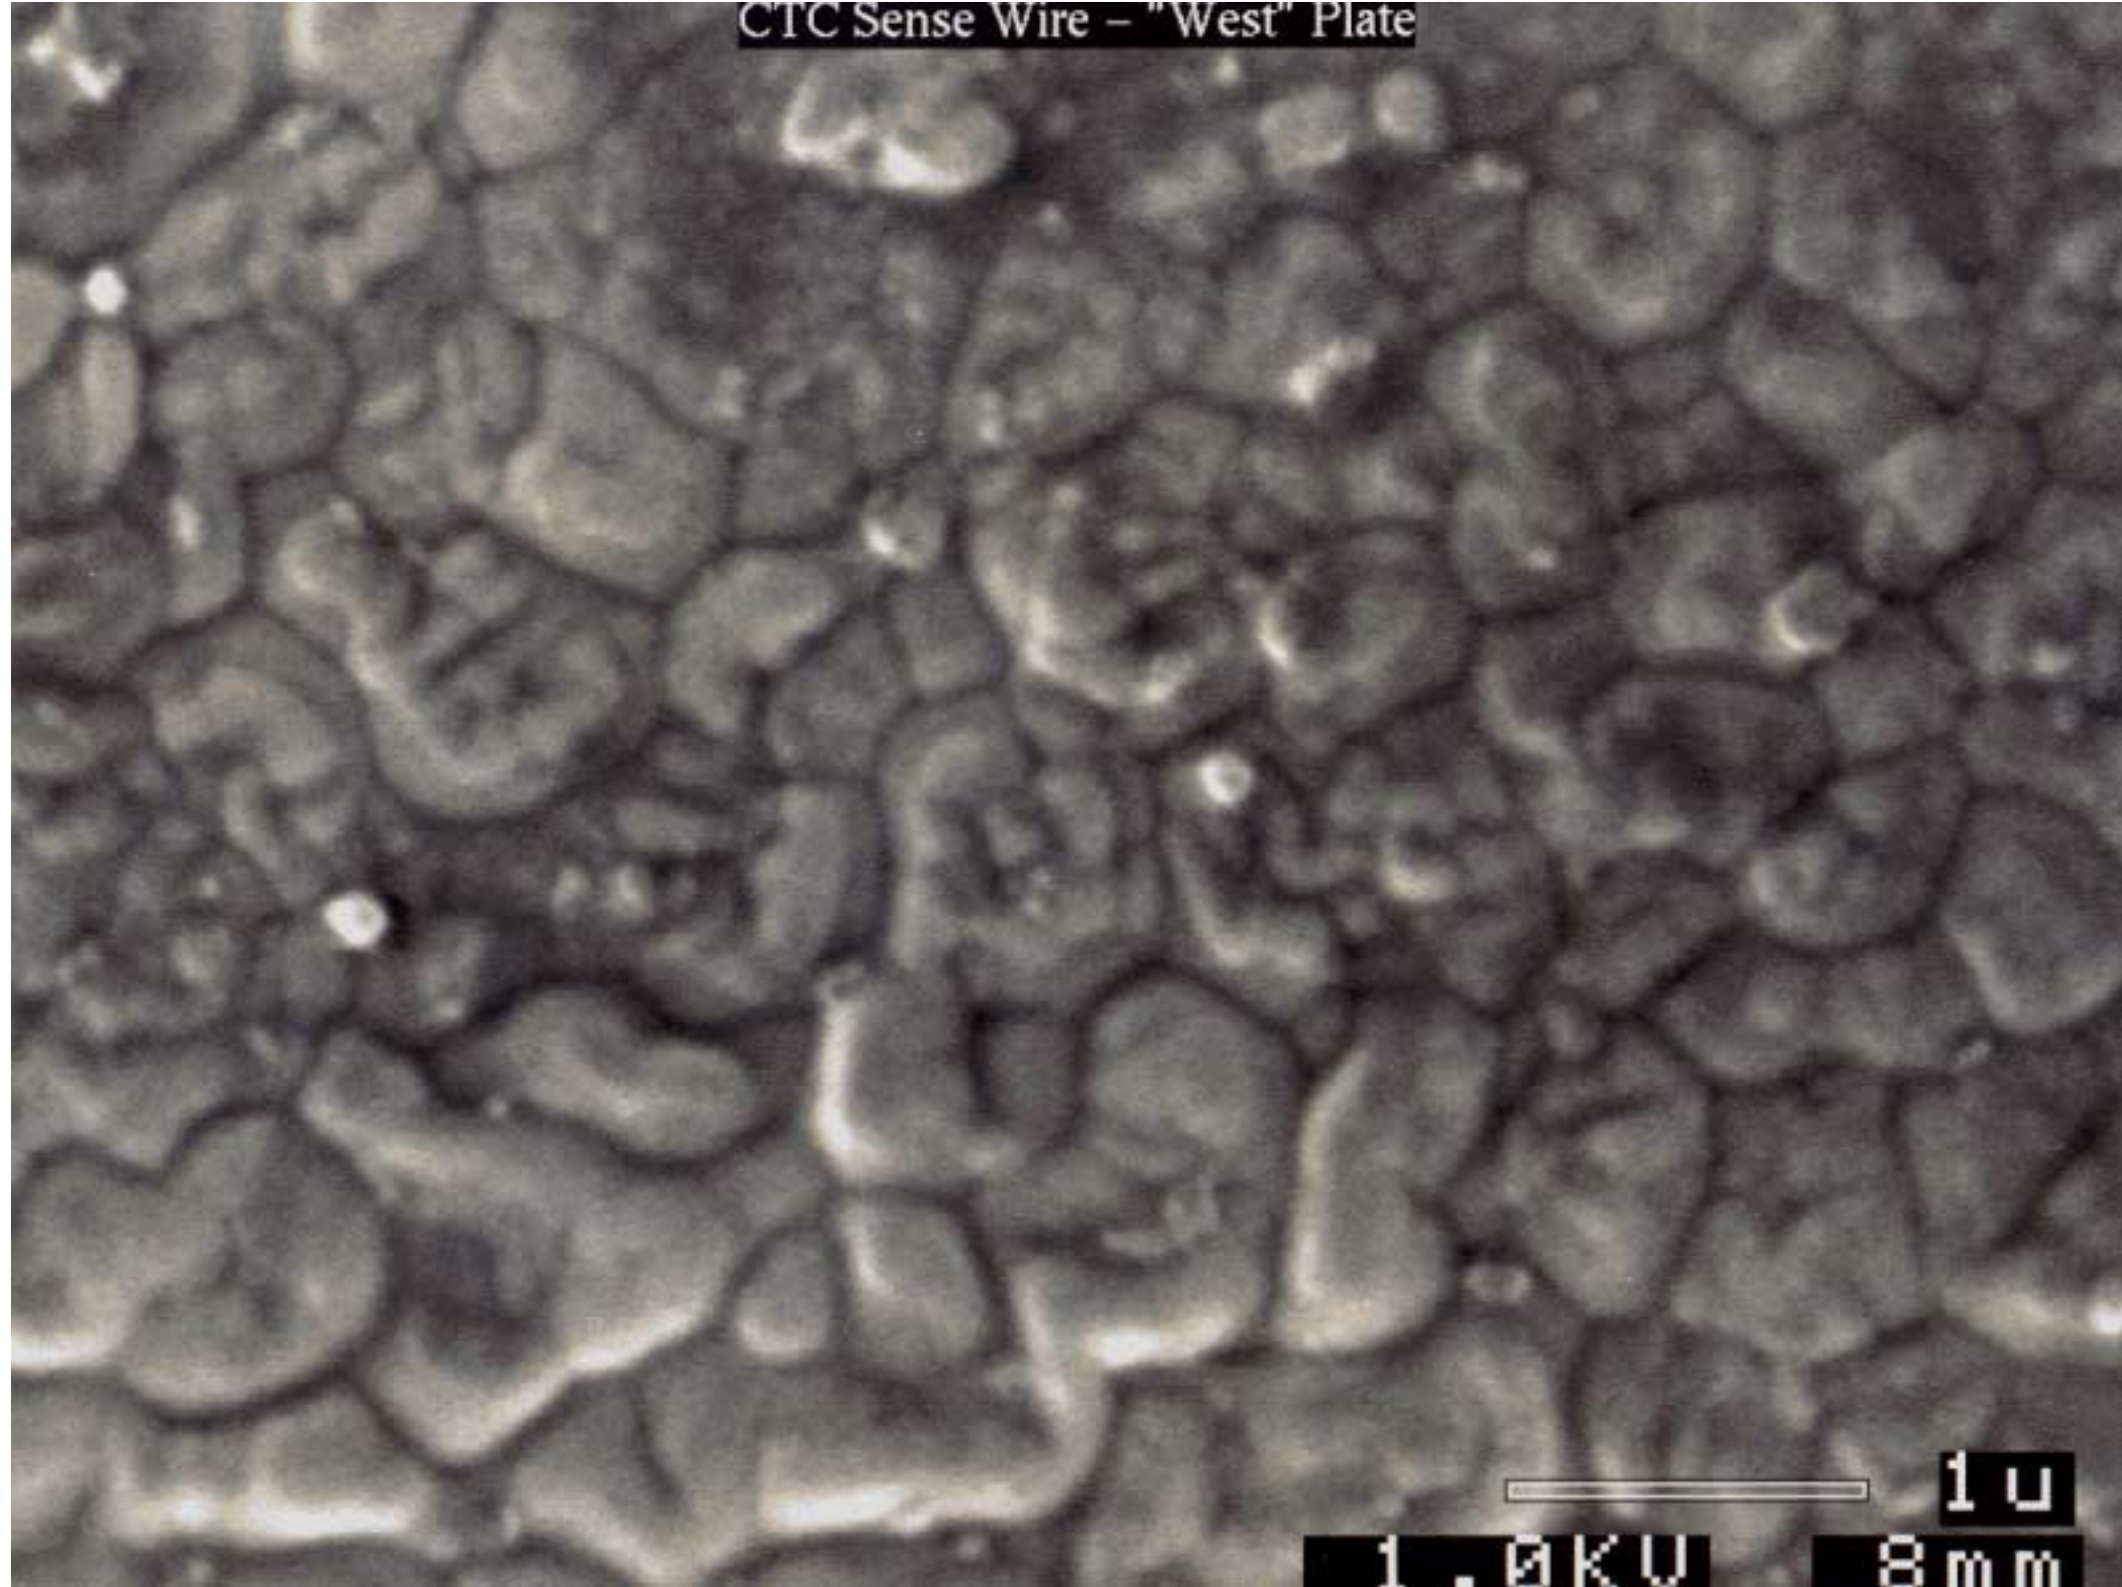
CTC Sense Wire - "West" Plate

- CTC sense wire growths showed carbon (23-20%), oxygen (8-15%), and silicon (1.2-3%). Some similarity to test chambers after the bubbler, but coating thinner and the “nodules” more sparse.
