Aging tests of MSGC detectors at Mons university

I. Boulogne, E. Daubie, F. Defontaines

Tests framework

FW MSGC tracker of CMS experiment

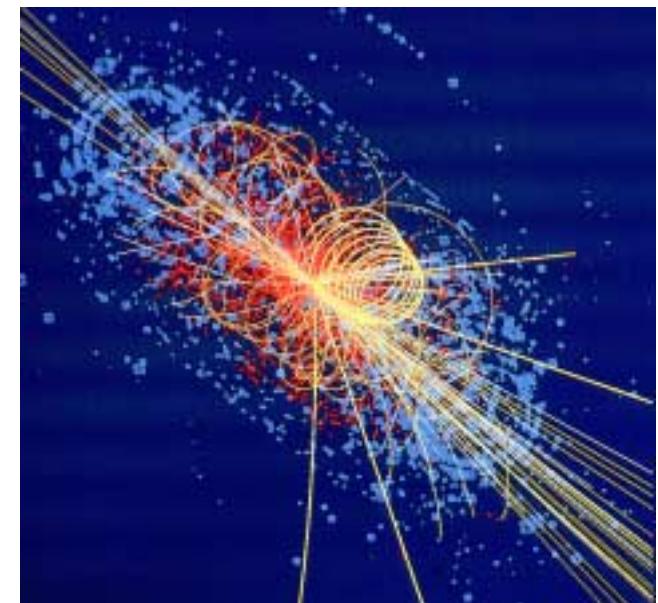
1995 → 1999 (design change) → aging tests @Mons

- max charged particle rate :
 $\approx 5 \cdot 10^4 \rightarrow 10^4 \text{ Hz/mm}^2$
- max current density :
 $\approx 0.5 \rightarrow 0.1 \text{ nA/mm}^2$
- max accumulated charge (10 years@LHC) :
 $\approx 100 \rightarrow 20 \text{ mC/cm}$ of anode strip

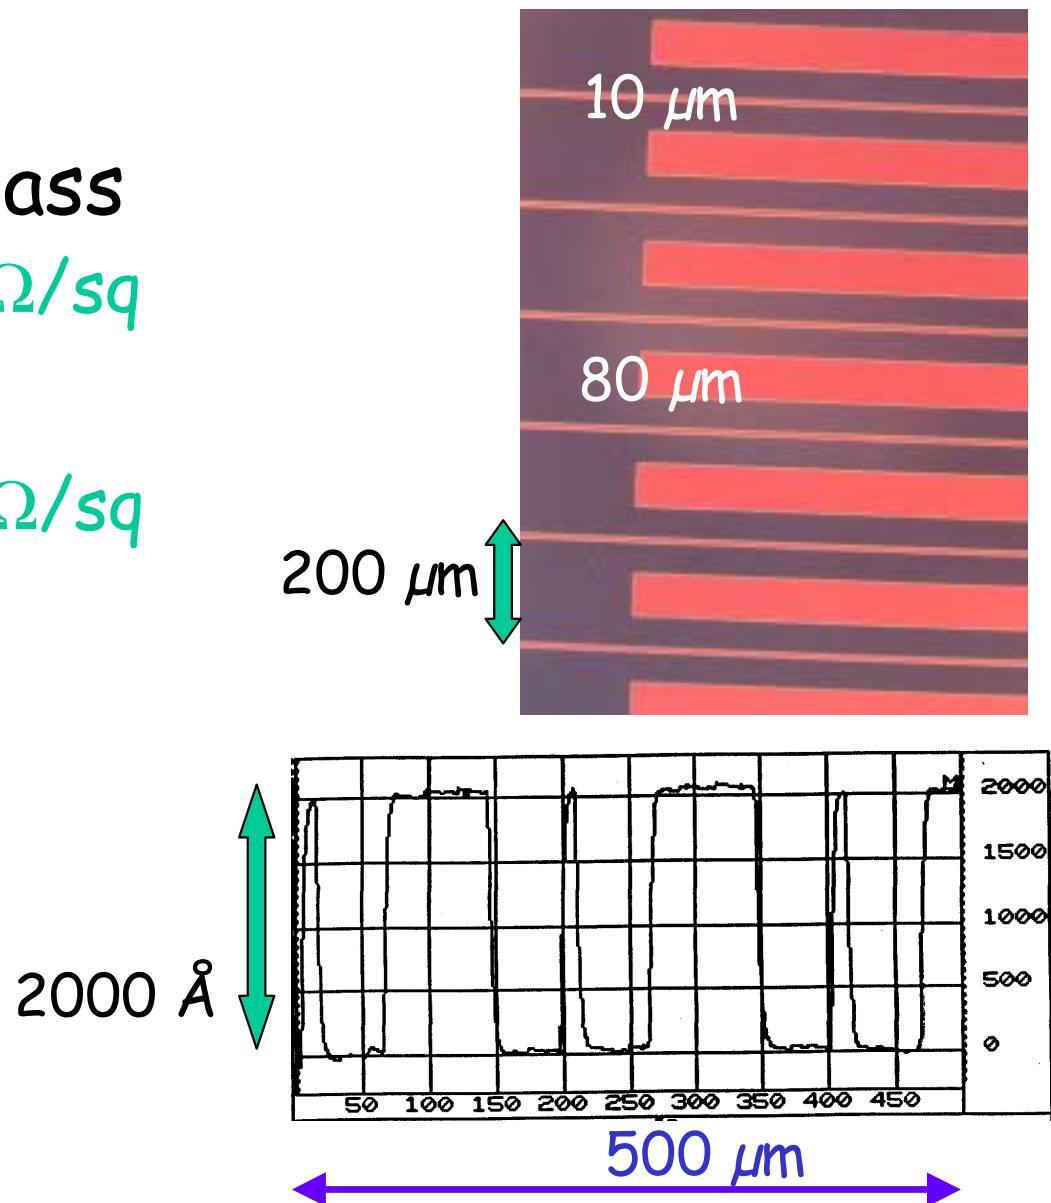
Kind of substrates (1)

active area $3 \times 3 \text{ cm}^2$

GLASS

- Bare borosilicate glass
Desag D263 $\approx 10^{17} \Omega/\text{sq}$
- DLC undercoated
DESAG $\approx 10^{14} \Omega/\text{sq}$
- + strips: Cr or Au

from IMT / CH
(SURMET coating)

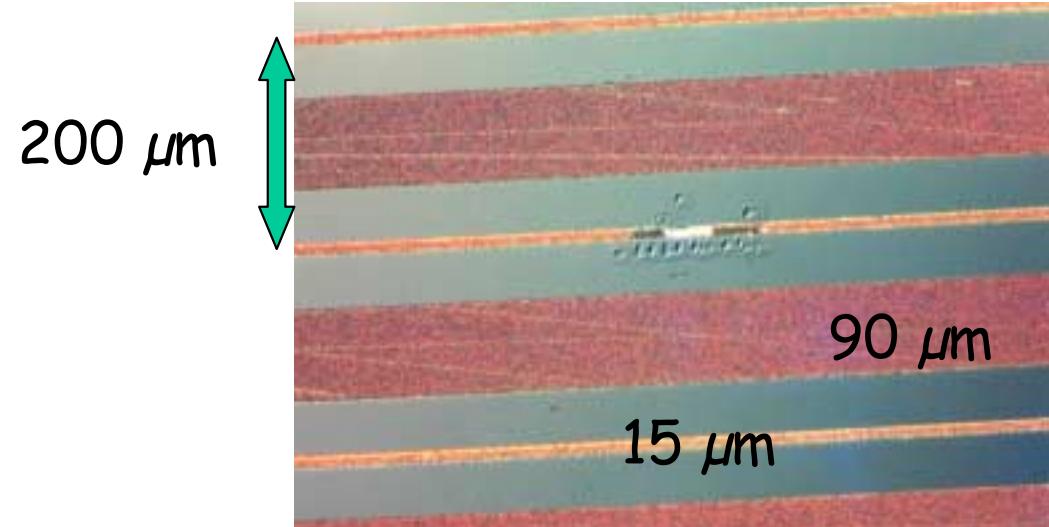
Kind of substrates (2)

active area $3 \times 3 \text{ cm}^2$

● semi conductive glass

$\approx 10^{13} \Omega/\text{sq}$

☞ Au strips

kindly provided by
Dr Lev Shekhtman
(Novosibirsk)

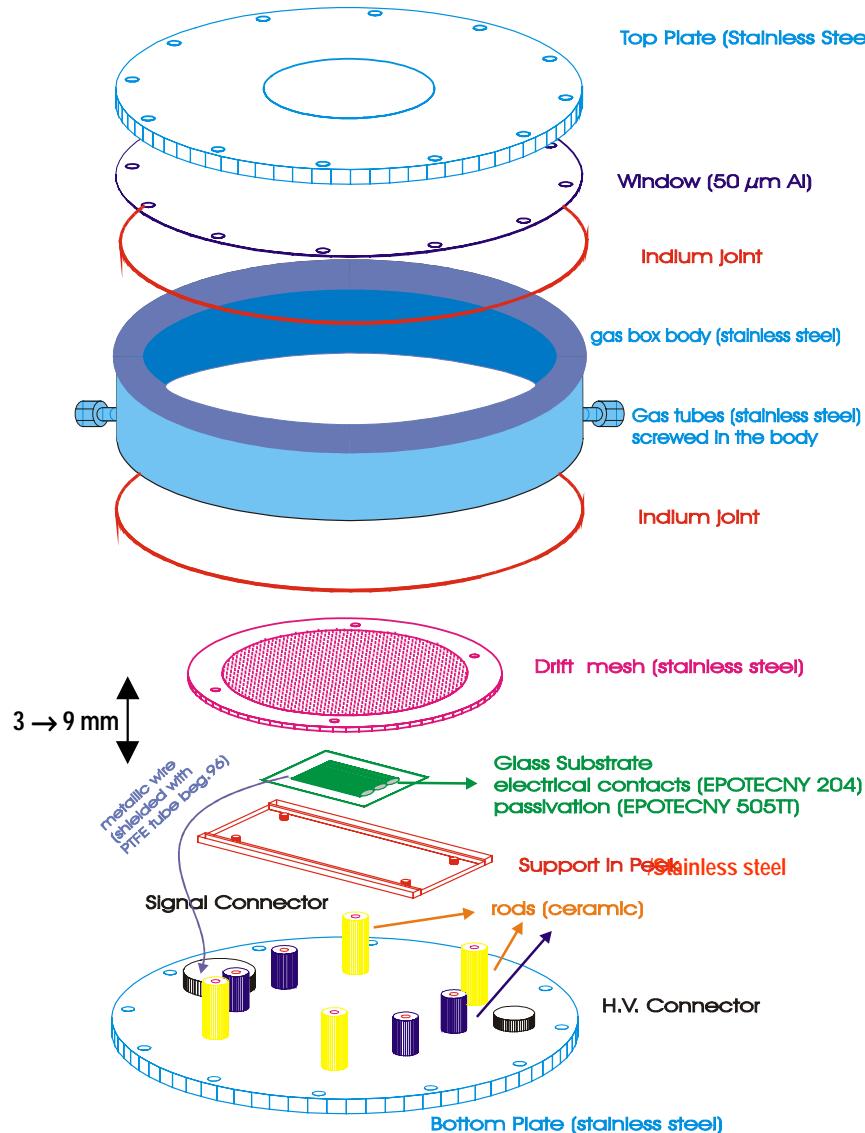
Gas boxes (1) : stainless steel box

3 kinds of bottom plate

Metal-glass feedthrough connectors

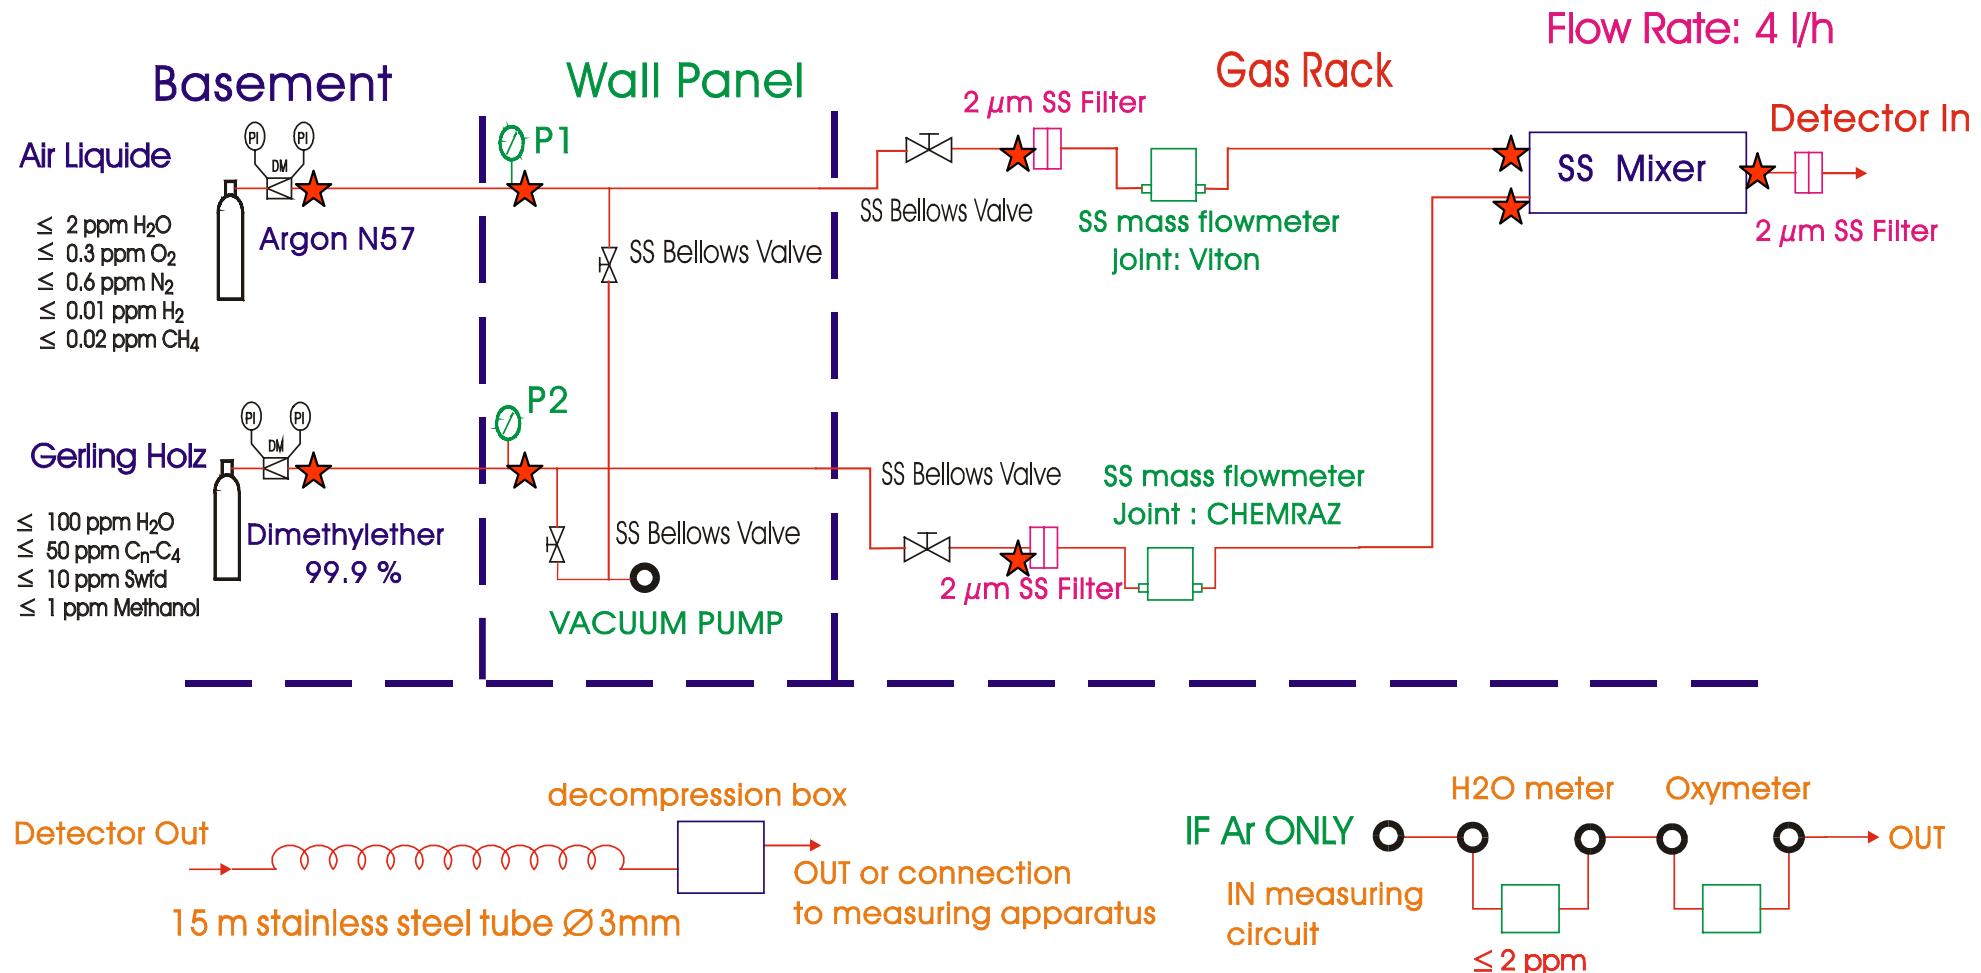
Gas circuit (beginning 1996)

Ar-DME or Ne-DME (50-50)

sealant : TFE paste

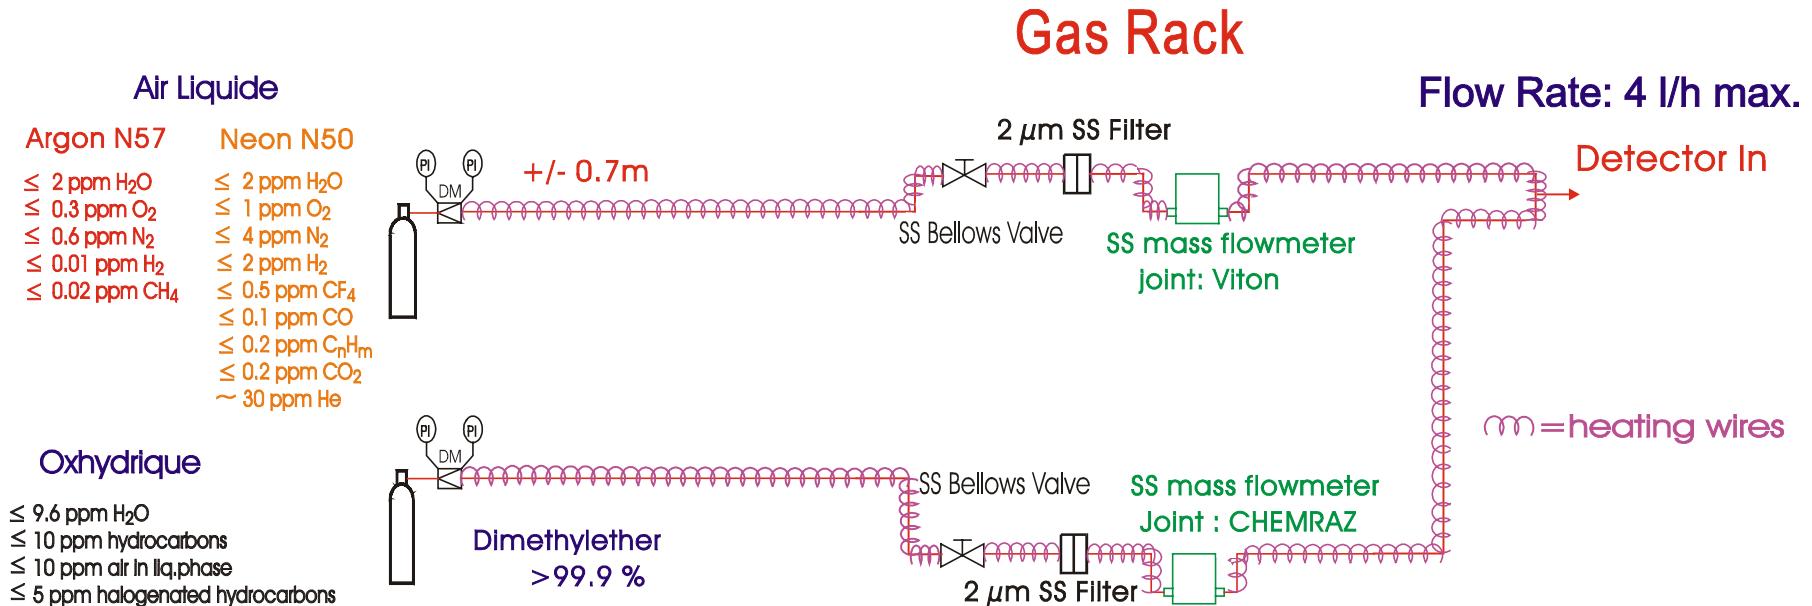
Gas circuit simplified step by step (beginning 1997)

- lines shortened
- TFE selant removed
- mixer suppressed
- no more connections to vacuum pump

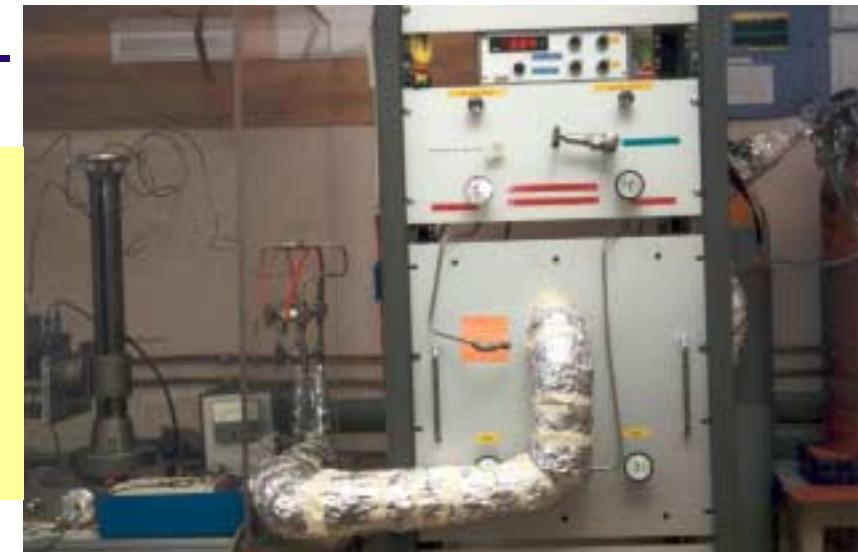
MSGC irradiation by means of X-rays

X-ray tube : Fe / Cu anode \rightarrow 6.4 / 8 keV

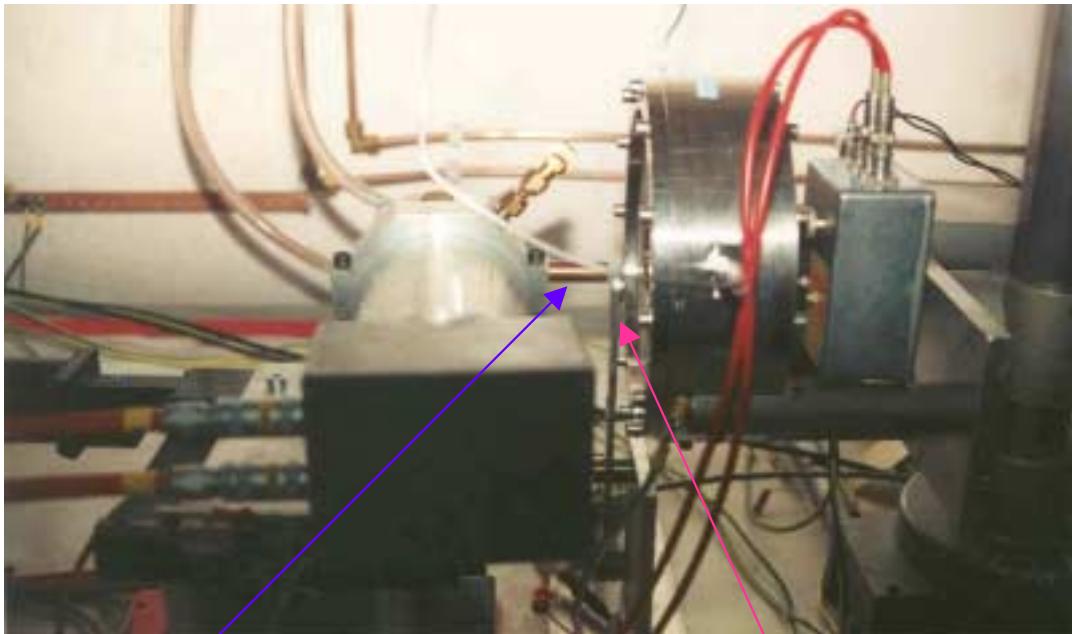
Brass collimator
0.5/0.7/1.1 mm \varnothing Pb shutter

irradiation spot :
 $S \square 1 \text{ mm}^2$

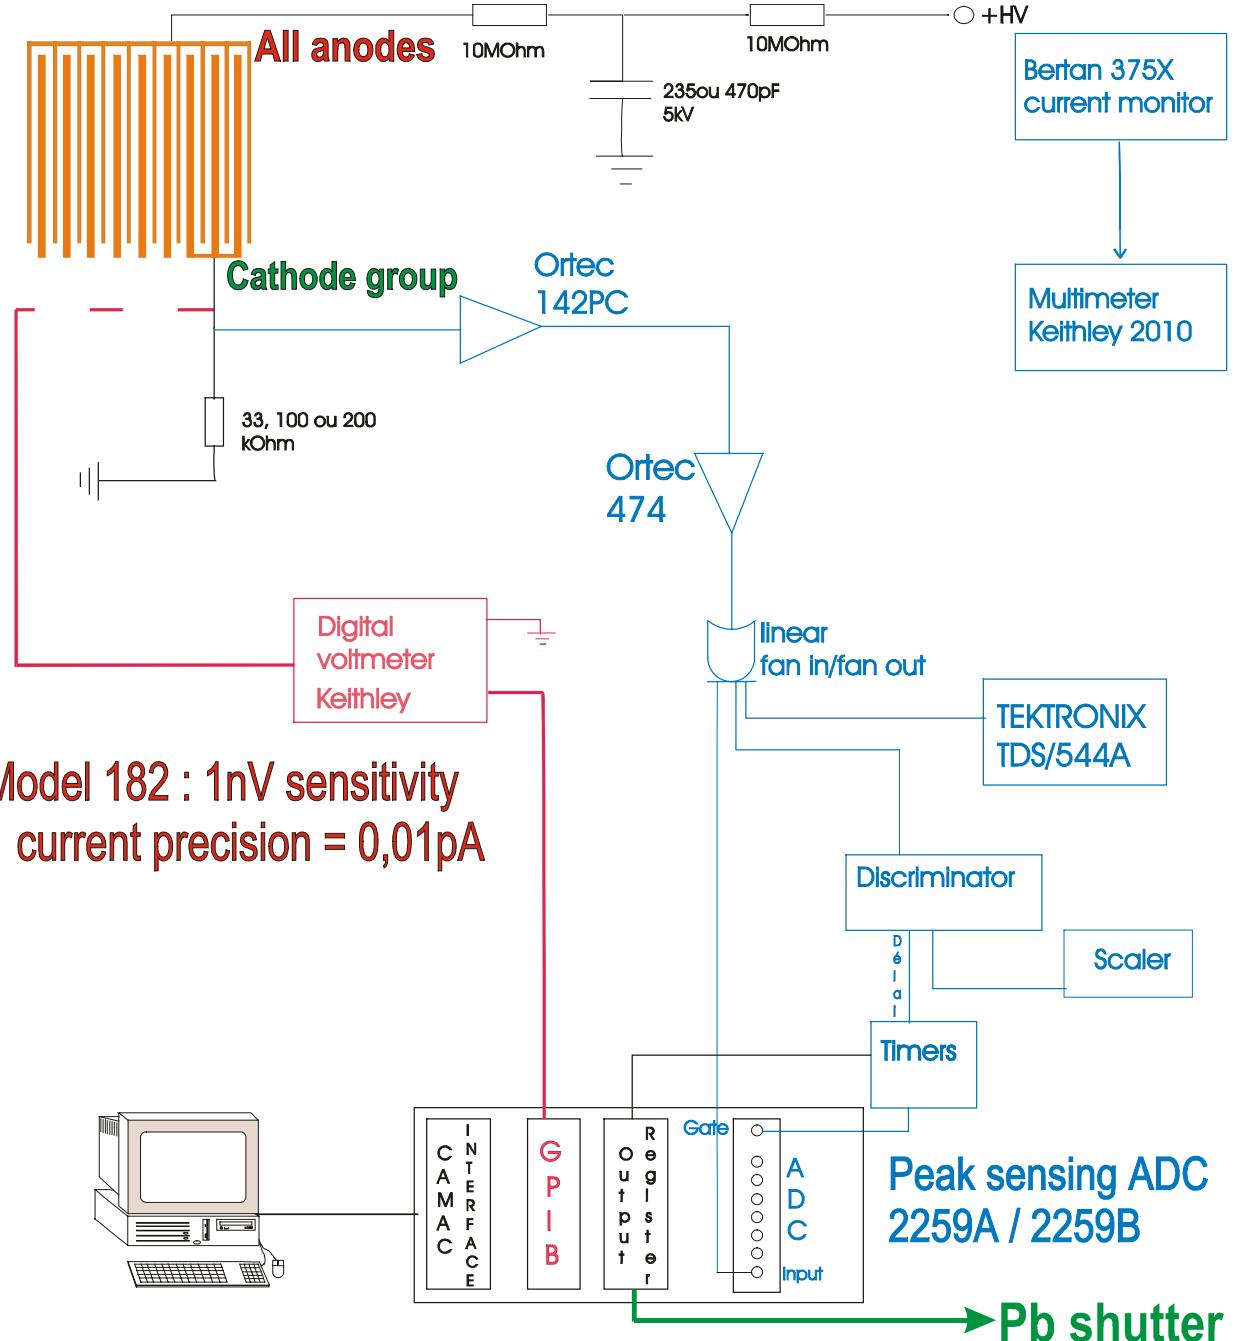
MSGC readout

PH = pulse height measurement

@low X rate → absorber

I_{cath} = cathode current signal

@high X rate

$$I_{cath} = I_{tot} - I_{dark}$$

Pb shutter

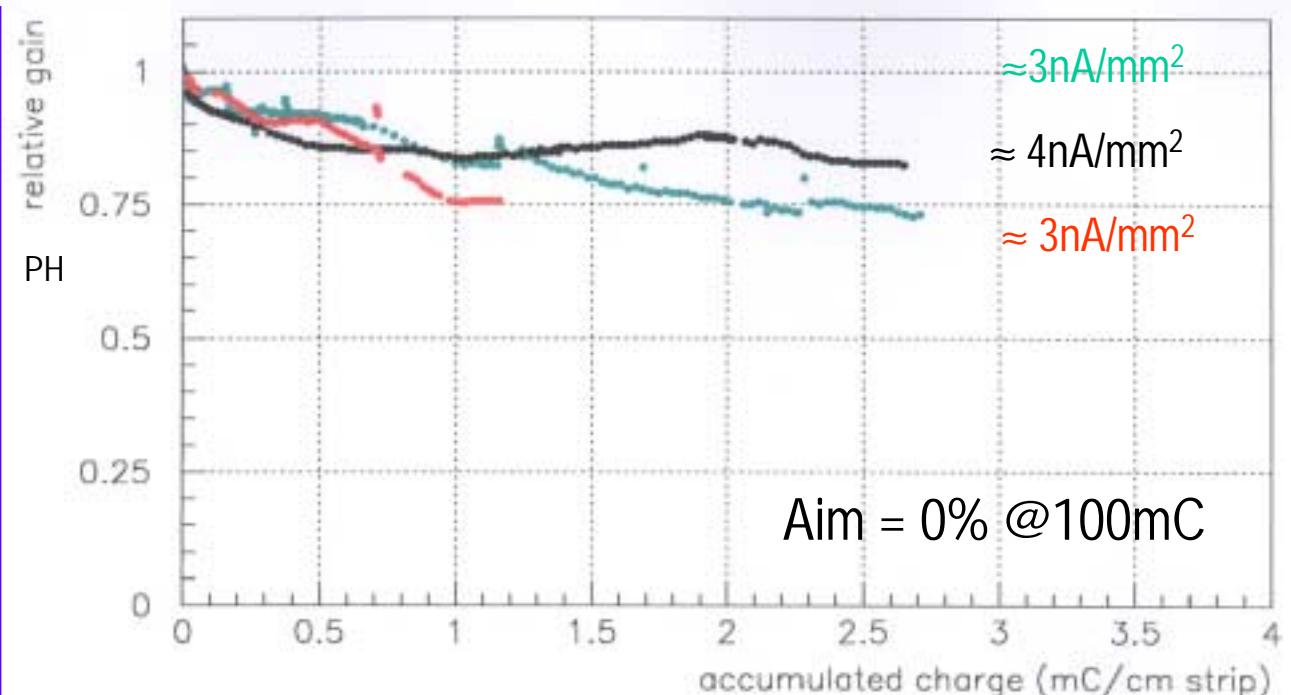
RESULTS (1) : Bare DESAG / Cr strips
 GAS BOX #1 Ar-DME(50-50) 4l/h

1st test (end 95)

substrate #1

-1000V/9mm $G \approx 1400$

higher drift field

-1500V/4.5mm $G \approx 1200$

substrate # 2

-500V/4.5mm $G \approx 1400$

Gain loss : 25% @ 2.5mC/cm strip

quasi no change compared to 1st test

better : < 20% @ 2.5mC no loss : 0.5 → 2.5 mC

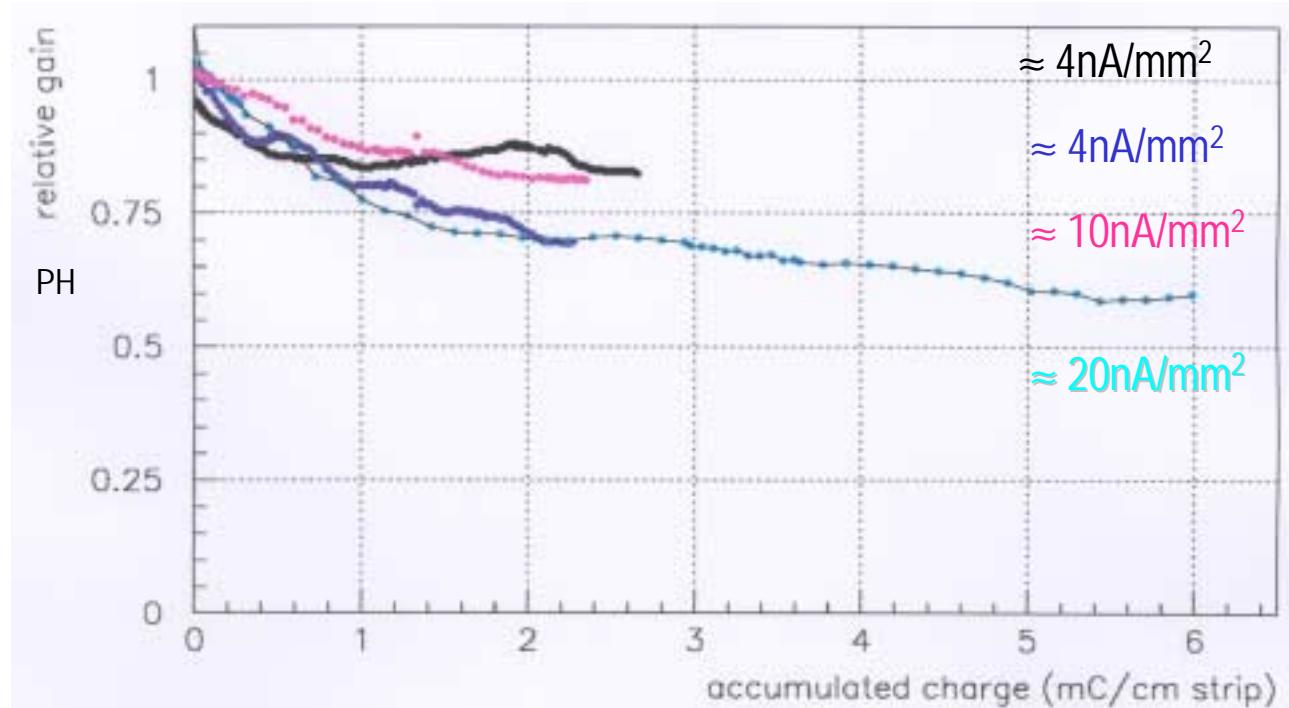
Bare DESAG / Cr strips
GAS BOX #1 substrate # 2 -500V/4.5mm $G \approx 1000$

Ar-DME (4l/h)

lower gas flush (1l/h)

higher XR flux (4l/h)

Ne-DME (4l/h)

Gain loss : < 20% @2.5mC no loss : 0.5 → 2.5 mC/cm strip

worse : sign of pollution

fast decrease @start (30% 0 → 2 mC 10% 2 → 6 mC)

quasi no change compared to Ar

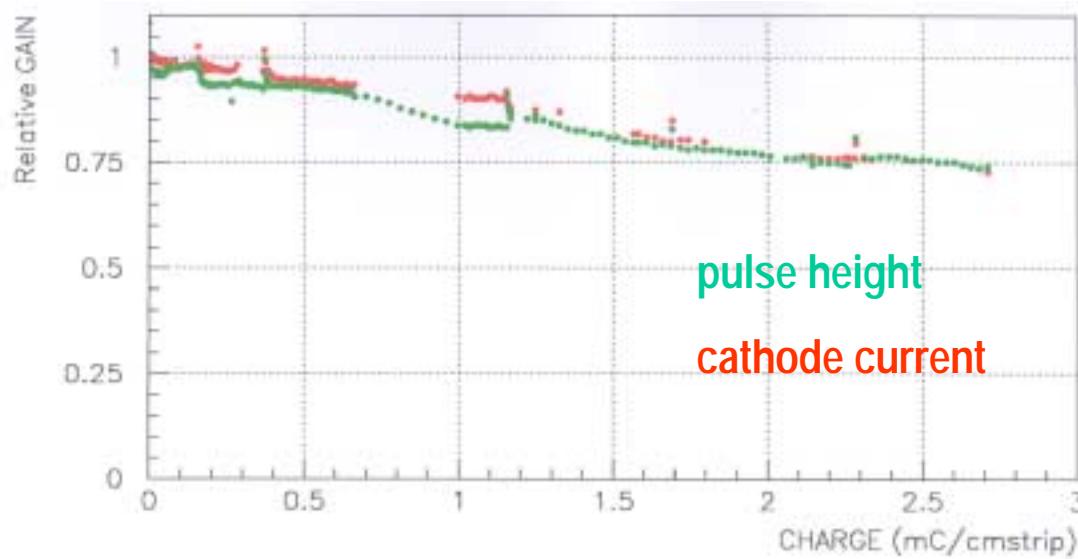
Bare DESAG / Cr strips

Same result from PH or
Icath measurement

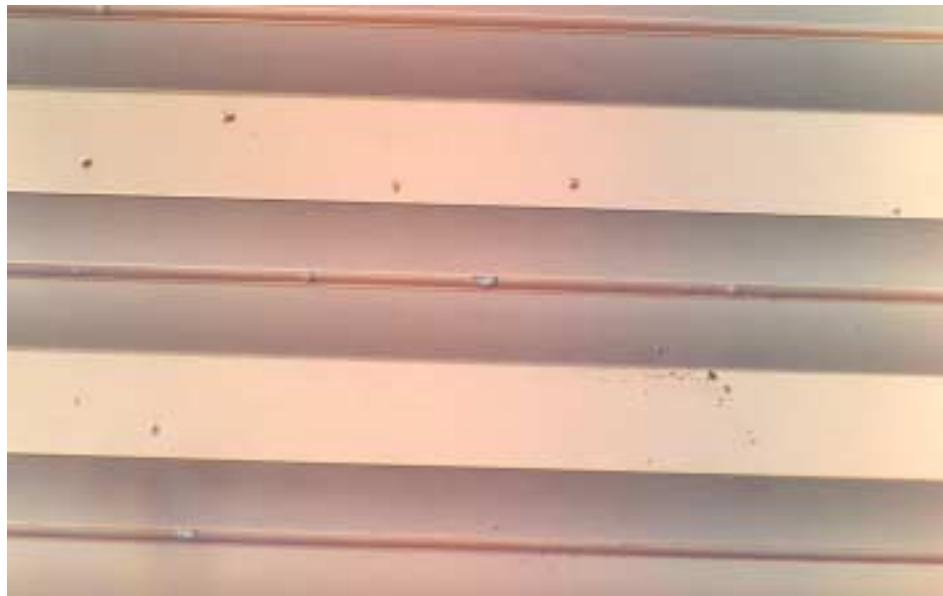
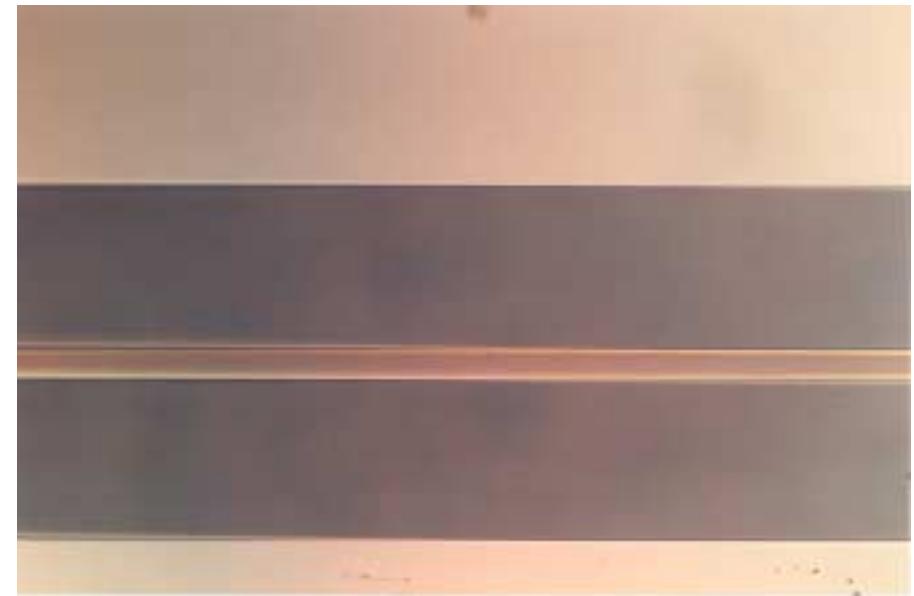
@irradiation points :
anode strips → faint
brown discoloration

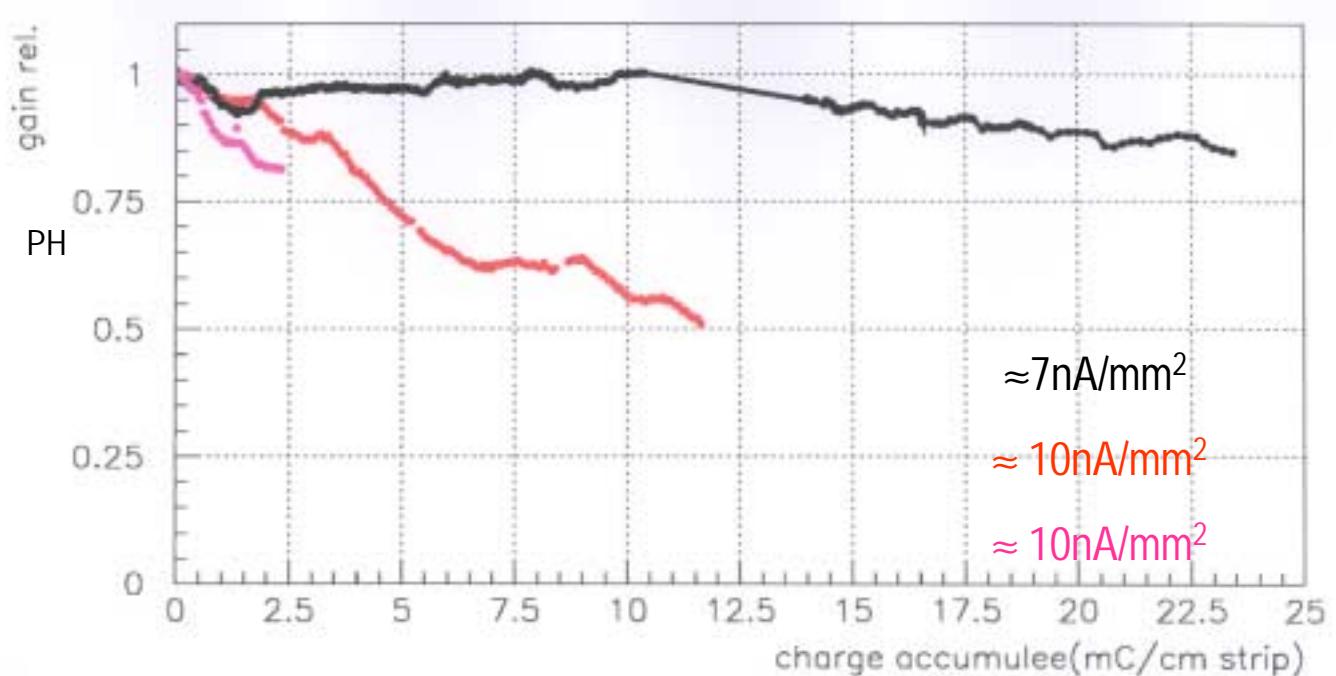
Results (2) : semi-conducting glass / Au strips

GAS BOX #2 -1000V/9mm $G \approx 1000$

Ne-DME (4l/h)

Ar-DME (4l/h)

Desag Ne-DME

Very few aging : Gain loss = 14% @23 mC/cm strip

worse : sign of pollution ...

better compared to bare DESAG

Good result obtained despite pollution (TFE + box#2)

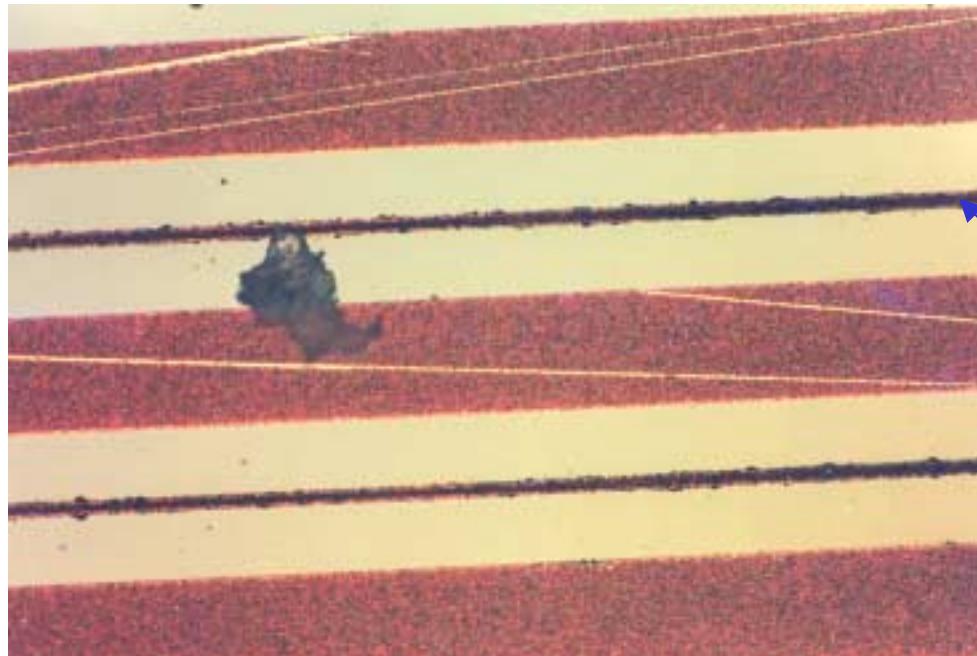
N.B. Substrate found broken (fixation springs too tight)
influence on aging ?

@irradiation points :
Anode strips covered
by a black deposit

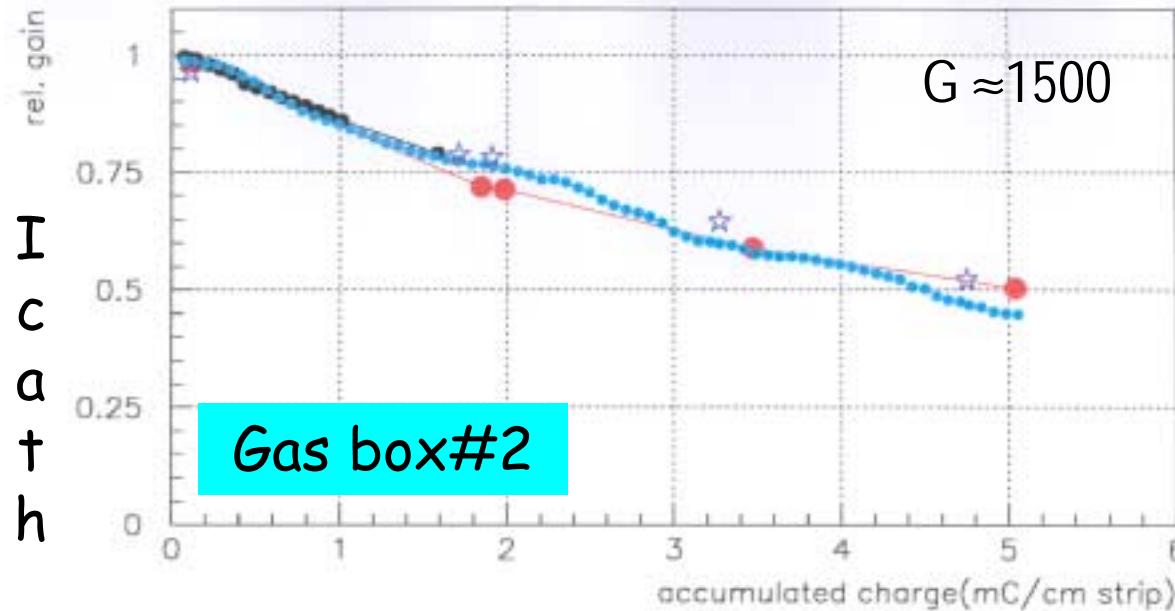
RESULTS (3) : *coated DESAG / Cr strips (10nA/mm²)*

Ar- DME Gerling Holz 4l/h

id. Air Liquide

3d test PHmeast \star

Very fast aging : gain loss
= 50% @ 5 mC/cm strip

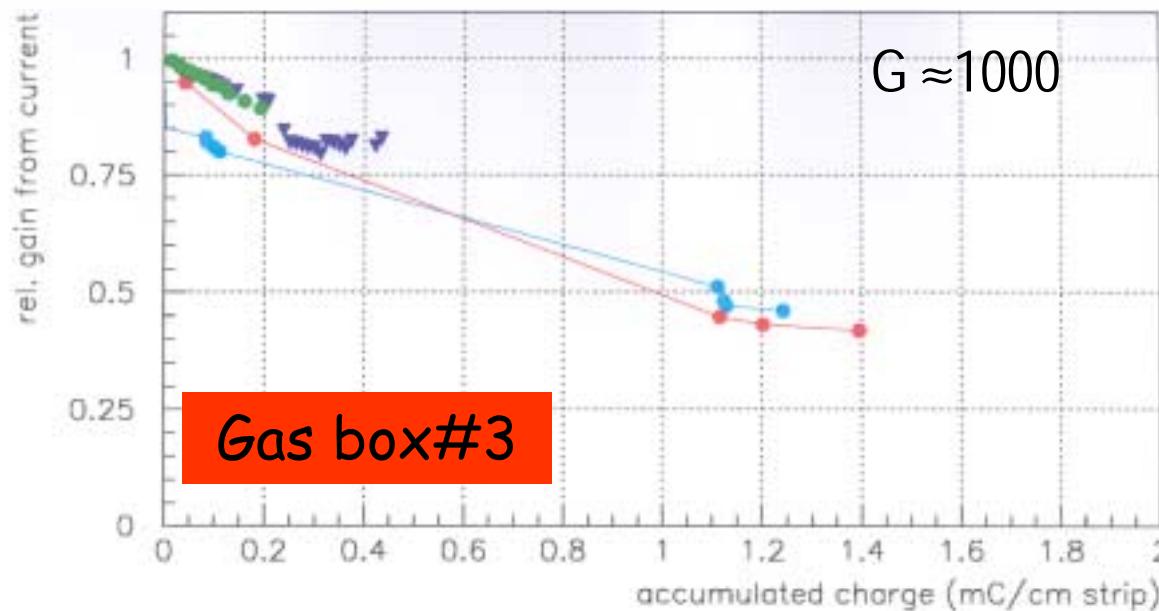
Sub.1 Ar- DME

sub.2 Ar- DME

Ar- iC₄H₁₀

sub. 3 Ar- DME(Messer)

Catastrophe !

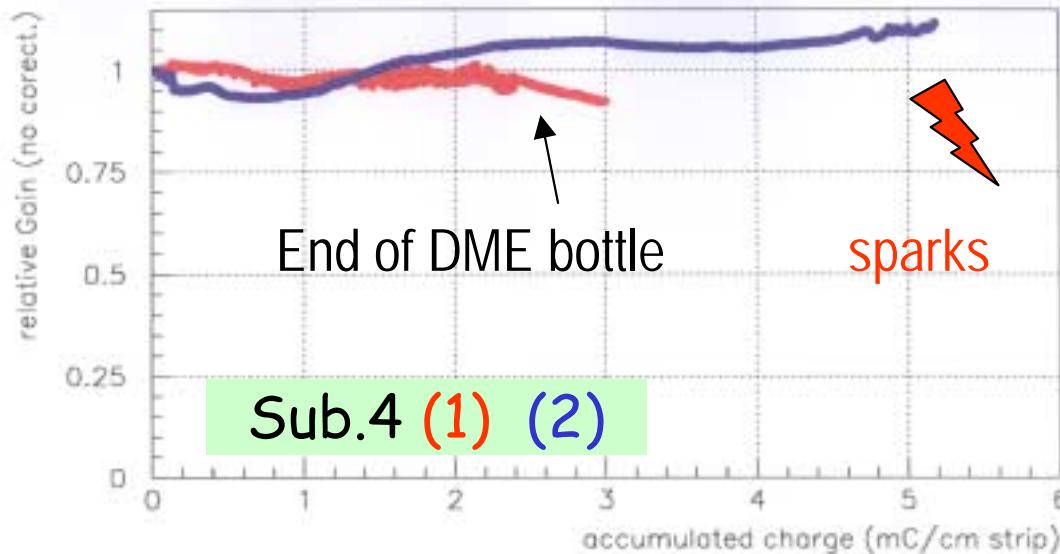
Gas box #1 + tube heating

Quasi no aging
but sparks appear !

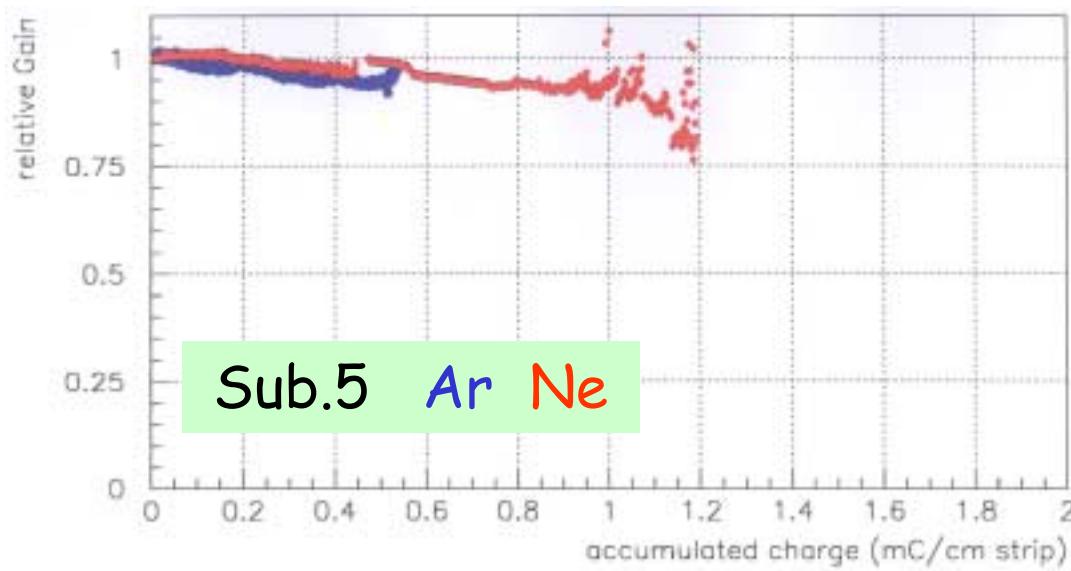
Quasi no aging
and many sparks occur for
both gas mixtures !

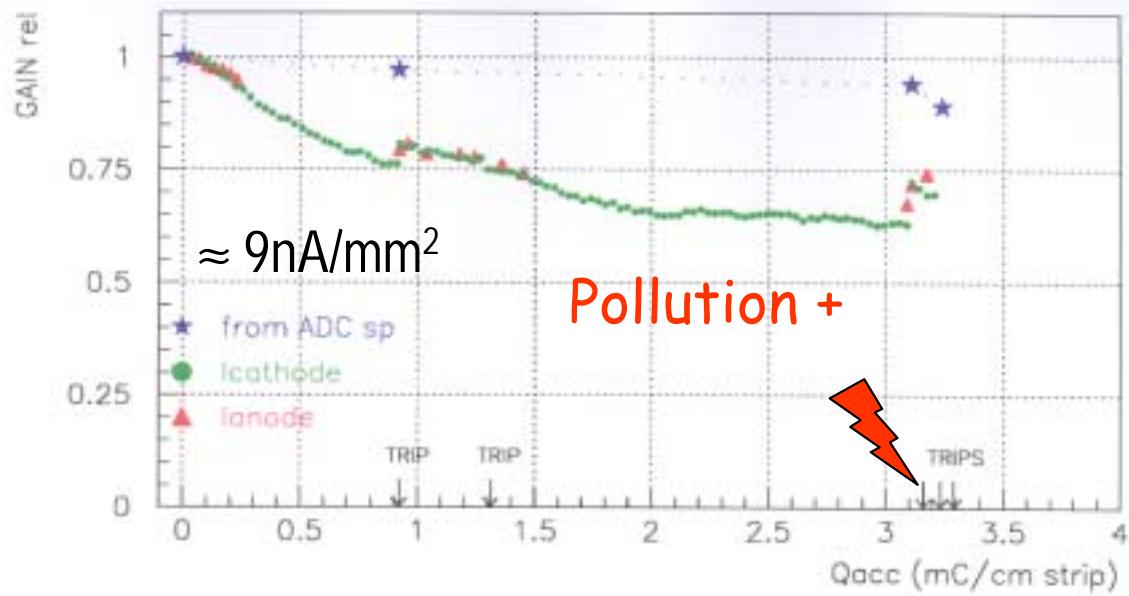
Gas box in PEEK coated DESAG /Cr strips Ne-DME(50-50)

Sub.6 $G \approx 1000$

Decrease of Icath
& sparks !
discrepancy PH / Icath

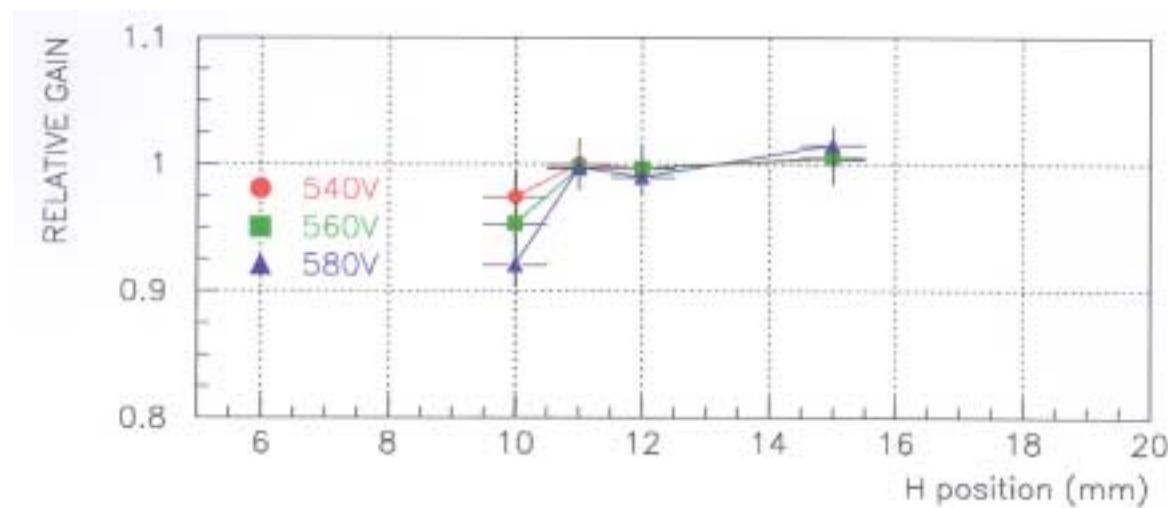
Scan after aging :
confirm meast.from PH
& depend on HVa ?

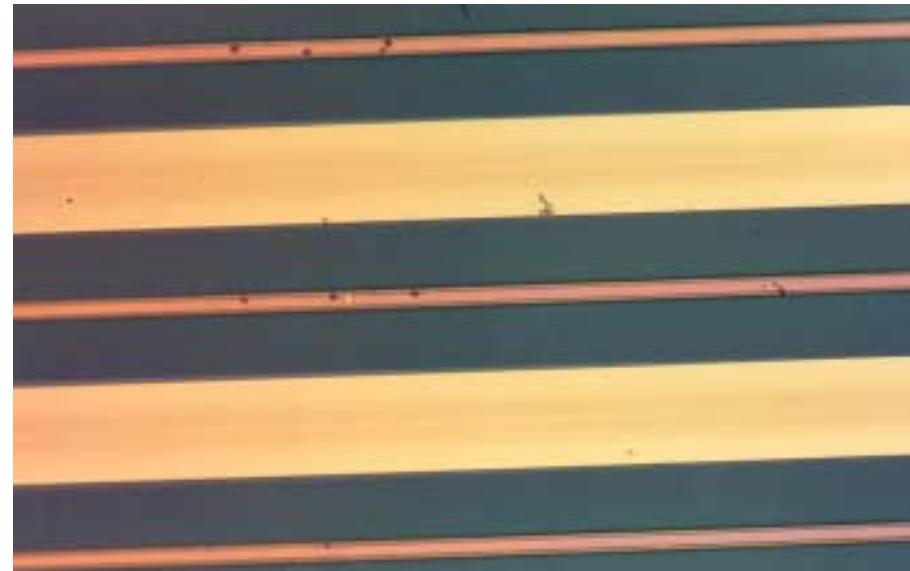
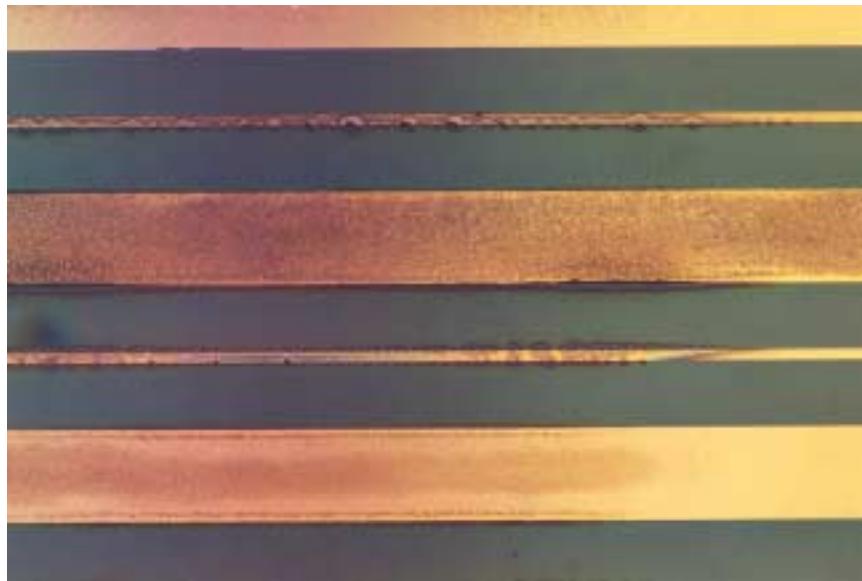
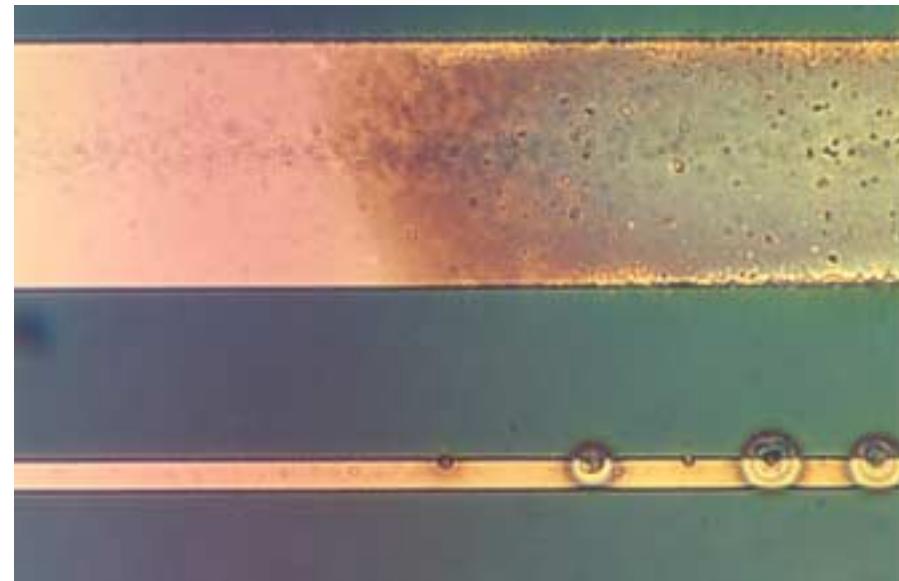
coated DESAG / Cr strips

@ irradiation points :

Sub. 1 2 3 :

discoloration of anode strips

Sub. 4 & 5 :

sign of sparks !

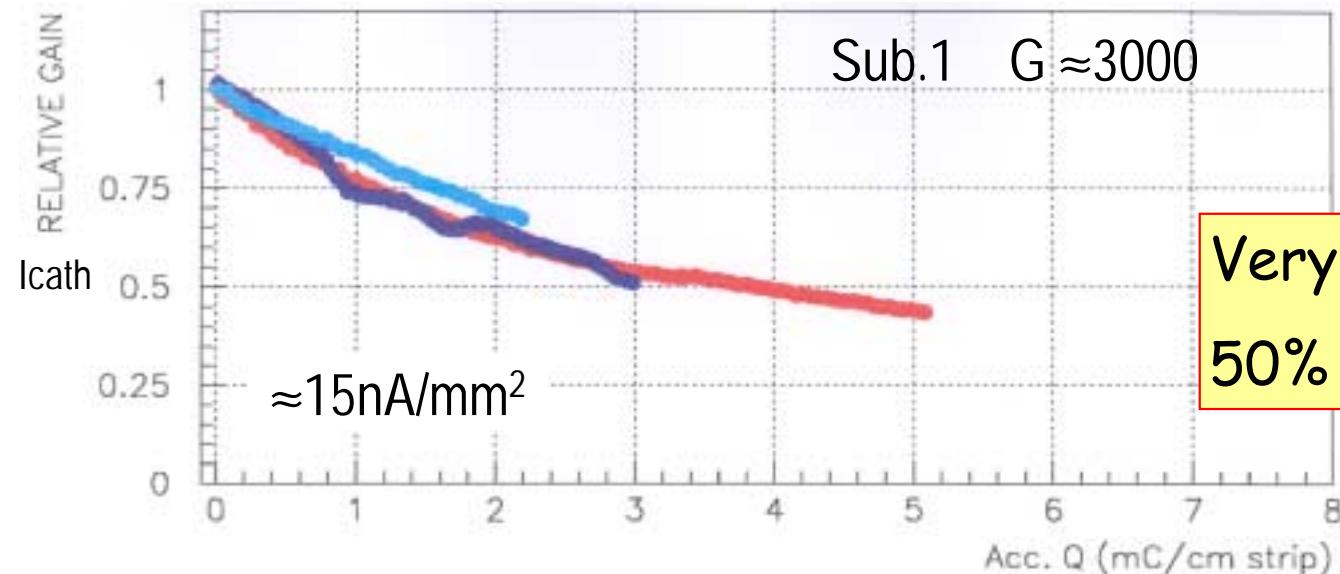
RESULTS (4) :

coated DESAG / Au strips

Gas box #1 PEEK support → -3000V/3mm

Ne-DME

Very fast aging : gain loss = 50% @ 3 mC/cm strip !! ?

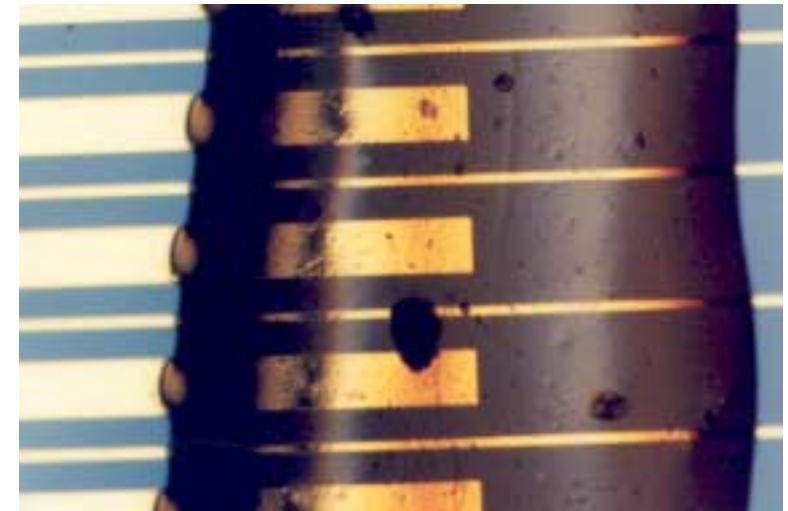
Visual inspection @irradiation points : no sign of aging !

But passivation glue darker

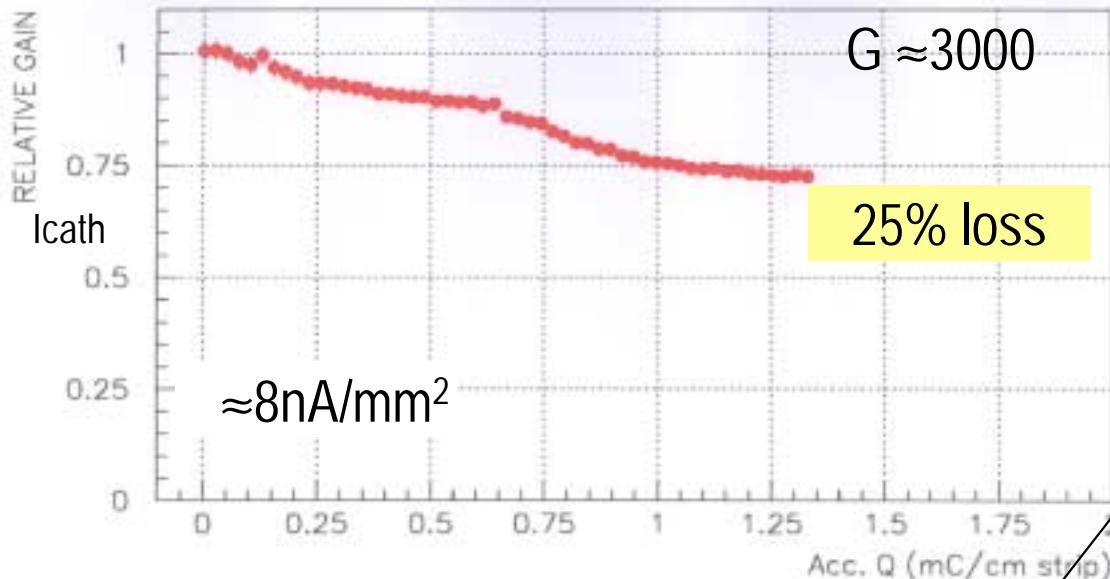
Gas box #1 PEEK support **coated DESAG / Au strips** Ne-DME

Sub.2 : no passivation glue

Once more : very fast aging !

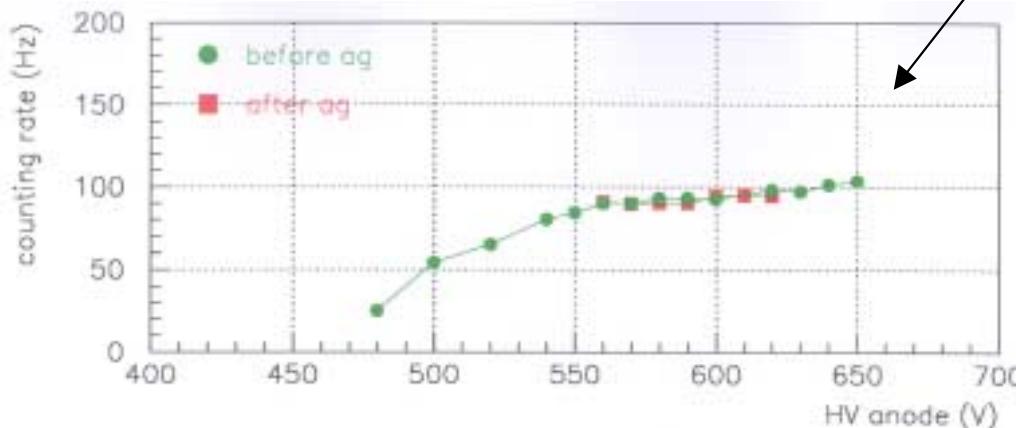
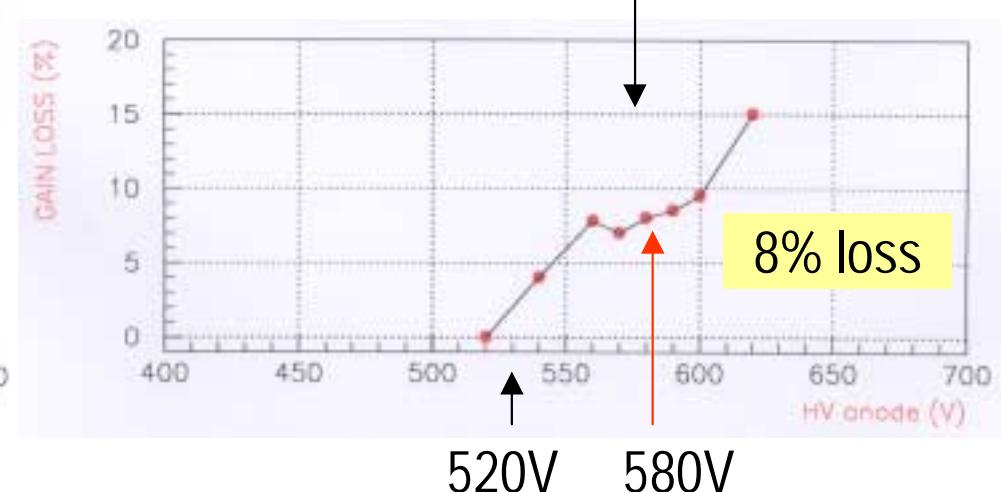
the real loss seems not so big :
plateaux before and after aging
+ mean Pulse Height @ low rate
→ loss of gain (HV_a)
