Aging tests of MSGC detectors at Mons university

I. Boulogne, E. Daubie, F. Defontaines

Tests framework

FW MSGC tracker of CMS experiment

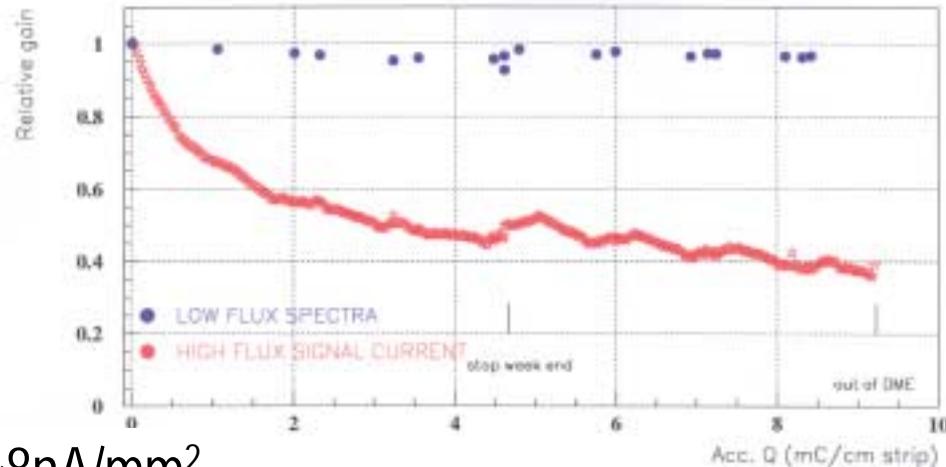
Gas box #1 PEEK support **coated DESAG / Au strips** Ne-DME

Sub.2 : 2 tests @ lower HVa (520V)

$\approx 8 \text{nA/mm}^2$

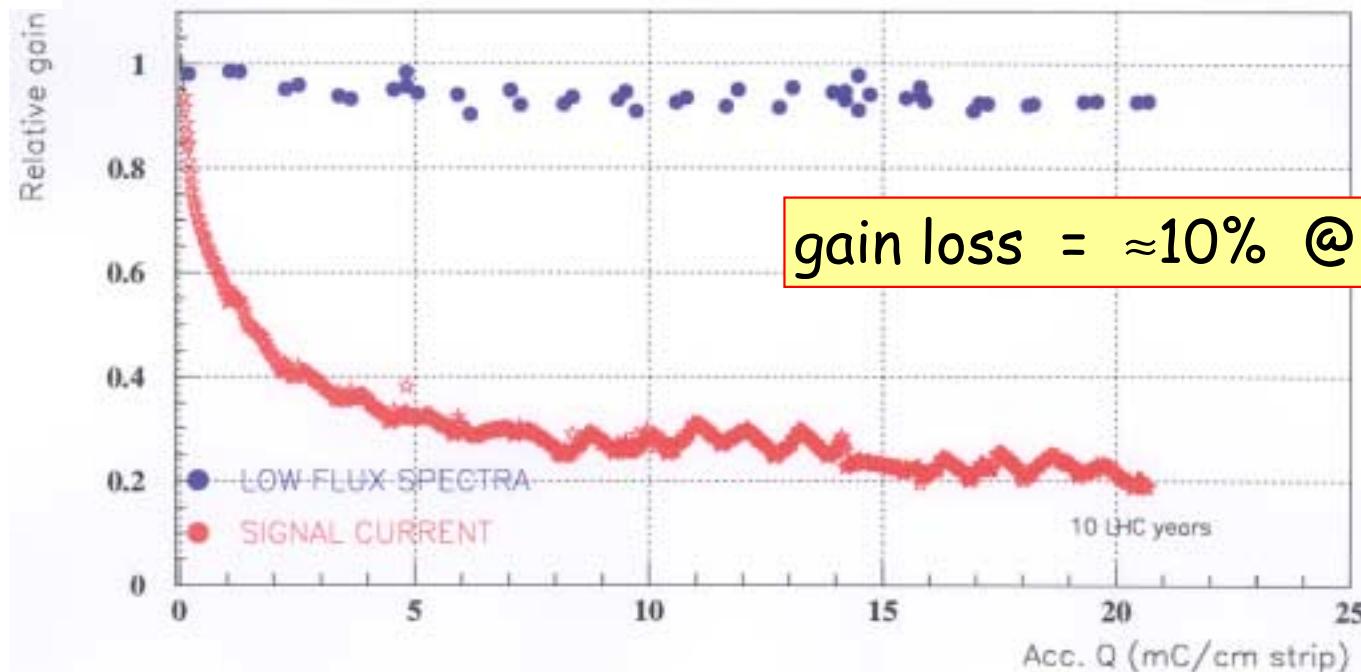
fast aging from Icath monitoring @ high rate

lower aging rate from PH measurement @ low rate

gain loss = $\approx 10\%$ @ 20 mC/cm strip

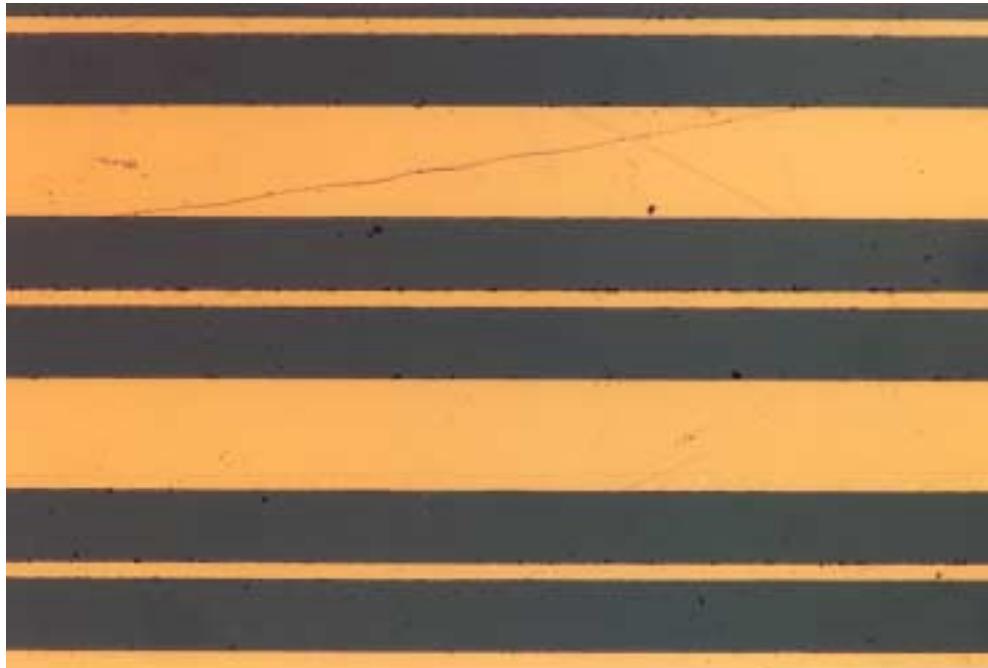
coated DESAG / Au strips

@irradiation points :
anode strips

black edges

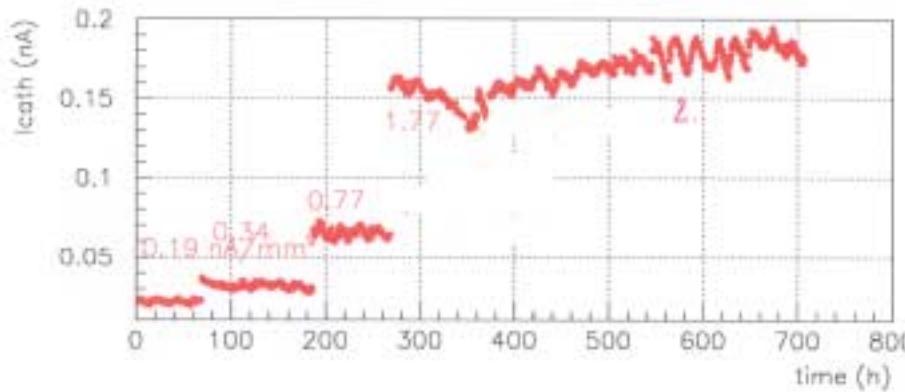
RESULTS (5) few months later : bare DESAG / Au strips

Gas box mix Ar-DME (50-50) 6l/h

Progressive increase of
irradiation rates :

$$0.19 \rightarrow 0.34 \rightarrow 0.77 \rightarrow 1.77 \\ \rightarrow 2.0 \text{ nA/mm}^2$$

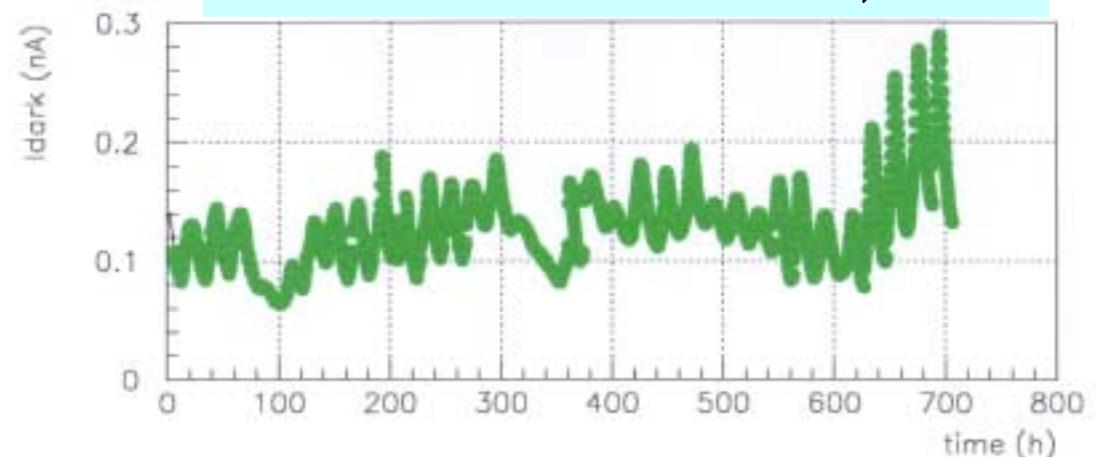
Variations of **relative gain** =
I_{dark} fluctuations → T°

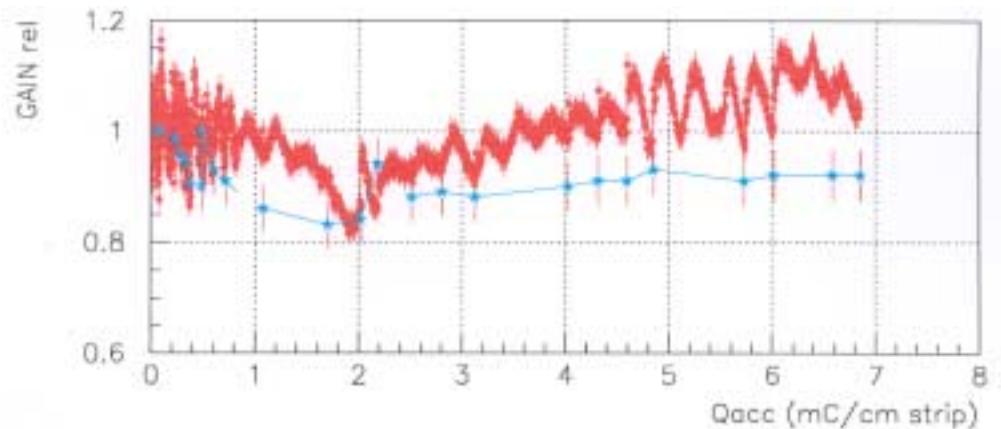
Gas box mix bare DESAG / Au strips Ar-DME

Quasi no aging from Icath monitoring @ high rate

same aging rate from PH measurement @ low rate
(except $\approx 10\%$ initial decrease)

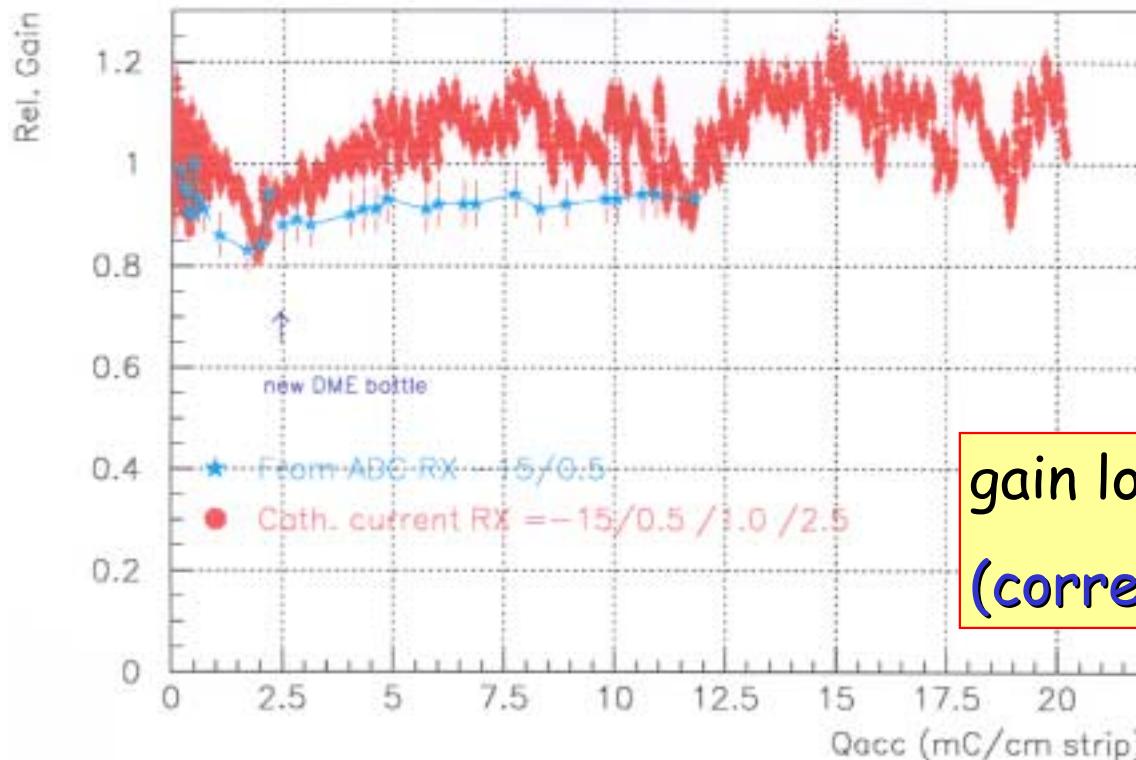
gain loss = $\approx 10\%$ @ 20 mC/cm strip
(corresponding to the initial loss)
