PETRA III.

- **PETRA III**
- **Availability**
- **Cavities and HOMs**

TUD – DESY collaboration meeting

June 24, 2016

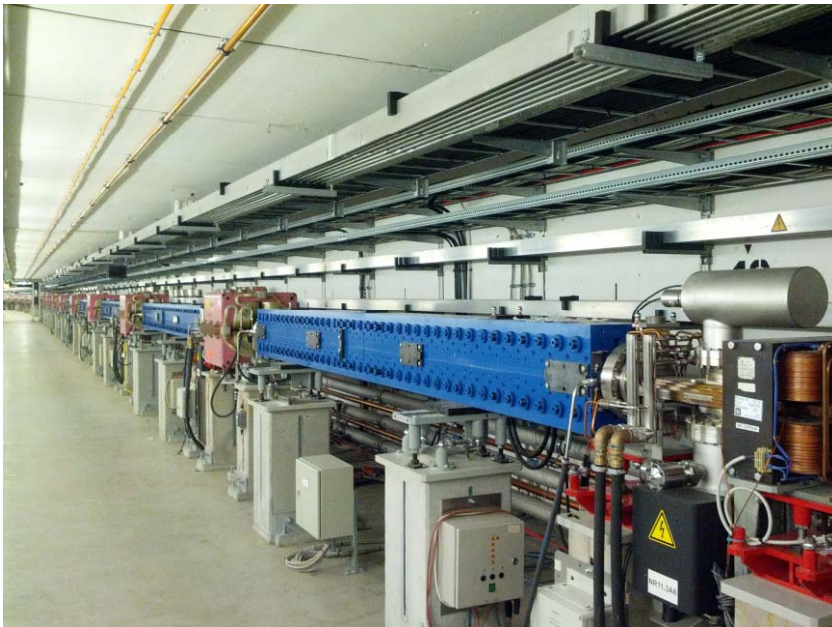
Damping Wigglers: $B \sim 1.5$ T, $\lambda = 0.2$ m
 $2 \times 10 \times 4$ m = 80 m
 $\epsilon_x: 5$ nm \rightarrow 1.2 nm

Dispersion correction in the wiggler sections:
 $D_x < 18$ mm, $D_y < 5$ mm

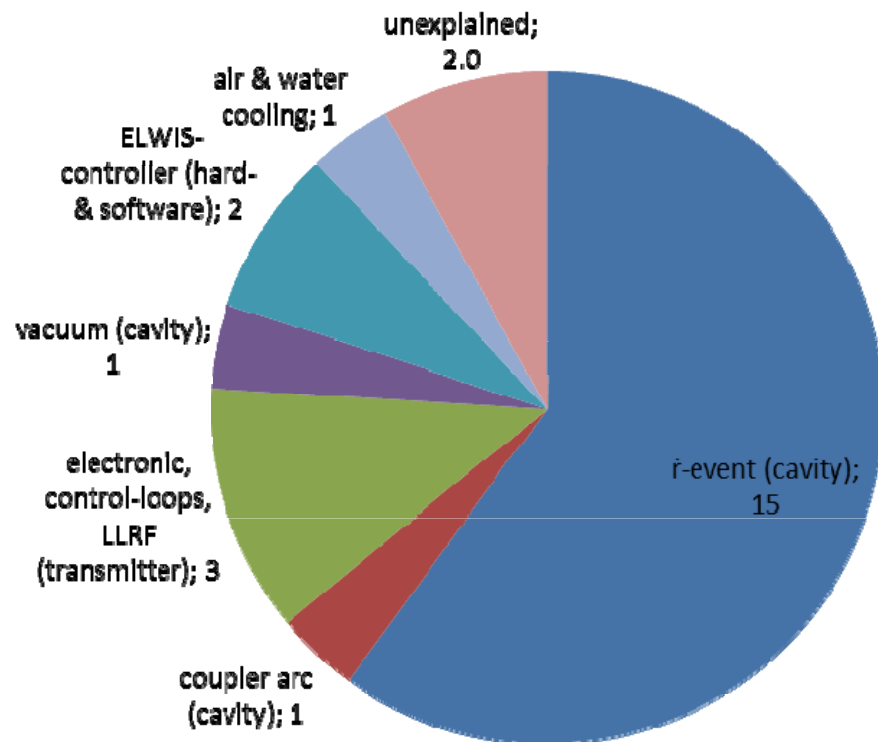
**Ranking of failure causes
Number of Trips 2015**

- > \dot{r} -problem seems to be quite persistent
- > A precise CST-MWS modeling of the cavity and Eigenmode analysis provided an useful overview of all modes,
- > but we have not yet understood the \dot{r} -problem
- > **Currently, we suspect a HOM in 3.8GHz range.**
- > **CST-MWS Eigenmode analysis should be extended to this range.**

Measures needed to decrease the number of rf-trips

Overcome the \dot{r} -problem !!!!
