Aging tests of full scale CMS muon cathode strip chambers

Abstract

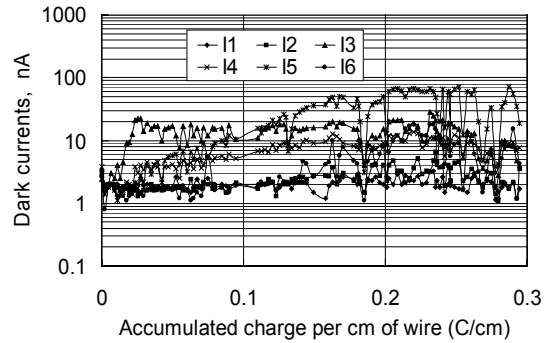
Dark current is yet another measure of chamber performance stability. Fig. 8 shows results obtained in 2000. One can see that dark currents did grow on average from ~2 nA per plane (about 600 wires) to around 10 nA (one of the aged planes did not change its dark current, while the largest increase was about 60 nA). In the 2001 tests the results were very similar, with all currents for six planes scattered between 1 and 10 nA at the end of the tests.

Fig. 8. The dark current vs. accumulated charge

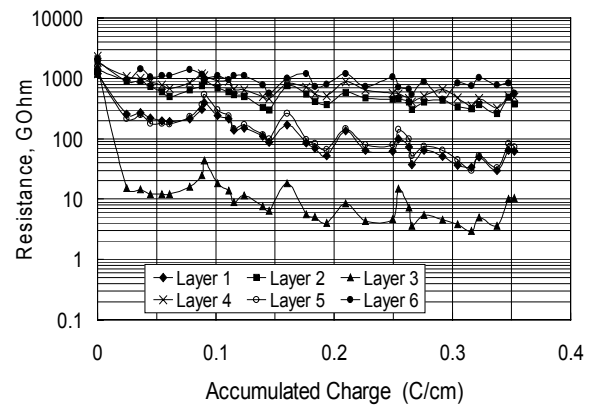
The last monitored parameter was the resistance between strips; it was evaluated by measuring current between strips at potential differences of 9 V. Fig. 9 shows an obvious systematic drop in resistance over the course of irradiation from ~1000 GΩ to as low as 10-100 GΩ for the worst planes. Still, this level of resistance is far too large to affect the strip readout.

The unchanged level of gas gain and the decrease in strip-to-strip resistance suggested that the polymerization deposits must have been formed on the cathode surface and not on the anode wires.

Fig. 9. Resistance between cathode strips vs. accumulated charge

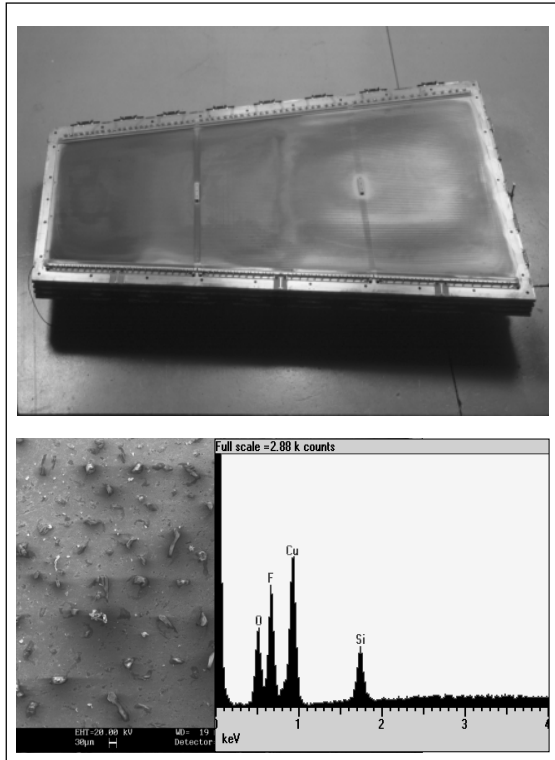
Fig. 10. Top: deposits on a cathode plane. Bottom left: magnified view of deposits as seen with the help of an electron-scanning microscope. Bottom right: element composition of cathode plane residue.

Disassembling the chamber confirmed these expectations. Indeed, whitish[20] deposits were found on the cathode surfaces spreading far beyond the irradiated area (Fig.10). The last plane along the gas flow stream (remember that this plane had HV turned off during irradiation) also had some of the residue. Analysis of deposits revealed presence of O, F, and Si. Analysis of wires showed that they had stayed fairly clean with only sporadic blots of polymers of similar composition (Fig. 11).

[20] It is interesting to note that, after a few days of being exposed to air, the residue became very dark.

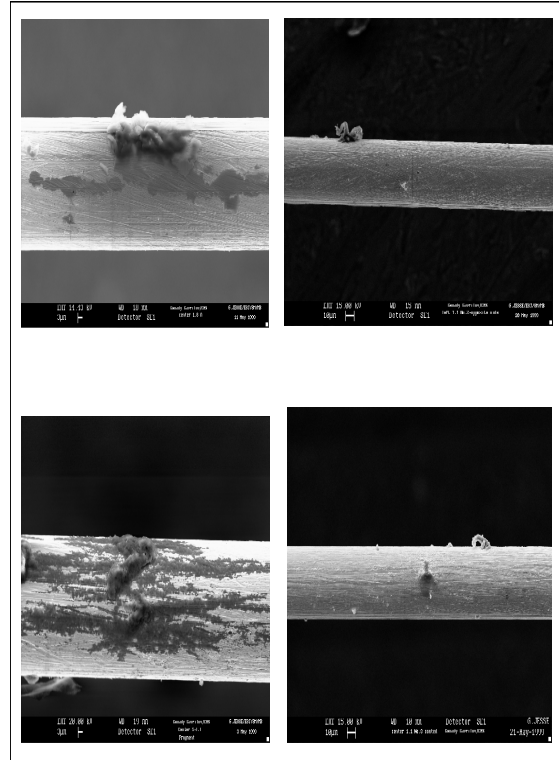
Fig. 11. Anode wires after irradiation as seen with the help of an electron-scanning microscope
