H1 Forward Silicon Tracker: water damage

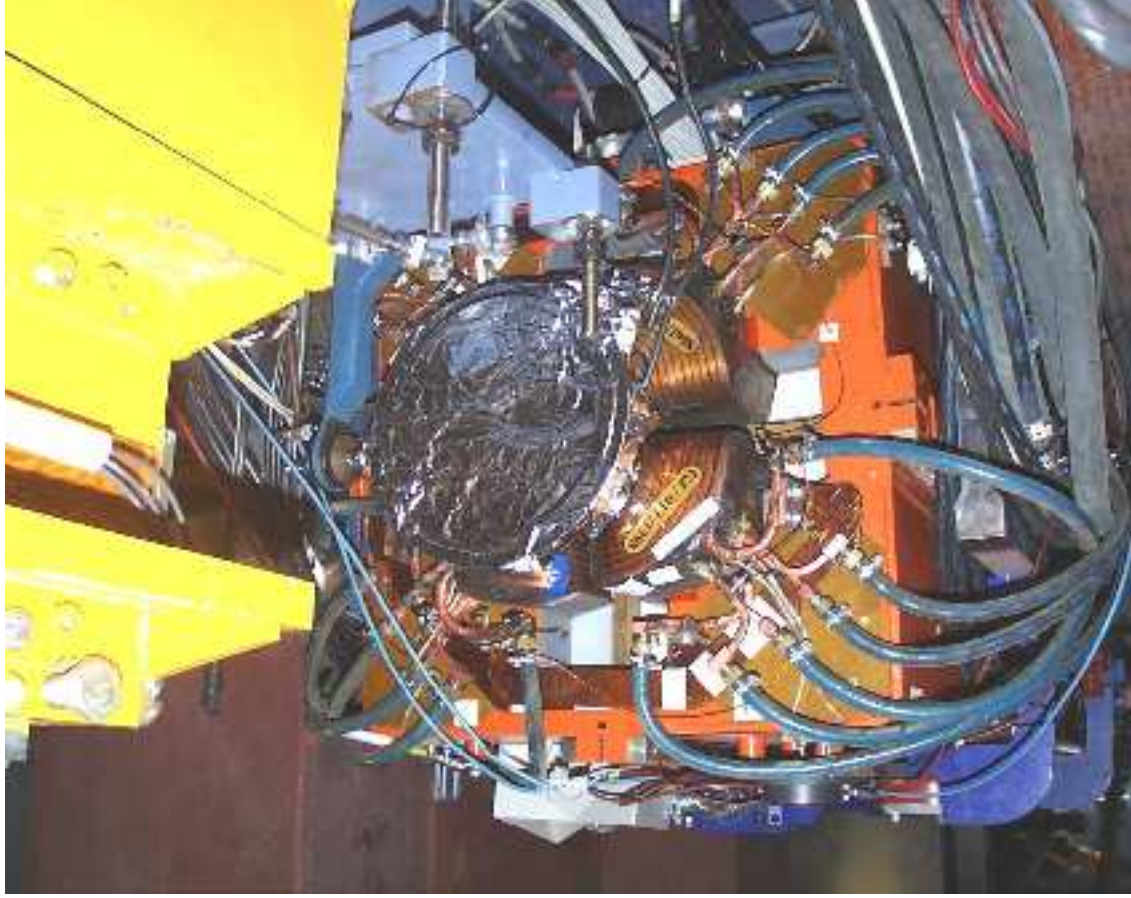
Absorber 4 removed

- Waiting for ABS4 with Cu insert.
- p and e beam pipes will be welded in situ.

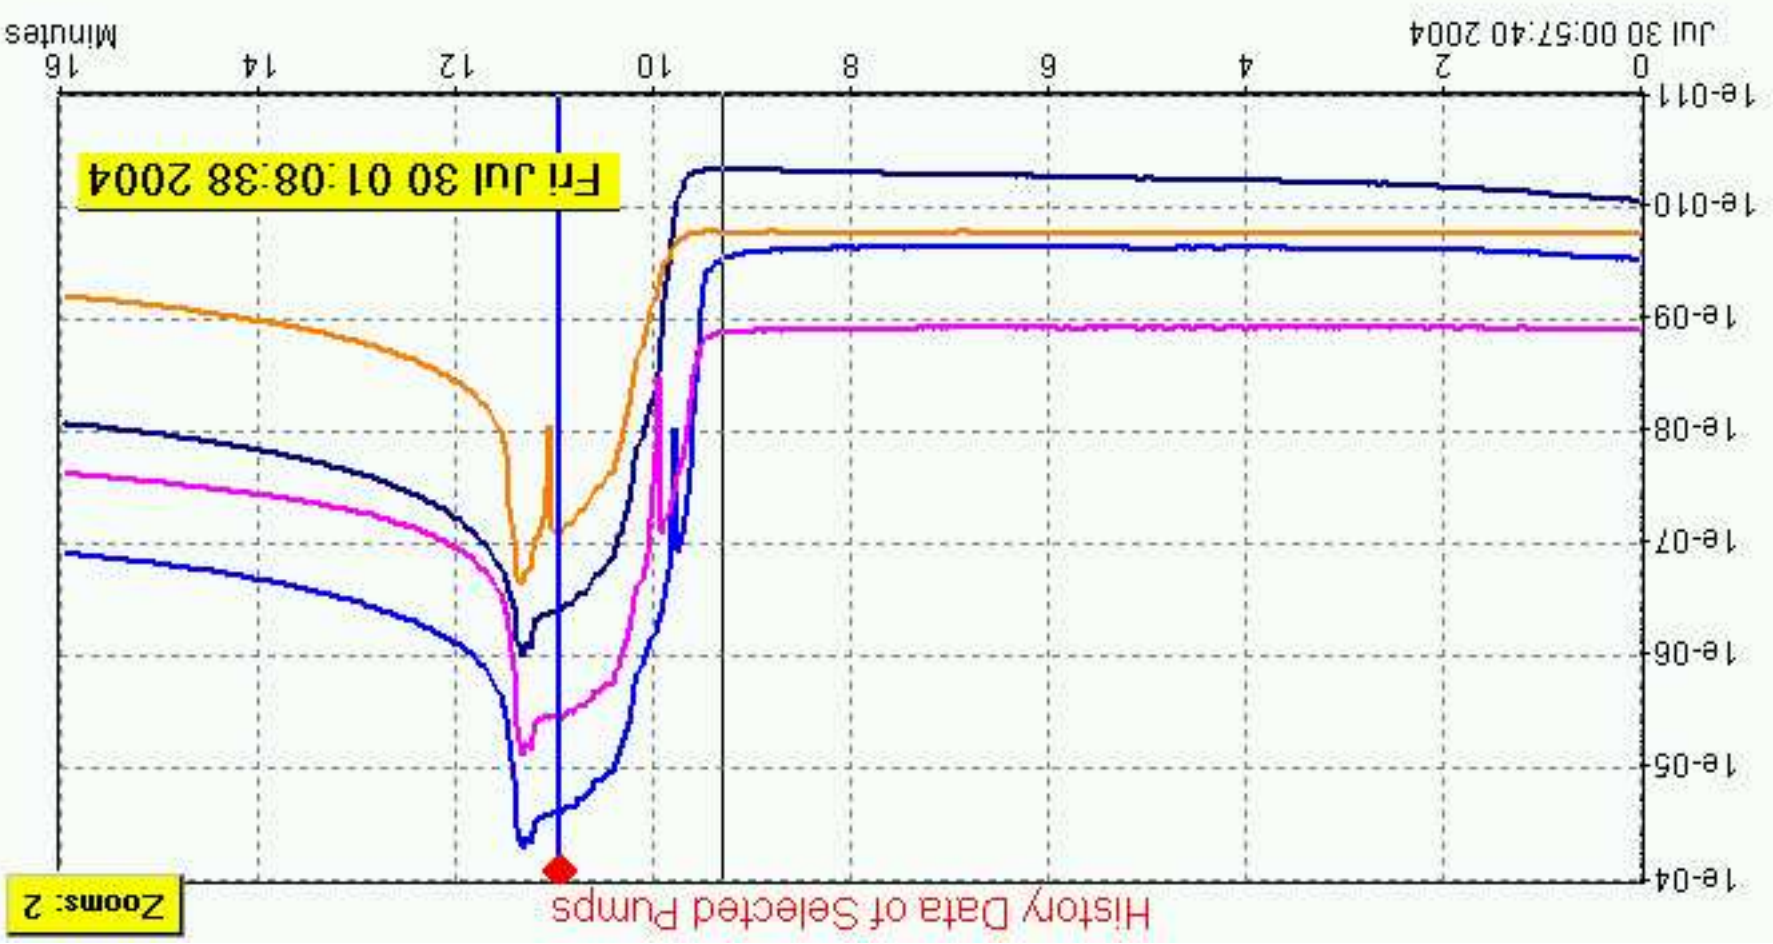
Gas burst on 30.7.2004

- BTS6.2 reacts 2 min before chamber trip.
 - Chamber trips at onset of gas burst.
 - Beam loss is another 1.5 min later.
- ⇒ Plenty of time for a BTS beam dump signal.

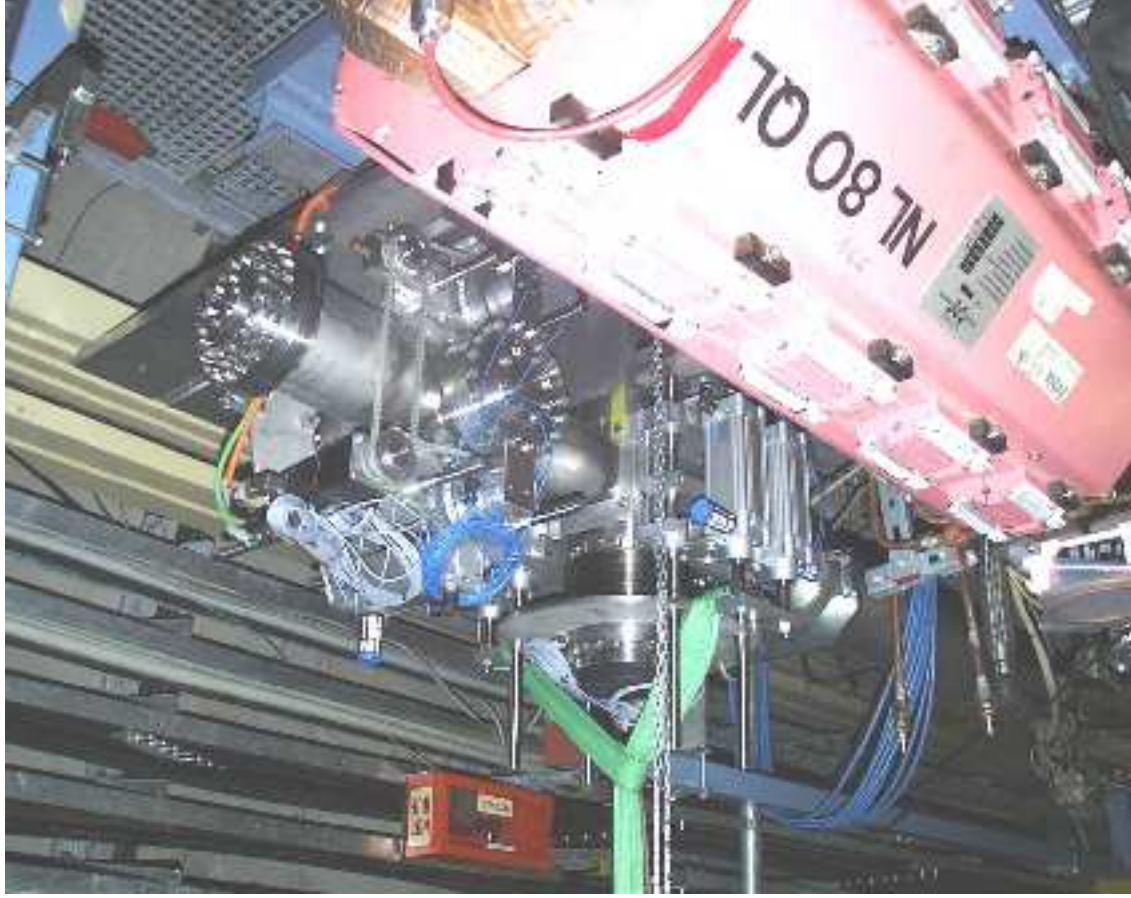
80/81 m horizontal and vertical pots.

- All stations installed: 61, 80/81, and 90 m.
- 80/81 and 90 m stations passed vacuum test.
- Electrical connection in progress.
- Fiber detectors to be installed last.
