PETRA-III 500 MHz Cavity

Status Report

Michael Ebert
DESY-TEMF-Meeting
Hamburg, 23.01.2017

Unsolved Reflected Power Trips „r events“

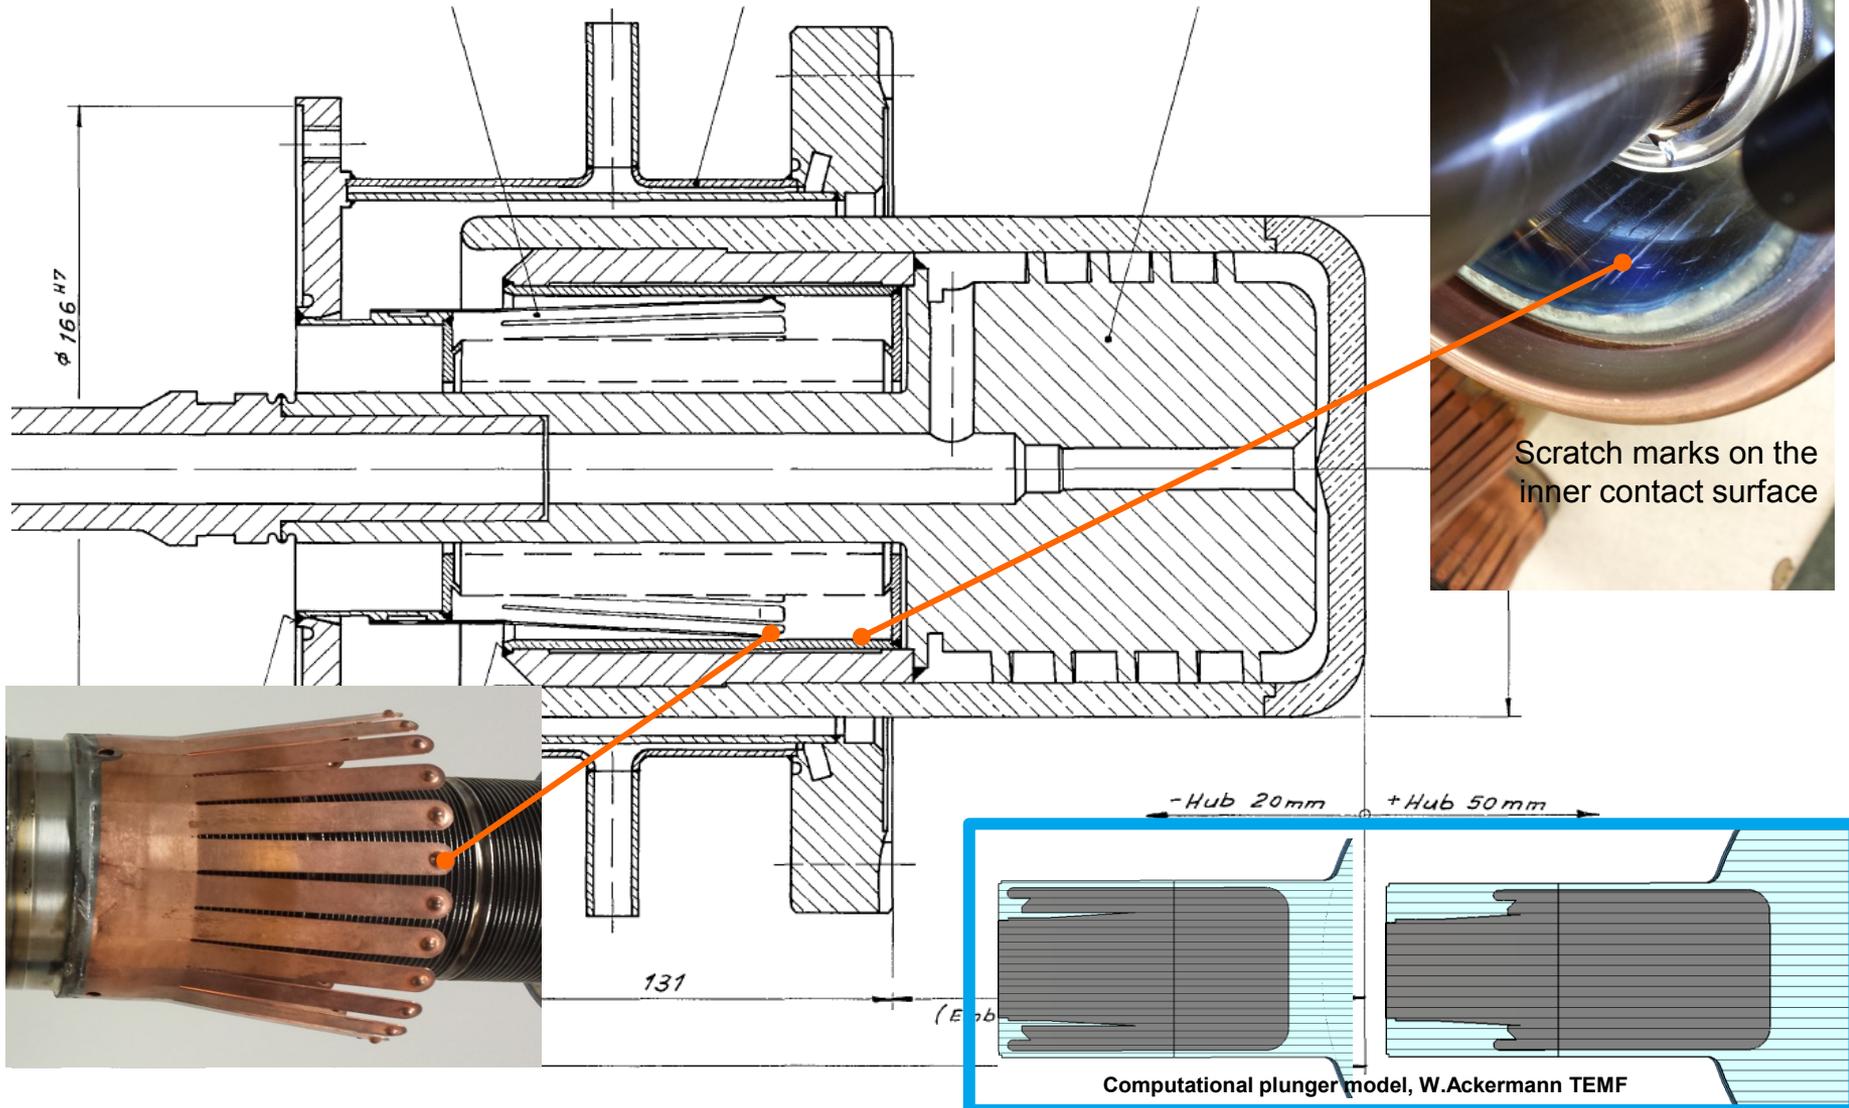
Suspect RF Springs

For decades, in the case of unexplained cavity problems, the plungers with their contact springs were always suspected

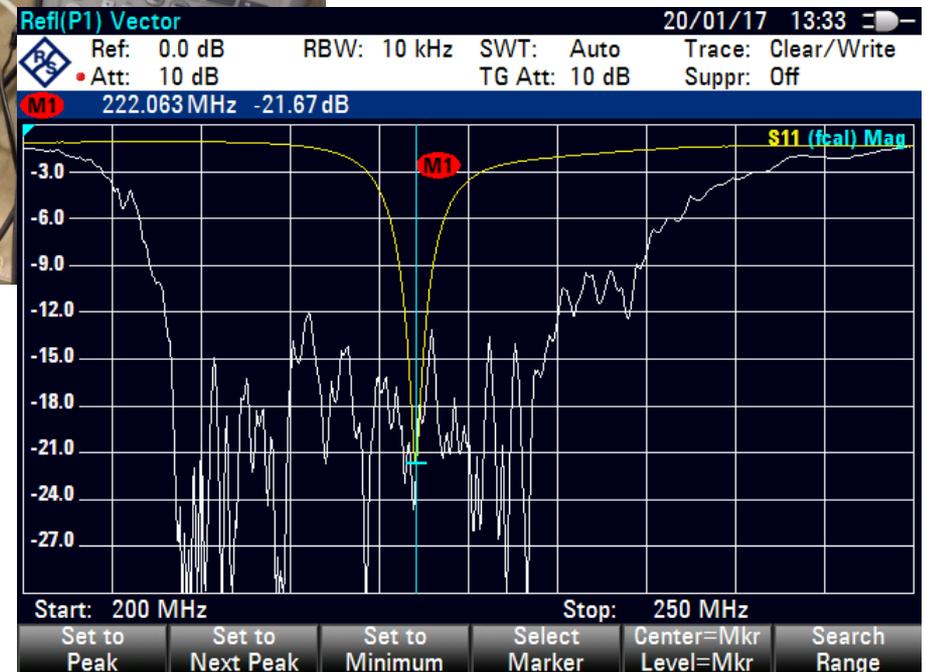
- > Plunger exited as coaxial $\lambda/4$ - resonator
- > Observation: Resonance is jumping up/down and back/forth during the plunger runs
- > This finding could be well explained by contact problems
- > **Question: How could we measure this with the plunger mounted on the cavity?**
