Aging Effects in the Central Jet Chamber of H1

- Introduction to H1 Tracking System
- 1) Corrosive Damage of Wires
- 2) Aging due to Sense Wire Deposits
- 3) Malter Effect on Cathode Wires

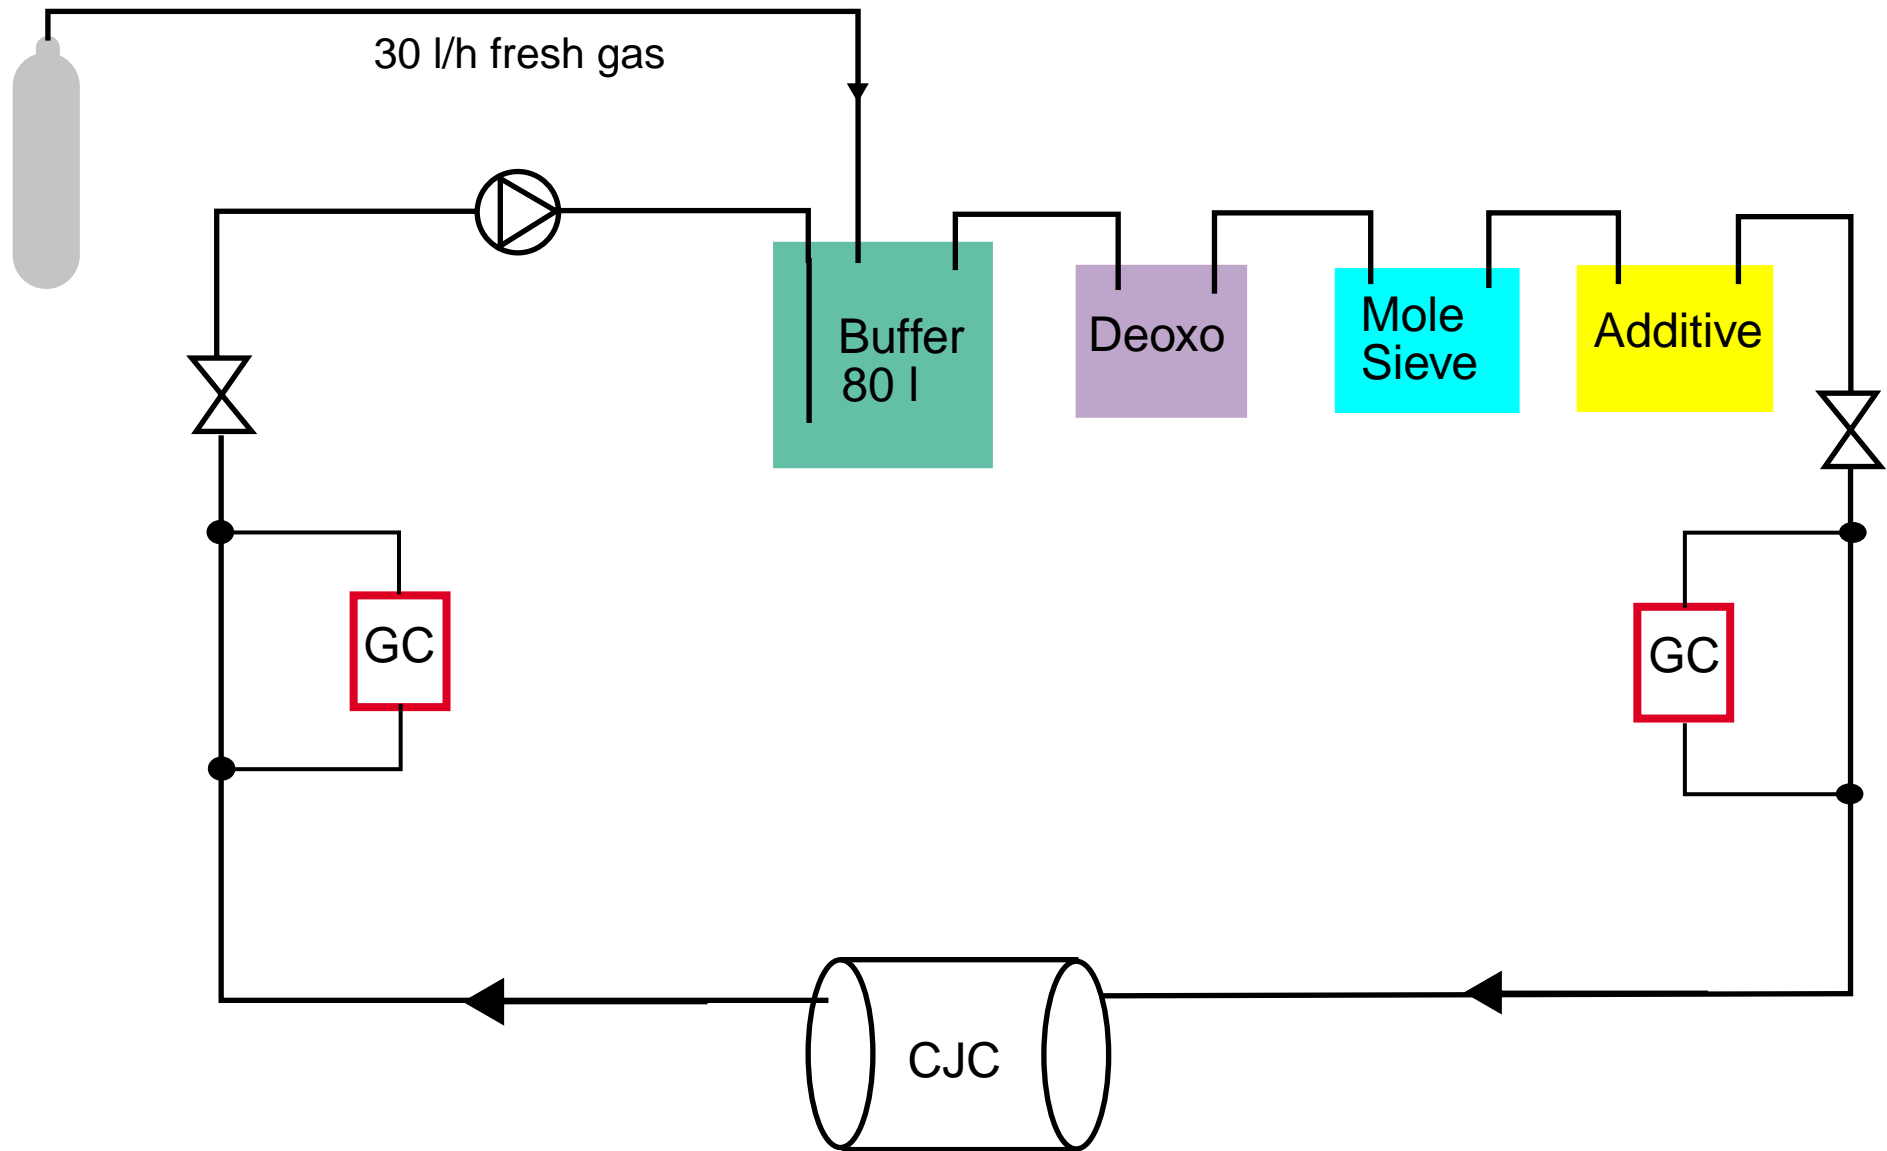
Layout of Gas System

- internal origin - from chamber itself ?
CJC1 and *CJC2* made from identical components (except outer Al-cylinder in *CJC2*)
- external origin
CJC1 and *CJC2* connected to same gas circuit
- accumulation due to non-uniform gas circulation?
potential problem might be **gas distribution ring** which is not common for *CJC1* and *CJC2*

gas rings replaced with individual pipes equipped with flow meters
in order to guarantee homogenous gas distribution for all inlets

- in order to increase the gas flow through CJC2 each chamber is now connected to its own gas circuit
- replace gas pipe from gas room to detector?
