Agieng studies for
the ATLAS
Transition Radiation
Tracker (TRT)

Contents

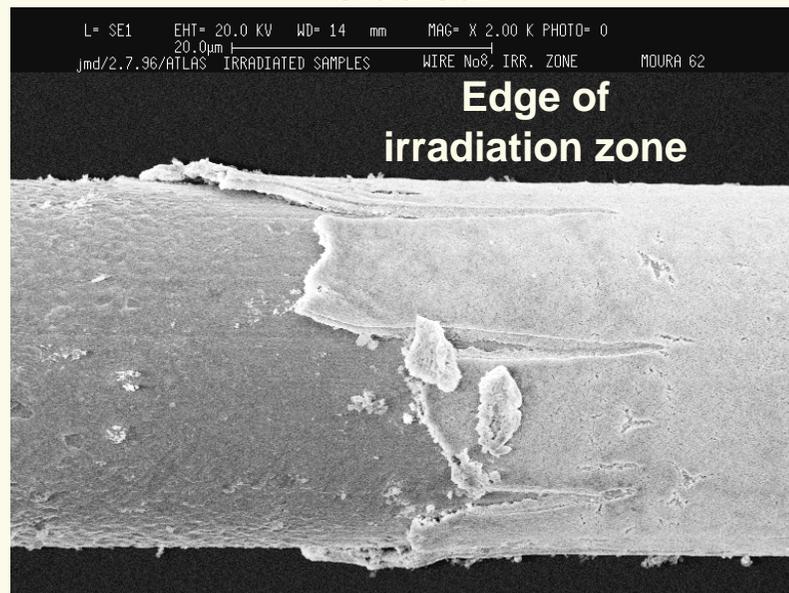
First observation in 1996 when cathode robustness to large irradiation doses was studied.

Wire - 30 µm gold plated Tungsten, current density of ~4 µA/cm, total accumulated charge of ~18 C/cm.

In some cases WO deposit was observed!

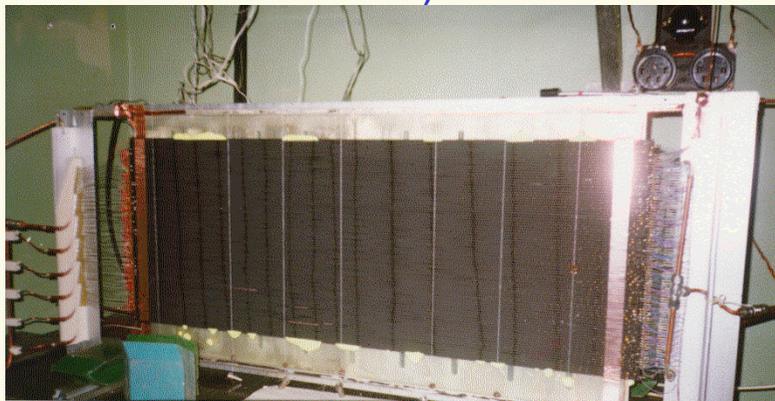
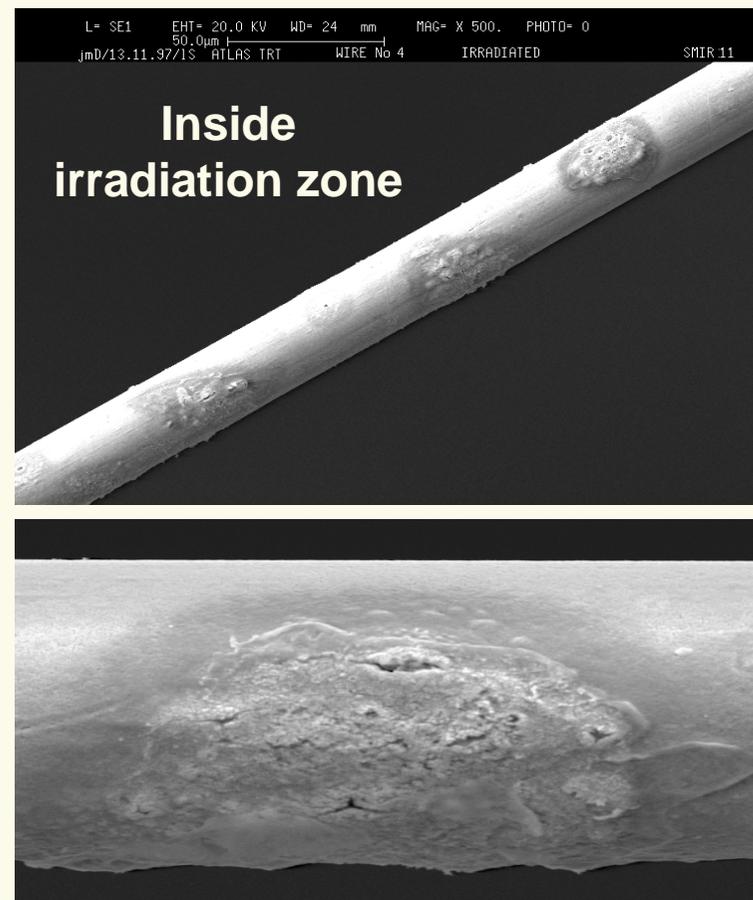
After 2 C/cm

Large-scale prototype:

- 61 straws of 1m length
- All straws were irradiated (60 cm of each straw) by X-ray tube
- 52 straws were in a closed loop gas system
- 9 straws were flushed
- Dose rate was $0.7 \mu\text{A}/\text{cm}$ (6 times less than maximum LHC)

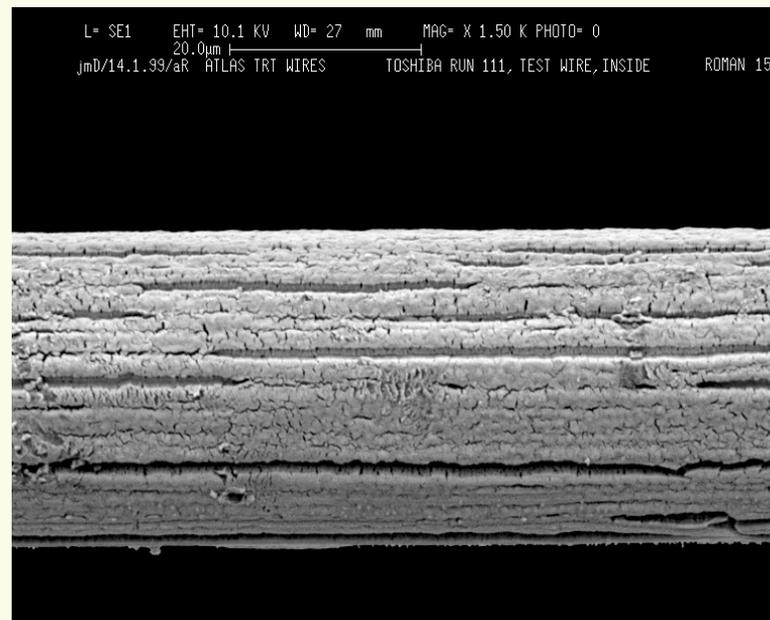
Effective wire diameter increased by ~2 μm

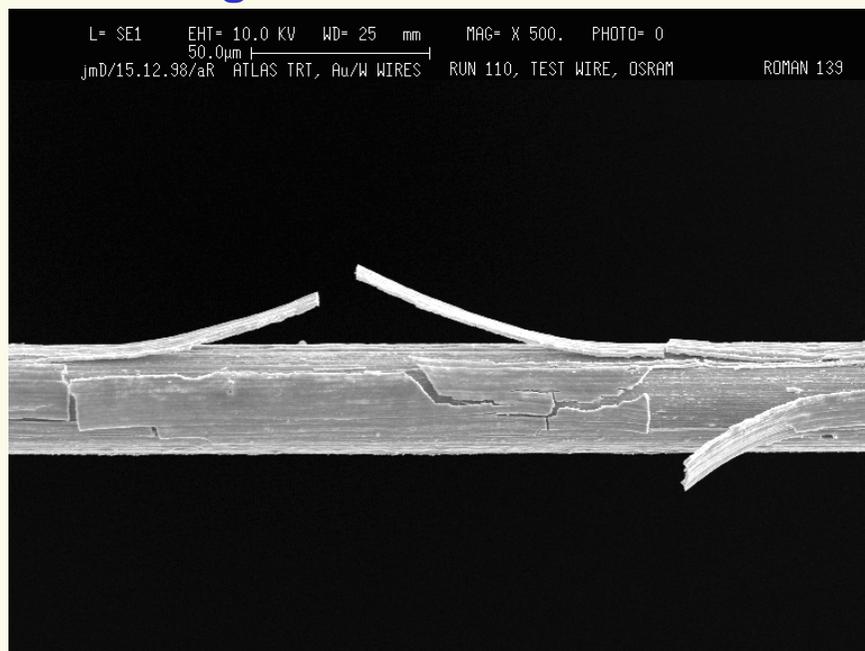
Conditions:

Mixture: 70% Xe +27.5%CF₄+2.5%CO₂

Wire: OSRAM, 30 μm, ~0.5 μm gold

Current density: 1 μA/cm

Total charge: ~2 C/cm

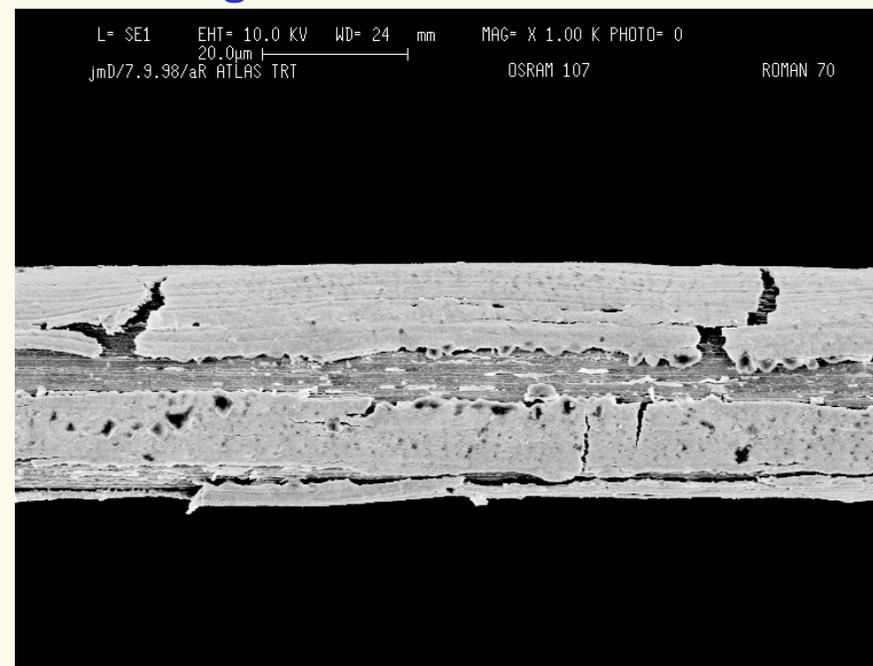
Conditions:

Mixture: 70% Xe +6%CF₄+24%CO₂

Wire: OSRAM, 30 μm, ~0.5 μm gold

Current density: 1 μA/cm

Total charge: ~2.5 C/cm

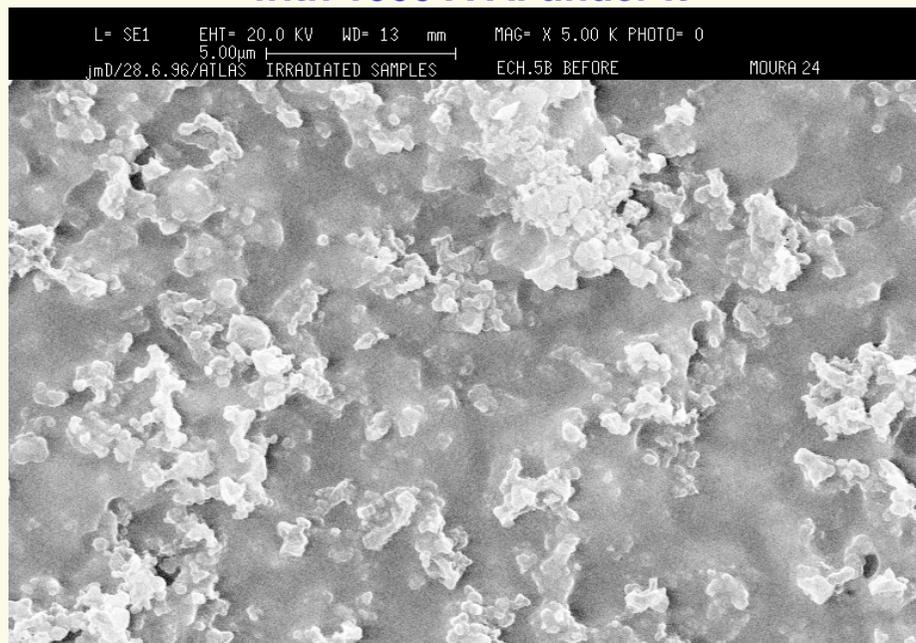
Straw cathode after 20 C/cm of accumulated charge

Some amount of polyimide was etched off after 20 C/cm but **NO** deposit on wire observed!

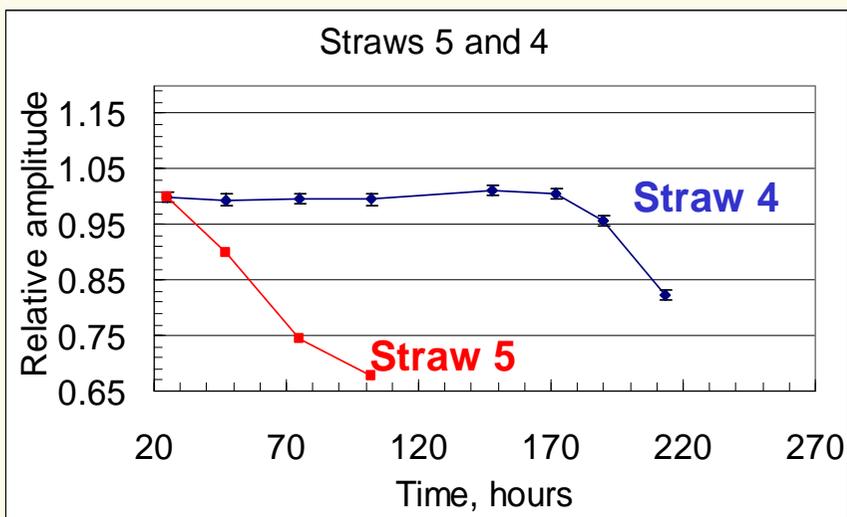
- Few serially connected straws
- gas flow from straw 5 to straw 4
- all straws are irradiated with a current density of ~ 50 nA/cm ($\sim 30\%$ of max at LHC)
- At the moment corresponding to 170 h of irradiation straw, 5 was disconnected from HV

Si deposit propagation along the wire

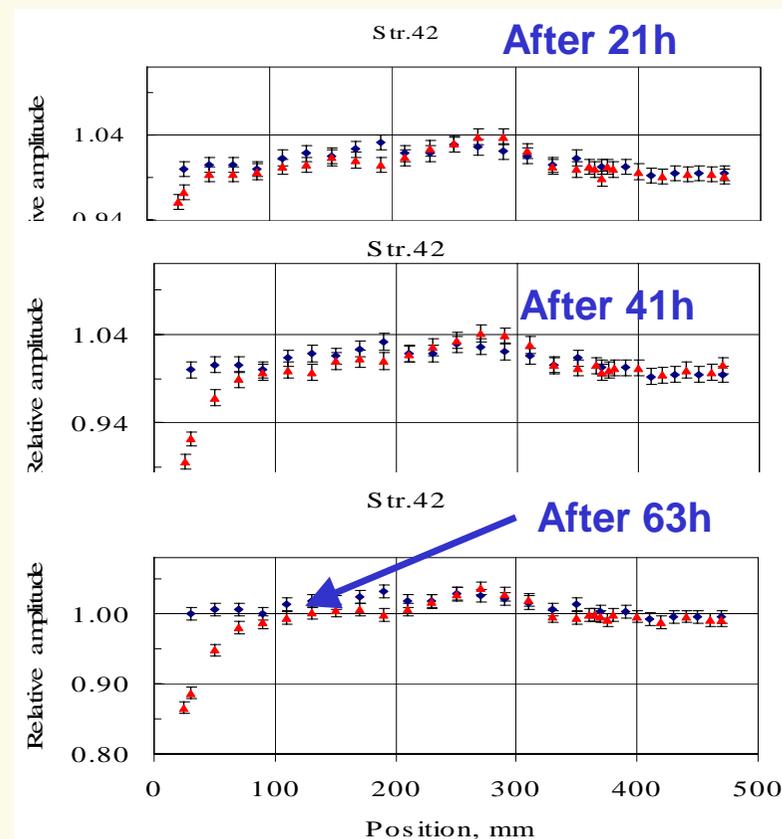
Straw of 50 cm long connected to the gas system with weak source of Si (irradiation length of 50 cm current density of 10 nA/cm)

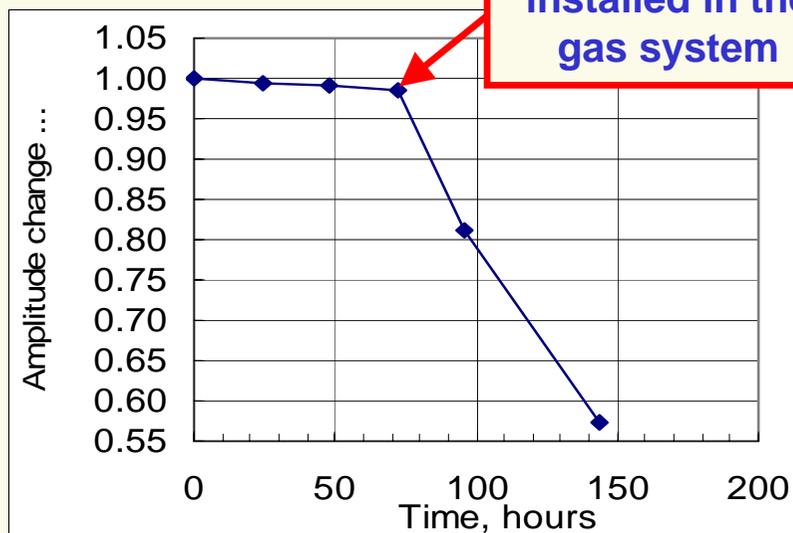
Example: “Vogtlin” flow regulator (rotameter) specially produced by company and claimed to be free from any lubricants (particularly Si-based).

Rotameter was installed in the gas system

70 hours was enough to pollute some parts of the straw!
