Restoring contaminated wires, removing gas contaminants, and aging studies of drift tube chambers

The original muon detection system of the Fermilab D0 colliding beam experiment contained 12,000 drift cells 10 cm by 5 cm in cross section and up to 580 cm in length. The gas mixture used was $Ar/CF_4/CO_2$ (90:6:4). There was one recycling gas system for all the chambers. During the first year of operation, it was discovered that inefficient cells, all in regions of high radiation, had a contaminating shell of crud coating their wires. The source of the contaminant was outgassing of the cathode pads, which were made from a laminate of fiberglass and epoxy/polyester resin, with a copper cladding on one surface. The vapor formed a brittle sheath on the wires, but only in regions of high current discharge due to radiation from the accelerator and colliding beams. A method for cleaning wires in place was devised. By heating the wire quickly to a temperature close to the melting temperature of gold, the sheath was ripped to shreds and blown away. The procedure for "zapping" wires and for removing the contaminating vapor is presented. The upgraded D0 experiment now uses Iarocci-type mini-

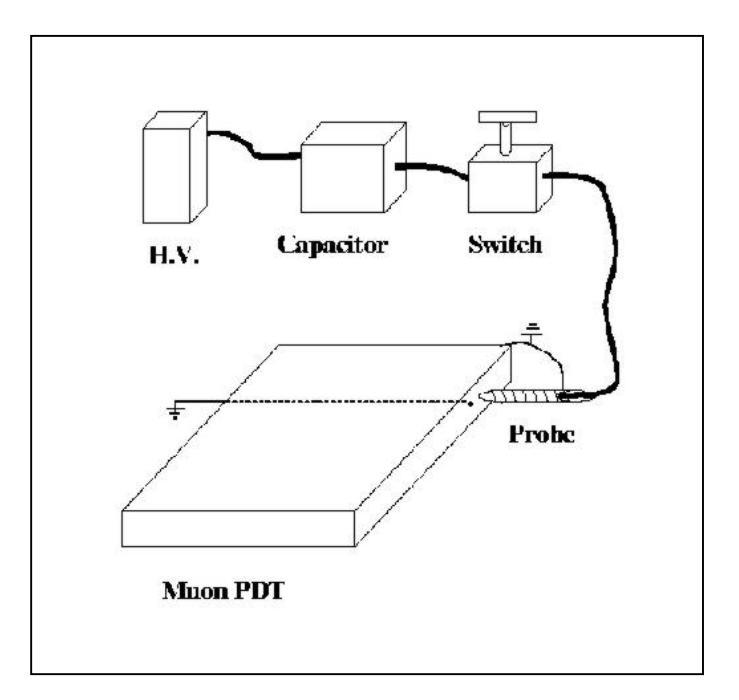
The procedure for zapping is illustrated in Fig. 1. One end of a cell sense wire is grounded to the chamber. A 1.5 microfarad capacitor is charged to between 3500 volts for a 190 cm long chamber and 6300 volts for a 580 cm chamber (this corresponds to a very lethal stored energy of 9.5 to 31 Joules). The zapping probe is then touched to the other end of the grounded sense wire and a switch is closed. The capacitor discharges through the wire in less than 2 milliseconds. The signals from the zapped wires are as good as newly replaced wires. Furthermore, the zapped crud does not return to the vapor phase and does not affect the detector performance. During a two-week shutdown we were able to clean over 5000 wires using this "zapping" procedure.

In our attempt to exploit the high current cleaning effect, however, we discovered that if the wire was heated quickly to a temperature close to the melting point of gold, the sheath of crud would shatter and be blown away! Investigating further, we found some other properties of this "zapping" procedure:

- If the heating was too slow, the crud cooked into a black, insoluble coating that was very hard to remove.
- If the temperature was too high, the gold melted and beaded up (later tests showed that the drift cells still worked if the gold was beaded up, or even completely removed from the tungsten wire).
- At the correct zapping speed and temperature, the gold might change its color (wires from different venders gave different zapped wire color). Green, orange and white tints have been seen.
- The zapping did not appear to harm the wire. One wire in our test chamber has been zapped over 100 times as a test. The signals from that zapped cell did not change, and the wire is still intact after 6 years have passed.
