# Additives that prevent or reverse cathode aging in drift chambers with Helium-Isobutane gas<sup>\*</sup>

A. M. Boyarski

*Stanford Linear Accelerator Center, Stanford, CA 94309, USA*

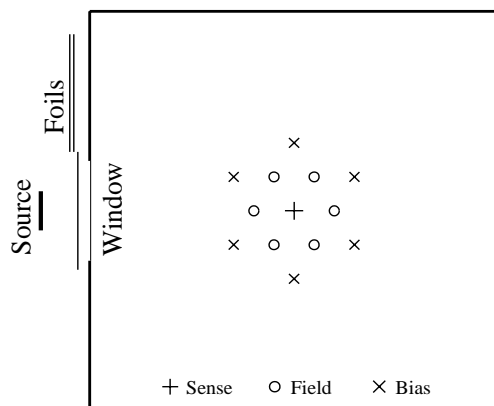
A small test chamber was built having one hexagonal BaBar-like cell as shown in Fig. 1. The sense wire (20 μm gold-coated tungsten-rhenium) is surrounded by six field wires (120 μm gold-coated aluminum) at 1 cm wire spacing. The six outer bias wires at 1300 volts together with 2050 volts on the

Figure 1. The test chamber. A single drift cell is enclosed in a square aluminum tube 10.2 cm per side, and 30.5 cm long.

sense wire provide a 19.2 kV/cm field on the field (cathode) wires and 239 kV/cm on the sense (anode) wire, giving a gas gain of approximately  $1 \times 10^5$ .

Gamma rays from a 100 mCi Fe<sup>55</sup> source entered the chamber through a thin Mylar window. Attenuation foils were inserted in front of the window to reduce the current to any desired level. A shutter made of 6 mm thick aluminum could completely attenuate the gamma rays. With the shutter open, the gammas passed through a hole that restricted the ionization to the middle 22 cm of the wires. With the attenuation foils removed, the anode current was 400 nA, and the maximum anode current density was calculated to be approximately 30 nA/cm at the mid-length of the wire.

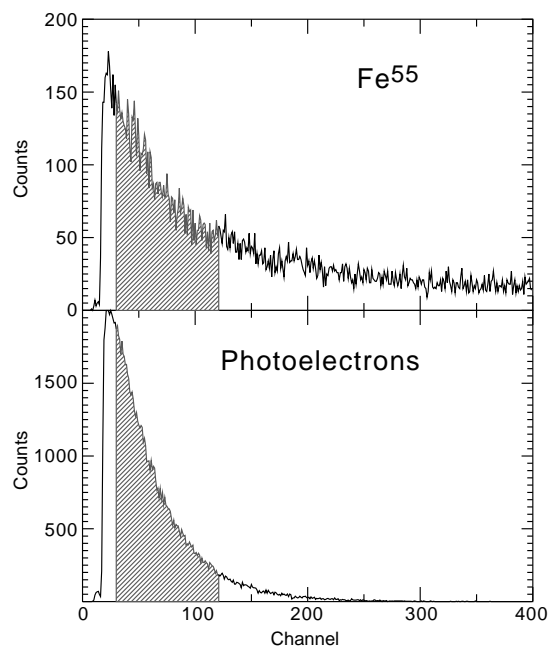
Figure 2. Pulse height spectrum for small pulses from Fe<sup>55</sup> and from single photoelectrons. The shaded channels are used to count single electron avalanches. The Fe<sup>55</sup> peak is off scale at channel 5500.

$\text{Fe}^{55}$  at a low source level, while the bottom plot shows the spectrum when incandescent light is allowed into the chamber. The latter spectrum is from photoelectrons off the cathode wires, and establishes the shaded channels (30-120) to be used for counting single electron avalanches. The small pulses from  $\text{Fe}^{55}$  are due to conversion locations grazing the boundary of the cell with only a single (few) electron(s) reaching the anode.

A Pico ammeter (Keithly 487) and a multi-channel analyzer (Perkin Elmer/Ortec 142PC, 570, and TRUMP PCI-8K) measured the cathode current and anode pulse spectrum, respectively. The 8K-channel range in the analyzer could accommodate both the Fe<sup>55</sup> peak at channel 5500 and the signal from one-electron avalanches at channel ~32. The analyzer did not record pulse heights below channel 20. The top plot in Fig. 2 shows the small pulse spectrum from

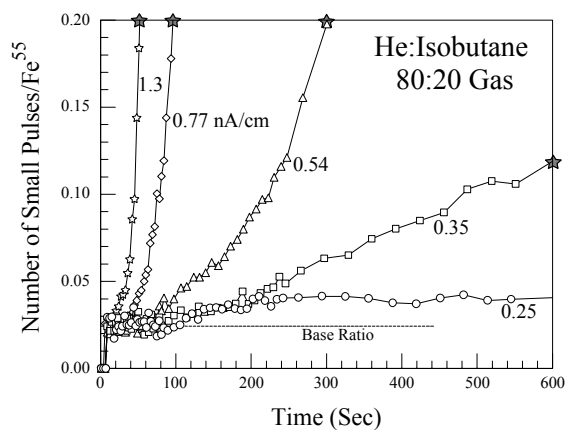
Figure 3. Transient behavior of small pulses in the He/Isobutane (80:20) gas after opening the source shutter, for various levels of wire current. A star at a boundary indicates that breakdown occurred outside of the plot area.

the transient behavior of small pulses for wire currents from 0.25 to 1.3 nA/cm in the Helium:Isobutane (80:20) gas with no additives.

When the source is first opened, the small pulse ratio starts at the same 0.025 base value for all current levels. At the highest current (1.3 nA/cm) the ratio grows rapidly until the chamber breaks down after 60 seconds. At lower currents the break down takes longer to develop. At 0.25 nA/cm the chamber does not break down although there is an increase in the number of small pulses.

In order to better understand the onset of the Malter currents, we measured the transient behavior of small pulses in response to a step in chamber ionization. This was done by closing the source shutter for at least 5 minutes and then opening the shutter while recording pulse spectra every few seconds. The ratio of small pulse counts to peak counts was then plotted versus time. Such plots were recorded for various chamber currents. Fig. 3 shows

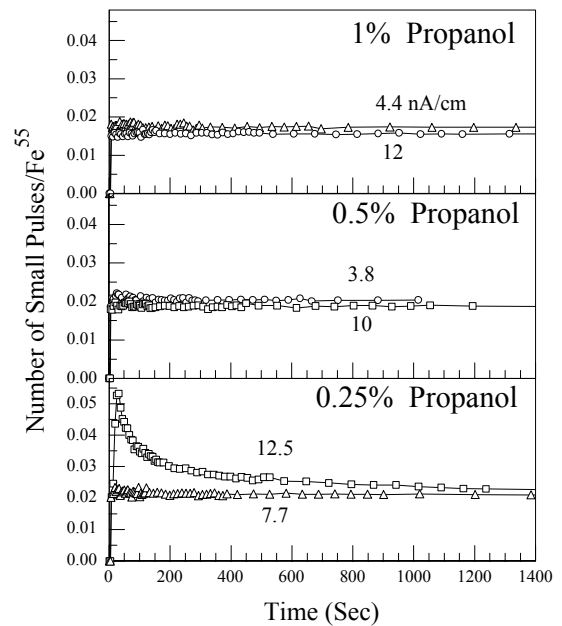
Some additives allowed chamber operation beyond wire currents of 10 nA/cm. The transient behavior with 2-Propanol,  $\text{CH}_3\text{CHOHCH}_3$ , is shown in Fig. 4. At concentrations of 1% and 0.5% there is no small pulse activity for wire currents of 10 nA/cm or more, while at 0.25% there is an initial increase at 12.5 nA/cm and then a gradual decline. The declining

Figure 4. Transient behavior of small pulses with an alcohol additive 2-Propanol. Concentrations above 0.5% show no small pulse activity.

A strange behavior already seen in Fig. 4 (bottom) is the rise and fall of the small pulse activity after the shutter is opened. This was seen for helium-isobutane gas alone, as well as for this gas with each additive studied, for currents slightly below the break down threshold. Fig. 7 shows this effect for the

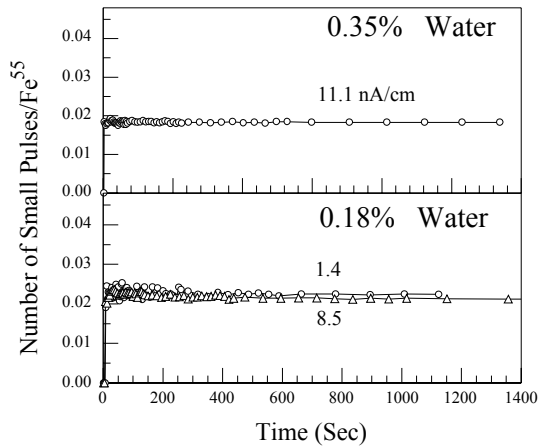
The transient behavior for a water additive is shown in Fig. 5. There is no visible small pulse activity with 0.35% or 0.18% water.

Figure 5. The small pulse transient behavior with a 0.35% or 0.18% water additive shows no increase in small pulses.

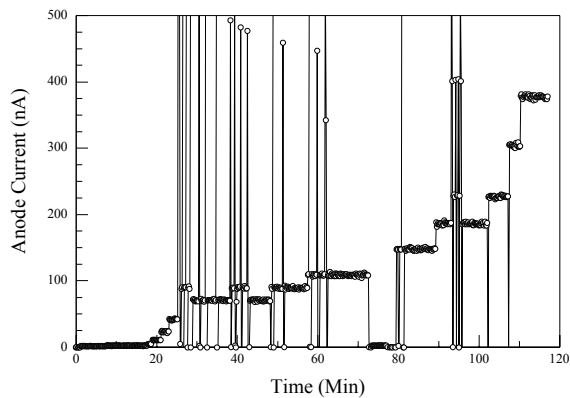
The final two additives tried in this study,  $\text{O}_2$  and  $\text{CO}_2$ , behaved differently. Whereas the previous additives allowed immediate operation at higher chamber currents, these did not. With  $\text{O}_2$  or  $\text{CO}_2$  it was necessary to increase the  $\text{Fe}^{55}$  source intensity slowly while keeping the high voltage fixed at the nominal settings. If brought on too quickly, the chamber would ignite in Malter mode, but after repeated attempts would become stable. Fig. 6 shows the anode current with 0.05% oxygen. After 2 hours of training the maximum  $\text{Fe}^{55}$  source intensity was reached, at an anode current of 375 nA (29 nA/cm current density).

Figure 6. The anode current during a curing cycle with 0.05%  $\text{O}_2$  is shown. The spikes are chamber trips, but after repeated attempts the chamber reaches a stable state at each current level up to the maximum  $\text{Fe}^{55}$  source level.

But more importantly, when the  $\text{O}_2$  was removed from the chamber gas, the chamber could still operate at the maximum 29-nA/cm current density. The  $\text{O}_2$  additive was able to cure a damaged chamber. This measurement was repeated several times (by damaging the chamber at high source levels and elevated high voltage, followed by a cure cycle) with the same result.

The fact that the chamber could not operate immediately at high currents with oxygen, but had to be slowly trained, is indicative that the oxygen reacts with and removes ingredients on the wires over a period of time. It requires both oxygen and a high chamber current to cure the chamber. Most likely, the ionic current passing through the high electric field near the wire surface heats up the local gas, which allows reaction of oxygen with the carbon-based deposits (polymers) on the wire surface. The  $\text{CO}$ ,  $\text{CO}_2$ , etc. combustion products are removed from the chamber by the flowing gas.

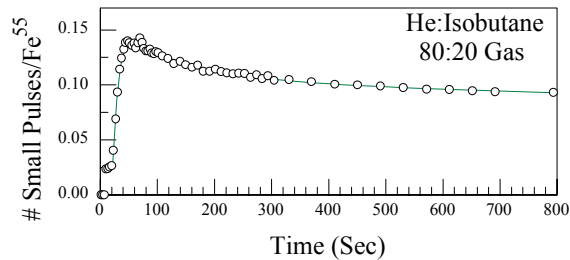
Figure 7. Small pulse activity at ionization levels just below the breakdown threshold shows a rise and then a fall from a step increase in  $Fe^{55}$  ionization.

Helium:isobutane (80:20) gas.

The increase in small pulses is readily explained by the Malter theory, in which an insulating deposit on the cathode collects the incoming positive ions and charges up to a point where the resulting high electric field draws off electrons from the cathode through the insulator. As the charge and the electric field build up with time, the rate of emission of electrons also increases as observed, until either Malter breakdown occurs or the charge build-up is balanced by ohmic current flow through the insulator.

But the sudden reduction in small pulses after a build-up period means that some other mechanism turns on which suppresses emission of electrons from the insulator. A likely candidate is heat. The positive ions gain energy when traversing the 19 kV/cm electric field at the cathode, and this energy is dissipated as heat in the collisions with the gas near the insulator or the insulating surface itself. As the insulator heats up, its effective resistance may fall. The charge build-up would then discharge more rapidly and the emission of electrons would decrease as observed.

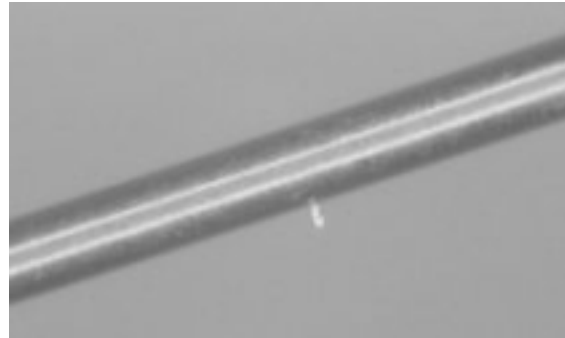
the wires, but many white localized structures or whiskers were found on both the anode and cathode wires. An example of a long whisker on a cathode wire is shown in Fig. 8.

Figure 8. Picture of a whisker on a 120  $\mu$ m cathode wire in a damaged chamber.

The chamber was then operated with 0.05% oxygen and run until cured to the maximum source strength. The chamber was again opened and pictures were taken of the same regions on the cathode wires. One whisker was gone but others remained as before. The one whisker could have fallen off the wire while transporting the chamber to the microscope room. There was no time to repeat this observation before the aging workshop.

*Note added in proof.* After the workshop, a glass window was added to observe the wires *in situ* from one side with an optical microscope having a resolution of approximately 2-microns. Pictures of whiskers and other features (a few per wire) on all the wires showed no discernable difference between the damaged state and the cured state. It appears that  $O_2$ -curing does not dramatically reduce the size of the observed whiskers.
